STUDY AND RENOVATION OF HISTORICAL MASONRY ARCH BRIDGE

Keywords: masonry arch, bridge, brick, mortar, material investigation, reconstruction.

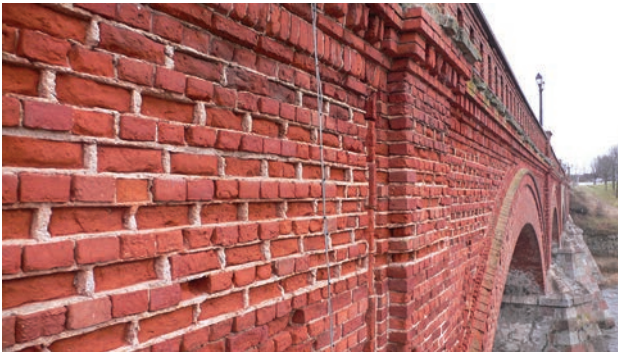
Fig. 5. Corroded and weathered bricks in wall surface from the upstream side

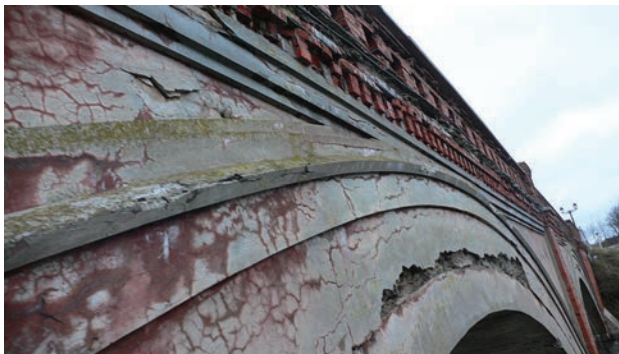
Fig. 6. Cracks and spalling in the reinforced concrete span surface

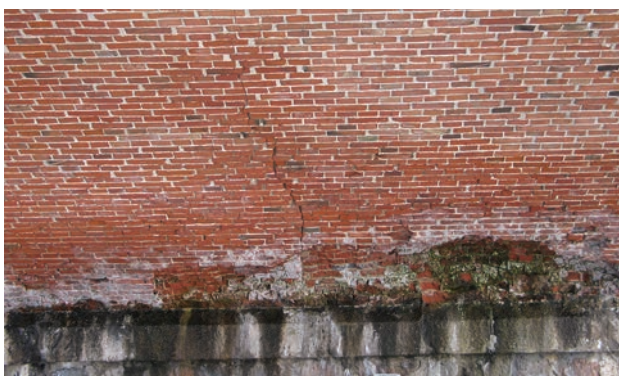
Fig. 7. A crack and falling out bricks around the water drainage pipes on pier 5

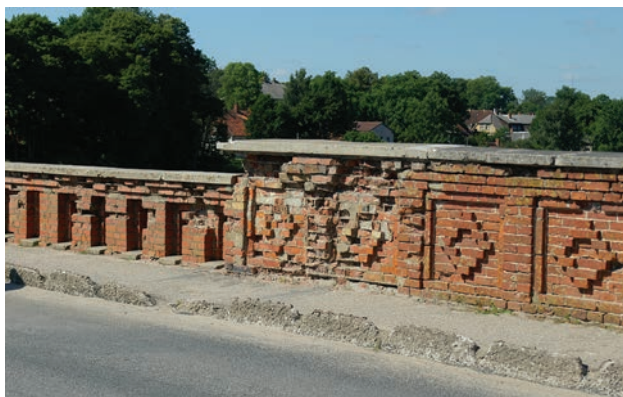
Fig. 8. Serious brick damages in the parapet structure

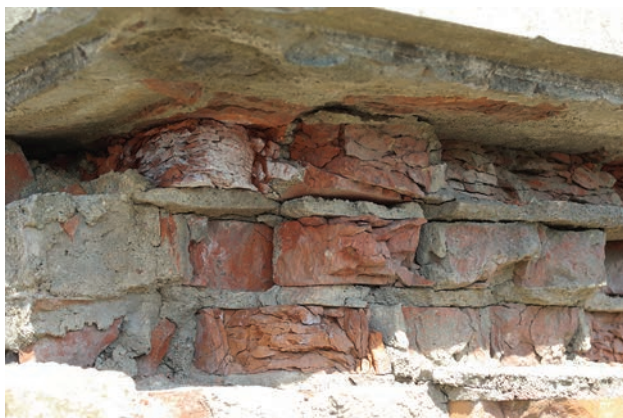
Fig. 9. Disintegrated bricks due to incorrect cladding material selection

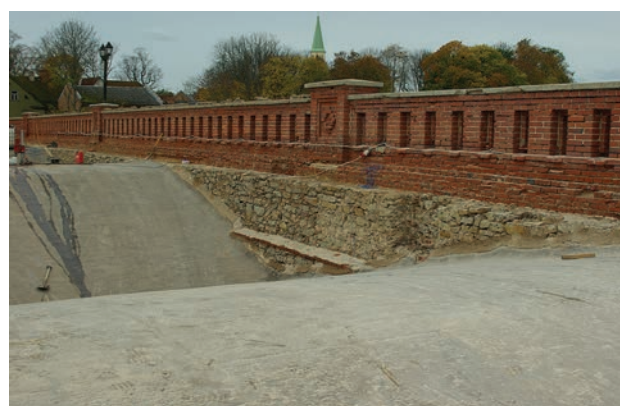
Fig. 10. Opened surfaces of brick arches showed remaining waterproofing and good technical condition

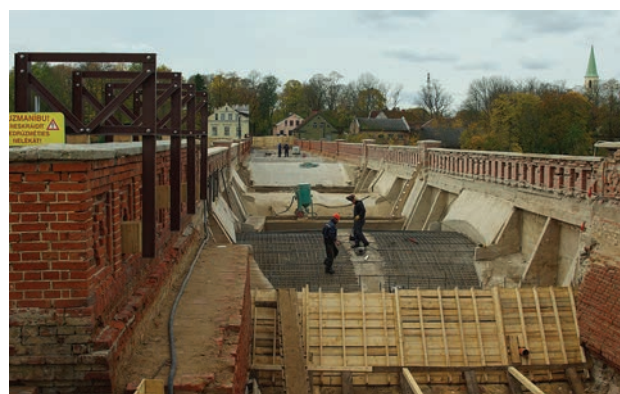
Fig. 11. Strengthening of the reinforced concrete arch span
