CONCRETE BRIDGE DETERIORATION CAUSED BY DE-ICING SALTS IN HIGH TRAFFIC VOLUME ROAD ENVIRONMENT IN LATVIA

Kristaps Gode¹, Ainars Paeglitis²✉

Institute of Transport Infrastructure Engineering, Riga Technical University, Kalķu str 1, LV 1658 Riga, Latvia

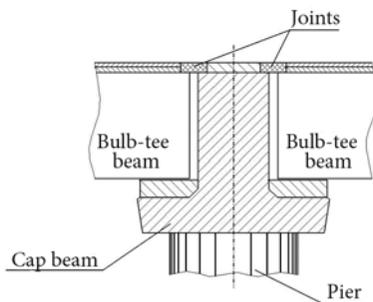
Fig. 5. Support structure of the bridge

The bridge above each pier has two joints, which are the weak point of these type structures (Fig. 5). Leaking joints may cause reinforcement corrosion damage to cap beam and tail-end parts of the prestressed bulb-tee beams.

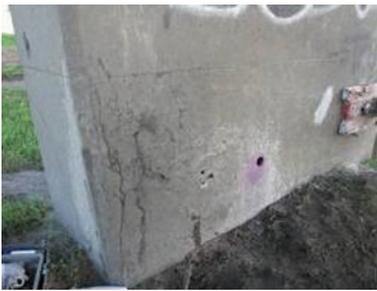
Fig. 8. Reinforcement corrosion cracks at the pier corner

angle. Reinforcement corrosion cracks were detected at the corner closest to the road (Fig. 8). Core drilling was performed at 83 cm away from the corner and 33 cm above the ground surface. A second core sample was taken from another side of this surface (Fig. 9).

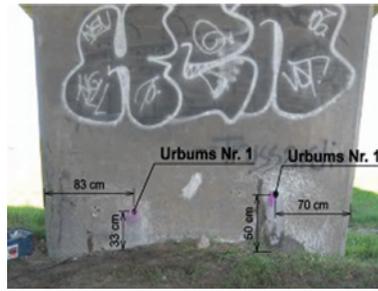
Fig. 9. Core sampling from the ramp No. 8 pier

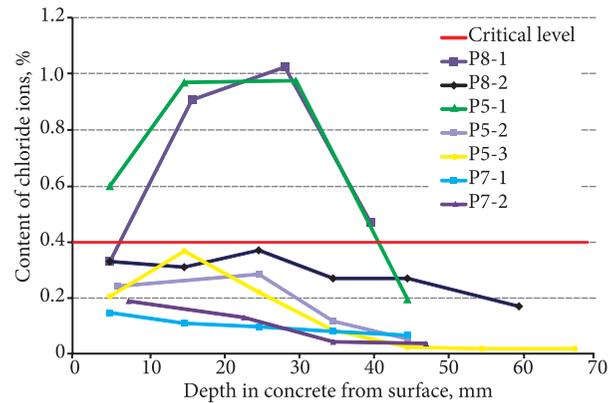
Fig. 11. Chlorides in cement paste of bridge piers

Fig. 14 shows that the amounts of chlorides vary greatly at different depths in concrete and in different places of the structure. In depths under about 15 mm the chloride content is low. This shows that chlorides closer to the surface were washed out. The profiles with the highest chloride concentration (samples P8-1 and P5-1) were found from surfaces facing toward the traffic direction and closer to the corner of the pier.

The profiles (P8-1 and P8-2) from the approach ramp No. 8 piers were obtained from the same surface facing towards traffic. Profile P8-1 shows much greater chloride concentration, because it is much closer to the road. At the reinforcement depth 42 mm the chloride concentration is close to critical value of 0.4%. Since no corrosion was detected, it is assumed that reinforcement corrosion threshold value is at least 0.4% or greater. Both profiles and the fact that there are reinforcement corrosion cracks at the pier corner, which is the closest to highway, show that chloride distribution is greatly influenced by the distance

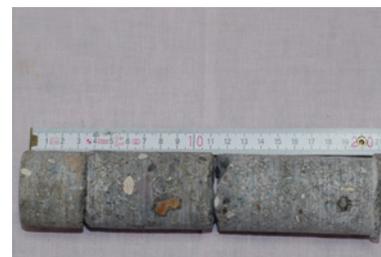
For the bridge over Biekēngrāvis we investigated corrosion initiated by de-icing salts that reach structure surfaces through leaking expansion joints. The core samples (Fig. 12) were obtained from the web of the beam near the tail end of it (sample P2 and P3) and from the cap beam side surface below the leaching joint (sample P1). The chloride profiles from obtained samples are shown in Fig. 13. The investigated web part of the beam did not have significant moisture signs. It was technically impossible to take the sample at very tail end of the beam, which might have a higher moisture exposure. The investigated cap beam surface that is located below expansion joint has been exposed to moisture and de-icing salts.

Fig. 12. Core sample from the web of the beam near leaking expansion joint

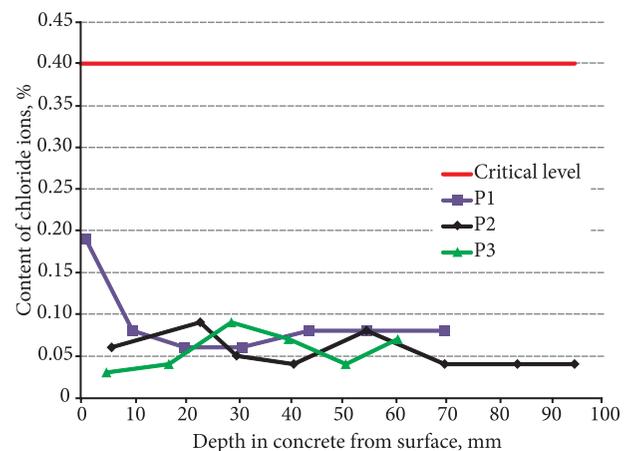
Fig. 13. Chloride profiles for the bridge over Biekēngrāvis

The investigation shows that chloride levels are low for the bridge over Biekēngrāvis. The concentration of chlorides in the vertical surface of the cap beam show greater amounts in the top layer, but it is sufficiently low so as not to cause reinforcement corrosion in the foreseeable future. The concrete of the girder and cap beam are of very good quality. The chloride level in the bridge beam close to the leaking joint, but not directly exposed to chlorides, also is very low. The corrosion risk exists only for surfaces with direct chloride exposure, such as horizontal surfaces on the bottom part of the cap beam. Investigation showed that parts below leaking joints at several places have severe reinforcement corrosion.

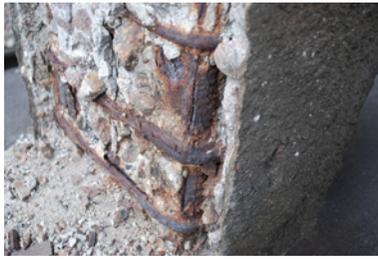
The bridge has deteriorated and also has leaking waterproof membrane beneath tram lines (Fig. 14). During inspection it was stated that corrosion of reinforcement bars in the beams is developing, what is causing the concrete cover to crack and delaminate. Two samples for chloride

Fig. 14. Corrosion of reinforcement

(Fig. 14). During inspection severe corrosion of the bridge piers towards the bottom were noted. The third sample obtained from the bottom part of the pier showed very high chloride content (Table 1). The inspection took place at the end of the summer season where most of the chlorides from the surface were washed out.

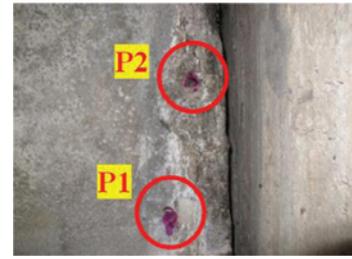
Fig. 16. Locations of samples P1 and P2 for bridge over the Daugava on bypass A5

As this bridge has leaking expansion joints, samples P1 and P2 were obtained from the tail end of the beam near a leaking joint where moisture was obvious (Fig. 16) and samples P3, P4, P5 from the position where no moisture or chlorides (signs) were present (Fig. 17). The inspection also took place at the end of the summer season where most of the chlorides from the surface were washed out. The samples were obtained by concrete drilling at different depths from the surface and collecting the concrete powder. The obtained chloride concentrations and chloride profiles are shown in Fig. 18.

Chloride profiles for samples P1 and P2 show higher concentration at depths of 40–60 mm because the sample was obtained near the tail end surface of the girder (P1 – 12 cm and P2 – 6.5 cm from the tail end surface). Most likely these chlorides entered the concrete from the tail end surface which is situated right beneath the expansion joint.

Visual inspection detected damage to the tail end surface of the girder, showing that there the chloride concentration is a lot higher and reinforcement corrosion is advancing. Reduced chloride amounts near the surface is likely to be washed out by water containing no chlorides during summer rains.

needed to initiate corrosion are a lot less. This means that these structures need to avoid being exposed to de-icing salts for longer periods of time. In cases of expansion joint or waterproof membrane damages it would be necessary to stop applying de-icing salts and repair damage to prevent chlorides reaching girder surfaces.

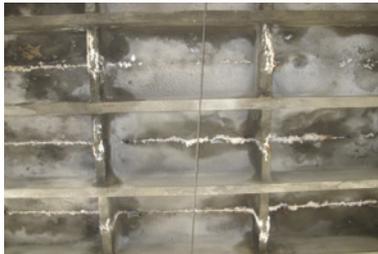
Fig. 15. Signs of leaking and deteriorated membrane

The main reason for corrosion deterioration of the bridge over the railroad “Gaisa tilts” is leaking waterproof membrane and also leaking joints. The leaking membrane is below tram lines, which makes them difficult to repair and it is obvious that they have not been repaired for very long time. The leaking waterproof membrane causes girders to have a high moisture level throughout the year and chloride contained moisture during winter. Corrosion damage usually appears on the bottom part of the beam and is spread within the whole span, which will cause the loss of structural bearing capacity in the middle of the span in the future.

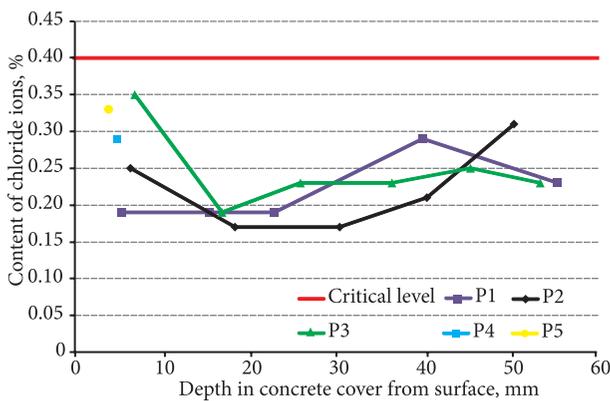
Fig. 18. Chloride profiles for bridge over the river Daugava on bypass A5

Chloride profiles for Riga bypass A5 bridge over the Daugava show that in general the chloride concentration level is not high and will not initiate intensive primary reinforcement corrosion. Higher amounts of chlorides are found in depths to 10 mm. At depths of 10–60 mm, the chloride content is more or less constant and is not reducing, which means that the girders have relatively high initial chloride concentration, varying between 0.19% and 0.25%, on average 0.22%. This high chloride concentration did not accumulate during the service life (especially for sample P3), where the girders have not been exposed to intensive and long-term moisture influence.

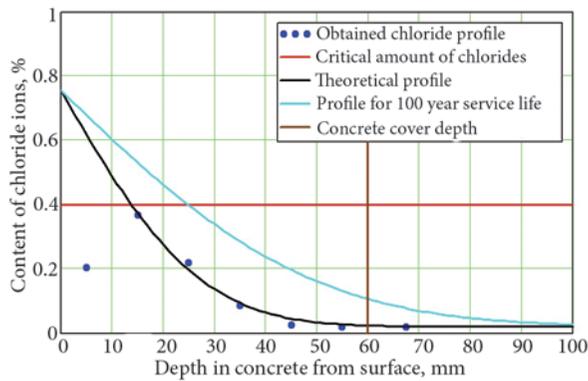
The profile P5-3 corresponds closely to the theoretical profile (Fig. 19). The future profile for 100-year service life is calculated by extrapolation. Fig. 19 shows that the critical concentration of chlorides at which it is assumed that corrosion starts has not reached the depth of reinforcement.

Fig. 19. Calculation of chloride profiles (profile P5-3) at deterministic level

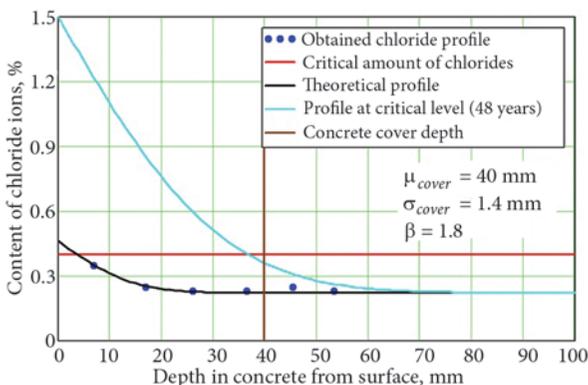
Fig. 20. Calculated chloride profile for 40 mm concrete cover in a case of a higher chloride exposure

performed at a semi-probabilistic level with reliability index β value of 1.8. In addition, the service life calculations were performed for a case of damaged and leaking waterproof membrane or expansion joints where high concentrations of chlorides reach superstructure surfaces.
