REMEDIAL WORKS AND REPAIRS OF HISTORICAL BRIDGE IN PRAGUE

Iva Broukalová¹✉, Vladimír Křístek²

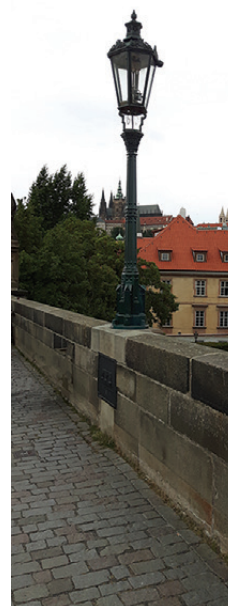
Fig. 3. New gas lamp

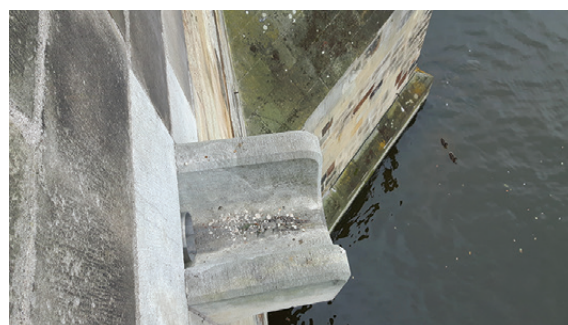
In the 14th century, the drainage of rainwater was provided by 24 stone gargoyles, which preserved. Current reconstruction retains draining water from the bridge deck through gargoyles (Fig. 4) from medieval times.

Fig. 4. Gargoyle with the new drainage system outlet

The pavement has transversal sloping 2 per cent, which creates two valleys in the distance 1.5 meters from the parapet. Rotatable bridge gully of cast iron funnels the rainwater by a lateral rust-stable outlet directly towards the gargoyles. Water seeps through joints in the pavement, is drained from the surface of the insulation.

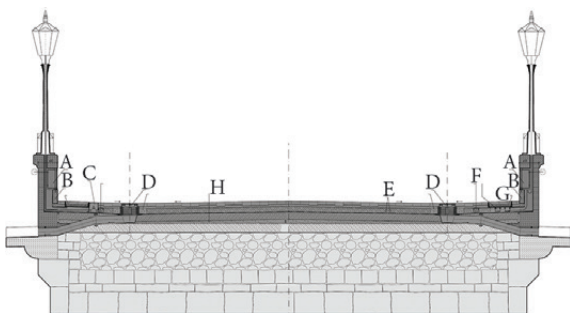
The depth of the protective concrete layer is 80 mm. This relatively thin layer incorporates all present-day networks in plastic installation ducts; i.e., piping and control cables for gas-lighting, cables of bridge night lighting and lighting of navigation signs, optic cables of the security system (Fig. 5).

Fig. 5. Bridge cross section of the arch crown (A – electrical enclosure box, B – stone cover of electric cables, C – gas supply switch, D – rotatable bridge gully, E – cable raceway of the security camera system, F – gas supply in conduit, G – electric cables in conduit, H – layers of the bridge deck: granite paving – layer of sand solidified with lime – protective concrete layer – drainage mat – sprayed insulation – screed concrete – geotextile – reinforced concrete layer from previous reconstruction) (Tvrzník 2008)

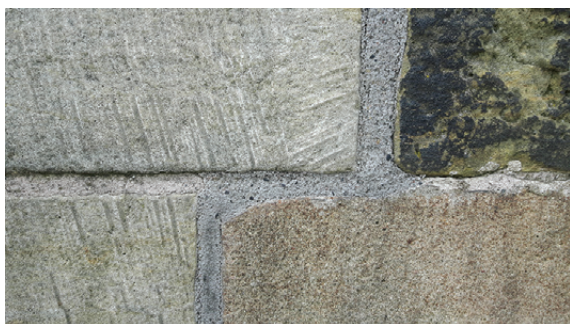
Fig. 6. Dilatation joint filled with polyurethane sealer and surface finish

Deformations of the parapet masonry are tied with deformations of the whole bridge. Because of the heat accumulation, the response to thermal changes of the bridge differs from the behaviour of the parapet. Therefore, dilatation joints had to be made in the brickwork. The joints are filled with polyurethane sealer, which is for aesthetic reasons spread by fine gravel (Fig. 6).
