# LARGE-SCALE TESTING AND LONG-TERM MONITORING OF REINFORCED EARTH ABUTMENT – A CASE STUDY

**Abstract.** Standard methods of controlling geotechnical structures are based on testing of individual elements (e.g., piles, anchors, barrettes) or on inventory of their displacements (for instance, current control, i.e., monitoring of retaining structures). It is only the bridgework where, due to uniqueness and importance of structures, the examinations are often run for the whole structures. The main problems are then the following: how to ensure proper repeatability of measurement accuracy (for long-term testing), how to establish optimum criteria of assessing the test results, how to use the results to make possible repair actions and how to interpret the obtained results. Based on an example of test of bridge abutment out of reinforced earth, the paper presents the method of displacement testing, basic criteria of assessing the results, measurement results during static load phase, during dynamic phase and results of long-term measurements. Large number of measurements enables for both evaluation of technical condition of the structure under testing (which was the main goal of the pr

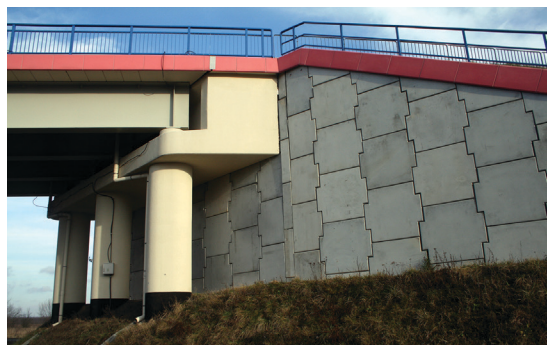
- Precast concrete facing elements did not make smooth and flat surfaces; bulging of the facade, offsets between elements, deviations from vertical, large differences in gaps between prefabricated facing elements were found; in extreme cases, the shape irregularities (deviations from design surface) exceeded 10 cm at local wall height of ca. 4.5 m (i.e., over 2% of wall height);

**Figure 2.** View of the facade elements of the abutment retaining structure

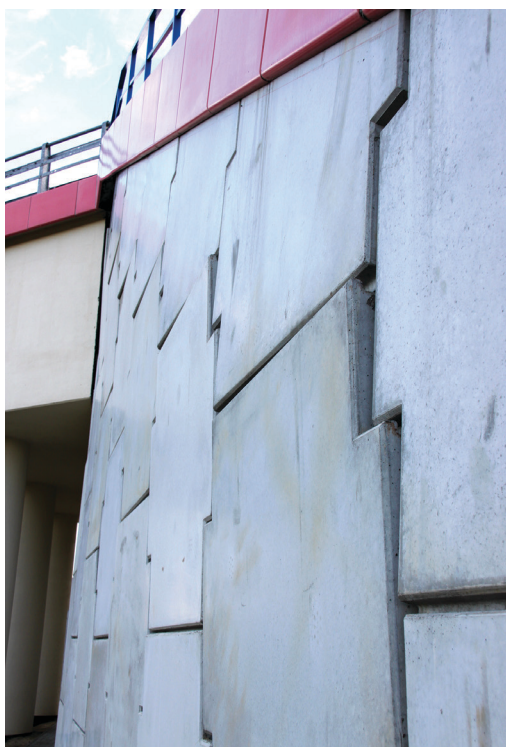
**Figure 3.** Selected shape defect of retaining structure surface

General view of the object is shown in Figures 1 and 2. Figure 3 shows a selected defect of retaining structure. A set-off between facing panels and their rotations and inclinations are visible. Prefabricates are clearly displaced each other and many of them are not in vertical plane.

The nature of visible defects indicated insufficient pre-tensioning of reinforcing strips. This way displacements of prefabricated facing elements revealed errors in constructing the reinforced earth structure. Presumptions were formulated about the reasons of these errors; however, no details could be determined as it was impossible to dismount even a single element displaced out of the distorted wall.

Essential and visually clear distortions of the shape of retaining structures resulted in decision to suspend putting the object into service. Due to the defects found, additional testing was proposed, including, but not limited to, load test of the structure. During testing, the embankment was loaded with prefabricated concrete road plates placed within the roadway at access area to the overpass; the value of load was close to that assumed in static analysis of the structure. Measurements made during testing included displacements of selected points on facing panels, displacements of columns of adjacent supports, and also vertical displacement of roadway pavement; also the mutual positions of panels were observed. Following load test, the object was approved for public traffic; however, decision was taken to run long-term geodetic monitoring of the retaining structures.

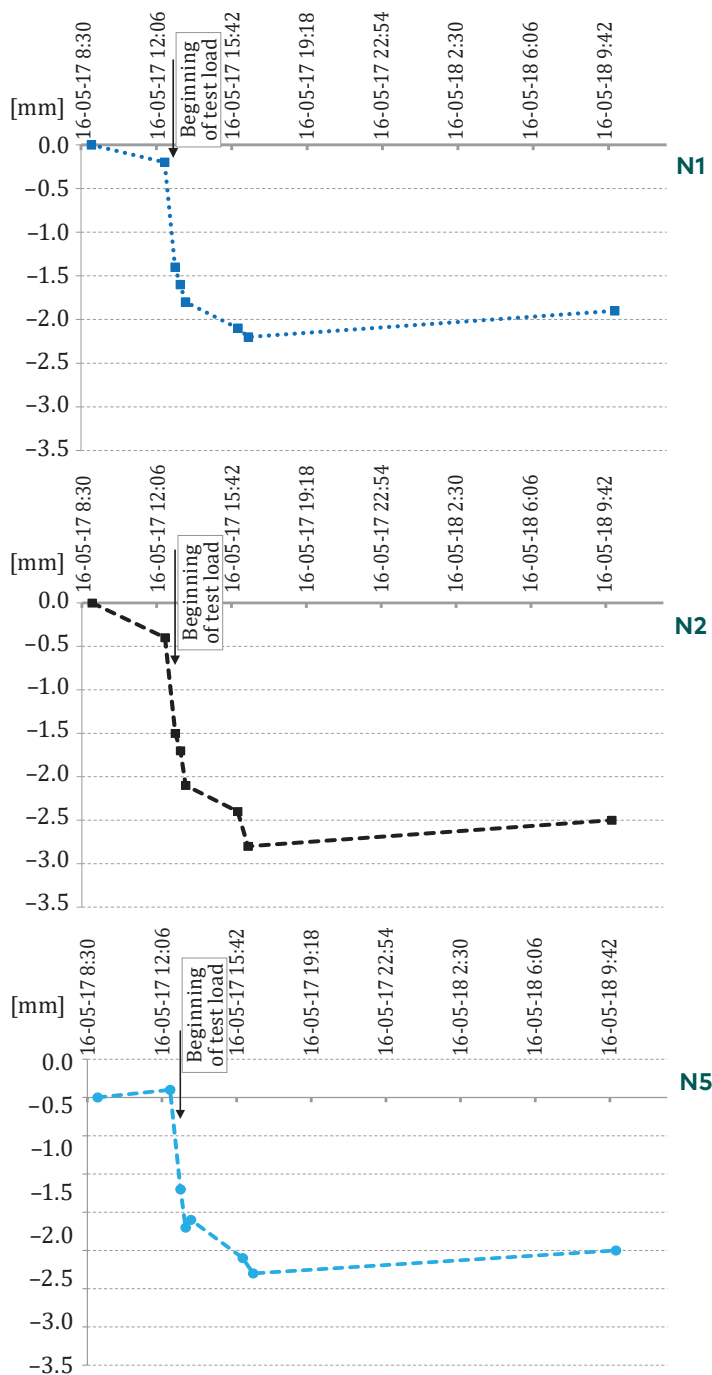
selected three benchmarks N1, N2 and N5 covering first 24 hours of test, are presented in Figure 7. As it can be seen from the course of the curves, the placing of the concrete road plates, which became the test load, took about 3 hours, from 1 PM to 4 PM. The load was left on the structure for 17 days. The charts of settlement, covering 20 days of experiment, again of benchmarks N1, N2, N5 are presented in Figure 8. The relaxation of the soil after the removal of the load is clearly visible in all three curves, which are representative.

**Figure 7.** Vertical displacements (in mm) of control benchmarks N1, N2, N5 within 24 hours from starting test load

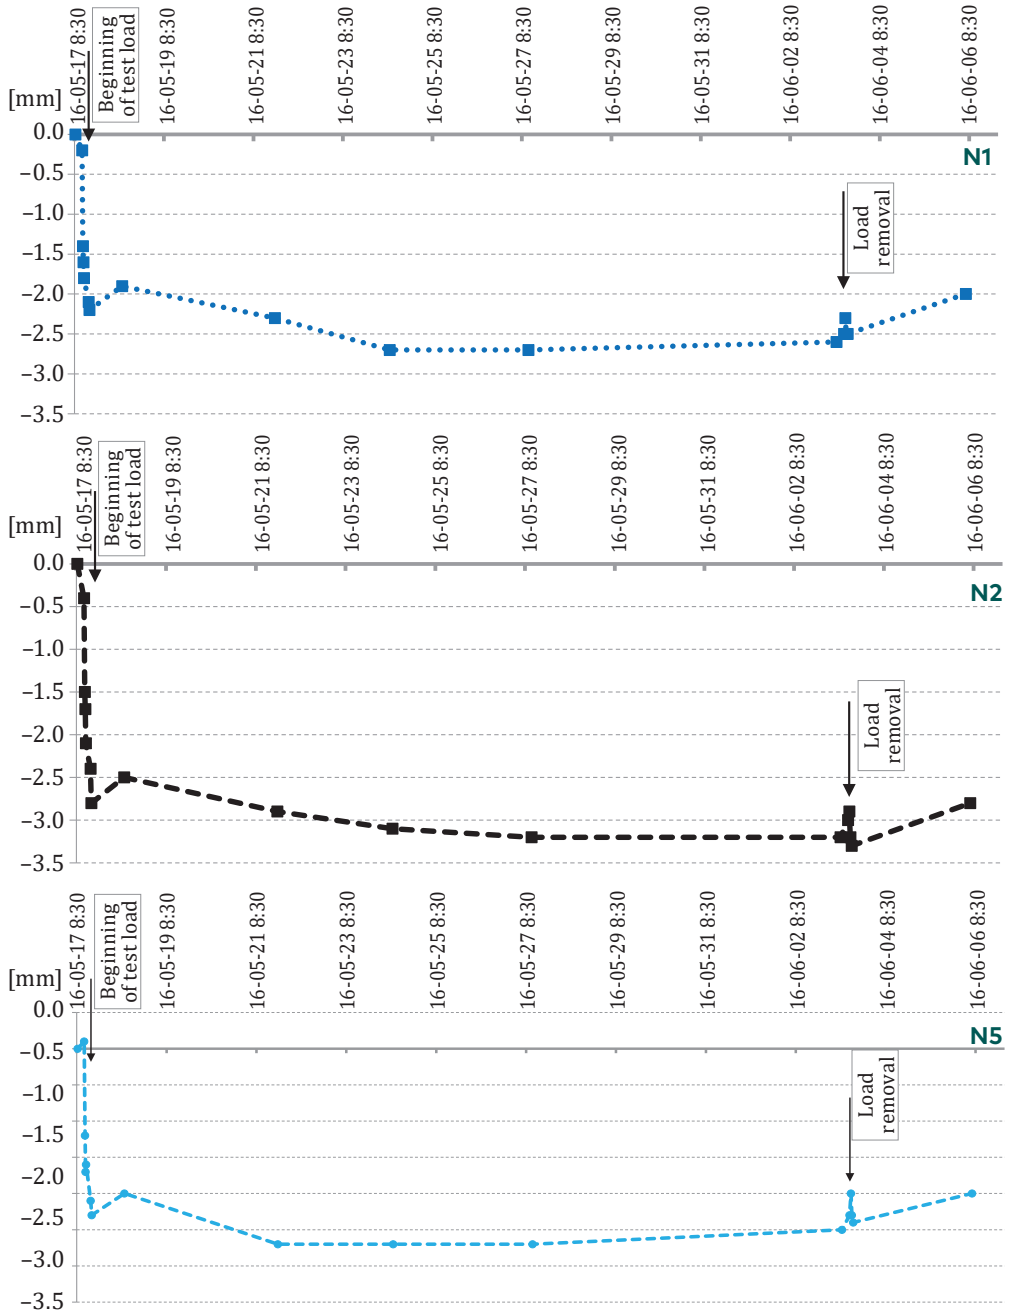
**Figure 8.** Vertical displacements (in mm) of control benchmarks N1, N2, N5 within 20 days from starting test load

- The structure under testing settled as expected, the settlements stabilized after around 4–10 days; on this ground, the assessment was made that the structure had some reserves of bearing capacity;
- The structure under testing did not show any alarming deformations in horizontal direction or any damage resulting from the actions undertaken.

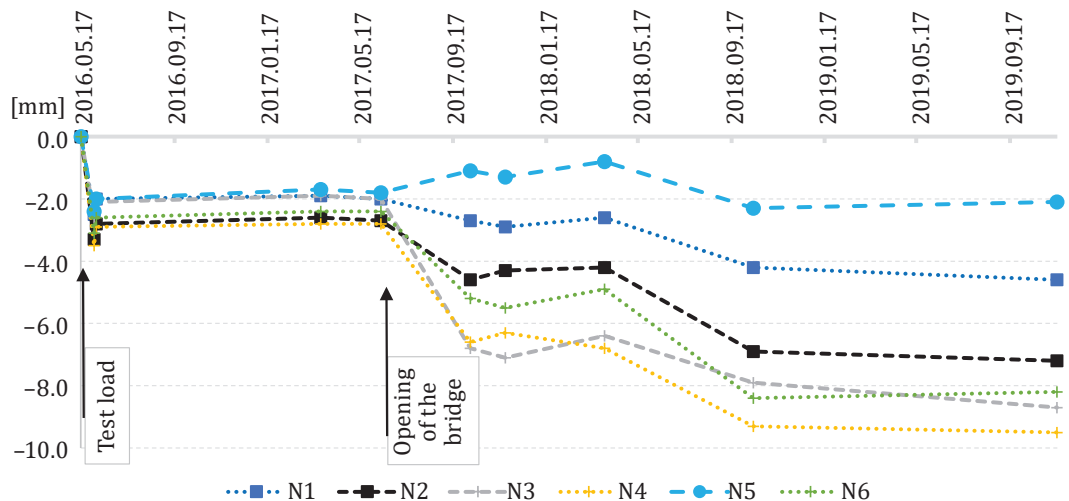
Considering the results obtained from the most reliable benchmarks N1 and N5, it can be seen that after opening the bridge for traffic, there were vertical displacements of no more than 2 mm (referring to the day the facility was opened for traffic), while the N5 benchmark did not show significant displacements. It should be borne in mind

Assuming, however, that the settlements of the entire structure from the beginning of the tests were not greater than about 4 mm (see Figure 9 – N1 and N5 curves), it should be assessed that they were relatively small. Relative settlements reached  $0.004 \text{ m} / 10 \text{ m} = 0.0004$  (0.04%), where 10 m is a total height of embankment.

It is worth noting that from the removing of test load (3.06.2016) to the opening the bridge for public use (5 June 2017), very slow but consistent displacements of the N1–N6 benchmarks upwards progressed, which proved that the soil structure was slowly relaxing after the load had been removed, (see Figure 9).

**Figure 9.** Vertical displacements (in mm) of control benchmarks N1–N6 within 3.5 years from starting test load

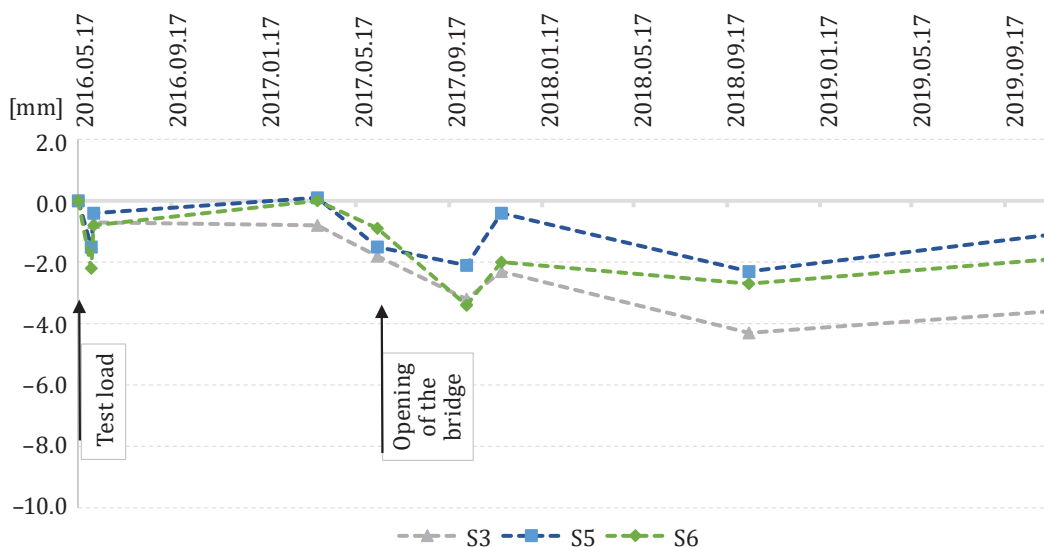
It is visible that the majority of control points revealed the horizontal displacements no greater than approximately 4 mm (outward the block of reinforced earth). For only one control point (S13) the displacement of about 7.6 mm was found, again outward. However, still it was less than 10 mm assumed as acceptable horizontal displacement (see Table 4)

**Figure 10.** Horizontal displacements (in mm) of control points S3, S5, S6 within 3.5 years from starting test load

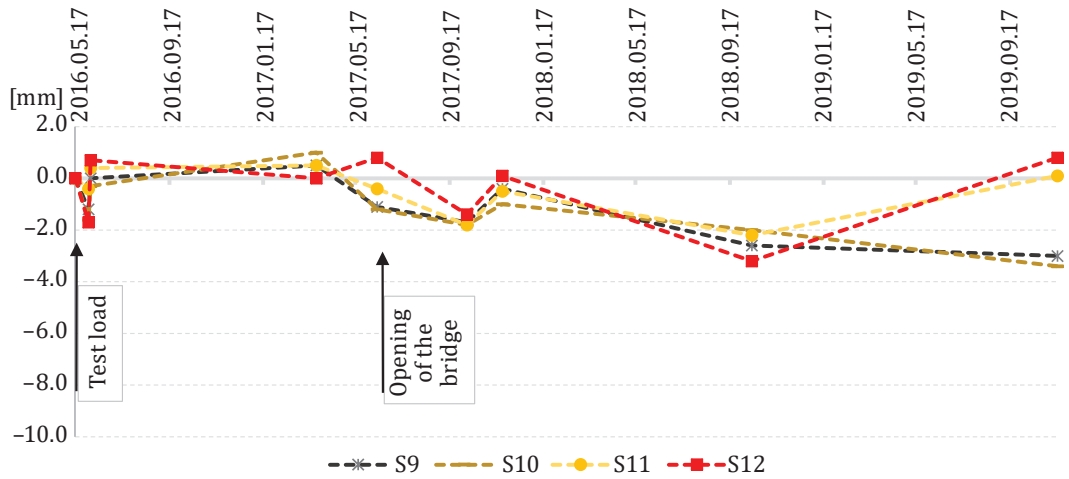
**Figure 11.** Horizontal displacements (in mm) of control points S9, S10, S11, S12 within 3.5 years from starting test load

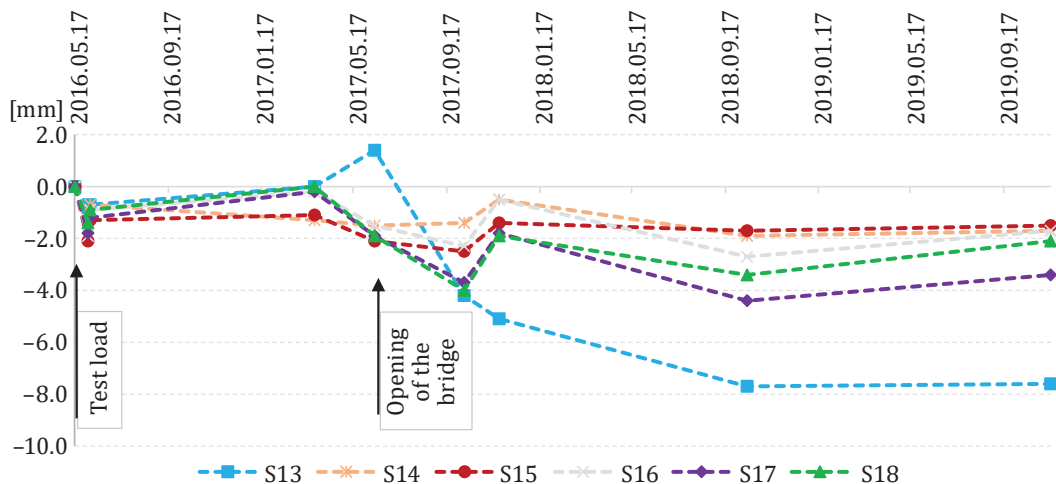
**Figure 12.** Horizontal displacements (in mm) of control points S13, S14, S15, S16, S17, S18 within 3.5 years from starting test load
