THE BALTIC JOURNAL
OF ROAD AND BRIDGE ENGINEERING

DETERIORATION OF BRIDGE DECK ROADWAY MEMBERS. PART I: SITE INVESTIGATIONS

Zenonas Kamaitis

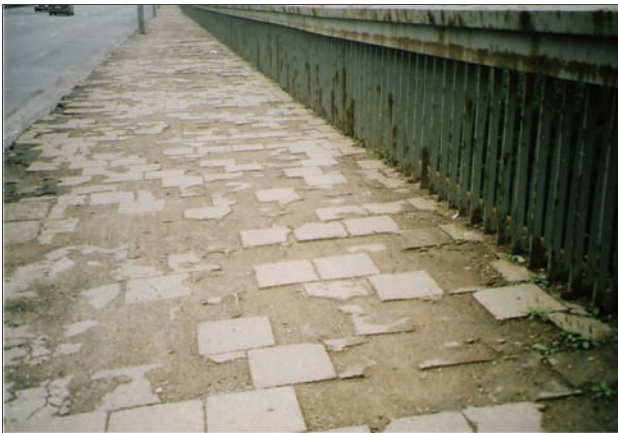
Fig 2. Deterioration of precast concrete overlay in bridge footways

Surfacing in footways differs from that in the carriageways. Three types of surfacing are practiced: bituminous concrete surfacing (40–60 mm thick), overlays in cement concrete (40–80 mm), and thin resin-based overlays (10–20 mm thick). The first two types of surfacing are often more permeable and poorly drained. This results in water stagnancy which may accelerate damage of underlying layers. In general, the problems raised in footways surfacings are similar to those encountered with carriageways surfacing (Fig 2).

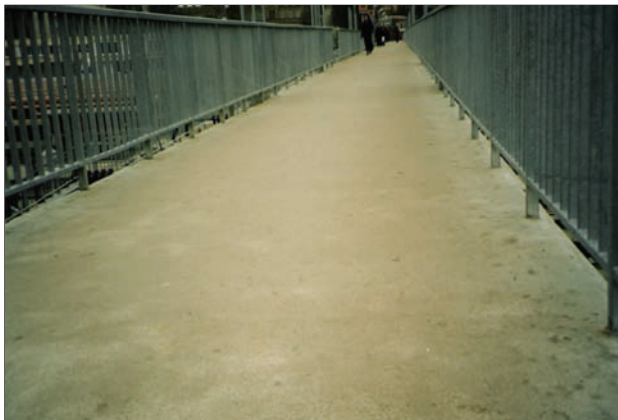
Fig 3. Polymer surfacing on footbridge deck

In North America and some European countries the polymer surfacing was developed and is used for bridge decks. Repaving of concrete footbridge in City Vilnius proposed by the author is a recent example of such application (Fig 3). Performance of this type of surfacing remains to be determined.

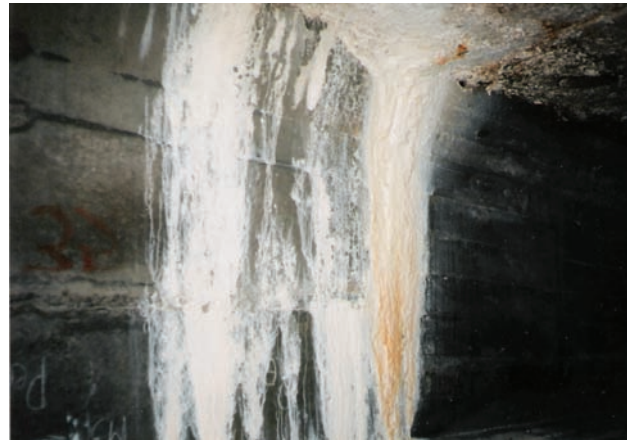
Fig 4. The effect of leaching on the underside of concrete deck of box-girder due to poor waterproofing

Damage to the waterproofing membrane can only be detected when water leakage with de-icing salts occurs through the structure. Water-saturated areas and efflorescence at the underside of the bridge deck are the indicators of insufficient waterproofing membrane (Fig 4). The leakage is observed also where the waterproofing membrane is perforated by the anchor bolts of bridge rails or luminance supports, in the connection of waterproofing layer and the

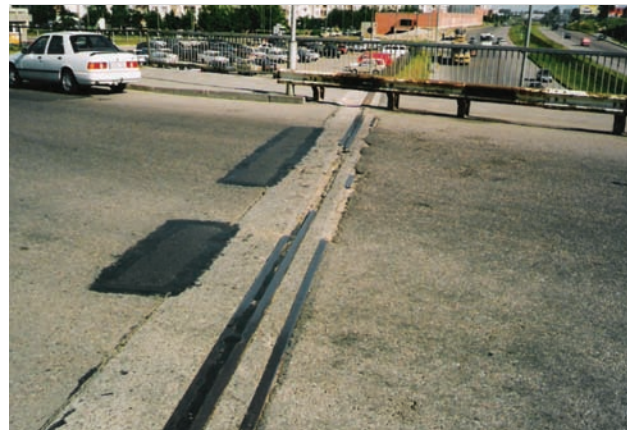
Fig 6. Deterioration of sealed deck expansion joint

Sealed deck joints should seal the deck surface completely and should prevent the accumulation of water and debris. The sealer formed-in-place usually has a limited service life because of poor installation conditions. In this type of joints the cracking often occurs in the sealer or at interface between the joint material and the surfacing. The cracks quickly multiplies, potholes are formed. The loose, torn, split or hardened seals are also observed. The first signs of distress occur within 5–7 years, together with deterioration of the deck overlays. To do nothing led inevitably to the result shown in Fig 6.

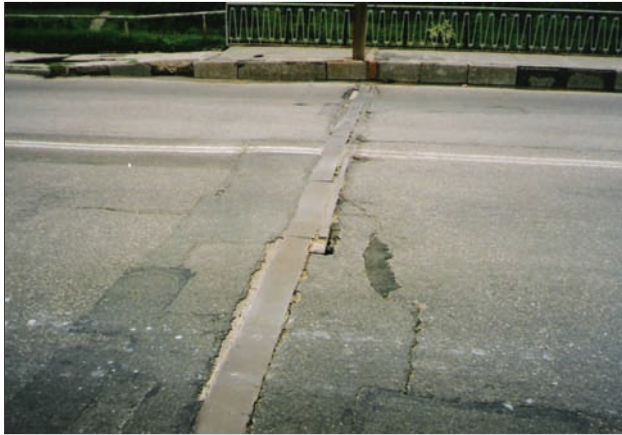
Fig 7. Deterioration of sliding joint

In the sliding plate and fingerplate joints damaged or missing steel plates, shapes, and bolts are frequently found (Fig 7). In the finger plate joint due to small tolerance between apposing fingerplates accumulation of debris contributed to the openings clogging. Leakage and excessive noise are the common problems in the sliding plate joints.

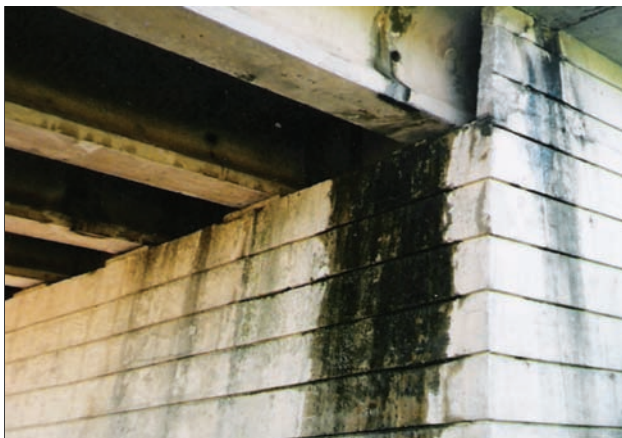
Fig 8. Deterioration of bridge beam ends and abutment due to leakage of expansion joint

ing of drainage elements may result in the locking of the joint. Where deck joints leak, contaminated water reaches the ends of concrete beams, exterior anchorages of prestressing cables, end diaphragms, bearings, and substructure, where moisture tends to collect and remain in contact with concrete over a period of years (Fig 8). As a result, the concrete cracking and spalling, rusting of reinforcement steel in many cases is observed.

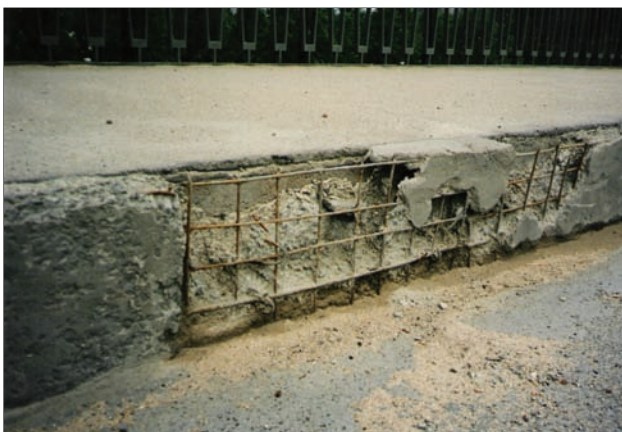
Fig 9. Typical concrete barrier deterioration

Safety barriers (parapet beams and curbs) are generally made of prefabricated concrete or reinforced concrete members. Reinforced concrete barriers may be subject to defects and deterioration such as cracks, spalling, and reinforcement corrosion (Fig 9). It seems that chloride induced corrosion is the main problem of reinforced concrete barriers. It is commonly recognised that chlorides do not directly cause damage to the concrete. This statement is based on diffusion of chlorides and ignores the deterioration of concrete due to freezing and thawing in presence of salt solutions. The first signs of reinforcement corrosion were reported after 8–12 years in service. In some cases most concrete barriers perform well despite being exposed to spray of traffic. It is observed that other members of the same structure prefabricated in the same factory are in excellent condition. Numerous examples of heavily salted security parapets in areas of severe exposure that show no spalling or either deterioration after 20 years of service lead to the conclusion that the quality of concrete (mixing, compacting, steam curing) and concrete cover to reinforcement has an important impact on durability of prefabricated members.

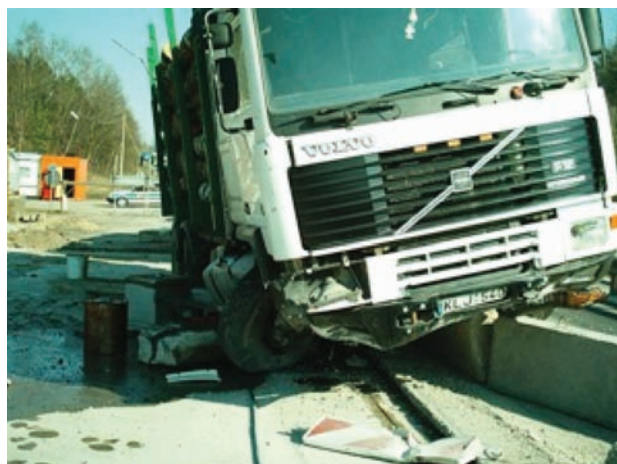
Fig 10. The truck carrying logs hit and crashed through the barrier and left the carriageway of the bridge over river Nemunas (courtesy of "Lietuvos Rytas")

Rigid concrete and flexible metal safety barriers are designed to resist impacts from vehicles. Barriers have to absorb some of the impact energy, to prevent errant vehicles from falling of the deck and to redirect the vehicle along the line of the barrier so that it does not turn over. Barriers minimum heights normally are specified in the codes such as the designed barrier is to take the entire traffic load. Vehicle safety barriers with a height of about 1,0 meter and taller arrest the heavy vehicles (cargoes). With a smaller height vehicle overturning or crashing through the barrier can occur (Fig 10). Thus, the insufficient height of barrier can increase risk for bridge users.

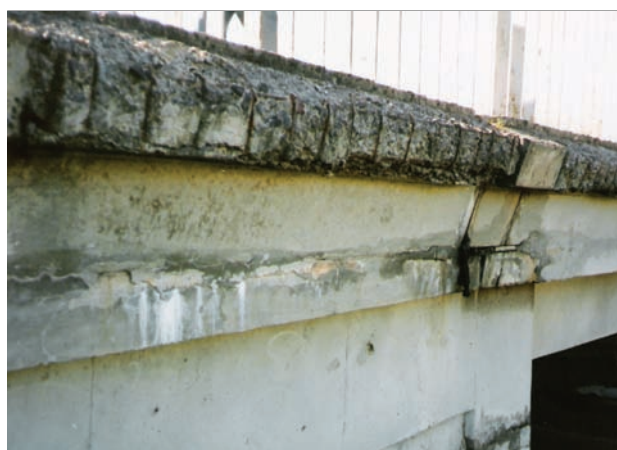
Fig 11. Intensive deterioration along footway deck slab and exterior beam due to seepage of water with de-icing salts from bridge deck

The waterproofing of bridge decks most commonly adopted in Lithuania are synthetic asphalt mastics, bituminous sheets prefabricated in rolls or thin membranes of synthetic resins. The latter were used only experimentally due to its sensibility to surface humidity and irregularities, high costs. Experience shows the disadvantages of these types. Waterproofing deteriorates with time, losses its characteristics. Defects in the waterproofing system (cracking, rutting, excessive creep) sometimes result from poor materials and construction or from deterioration of surfacing. Waterproofing is susceptible to damage during resurfacing operations. It was observed the cases when the fabric membrane edges were not adhered well to each other allowing water penetration. The design fault observed on majority of old bridges is the absence or interruption of protective system near the safety barriers or curbs. In many cases waterproofing is not used beneath sidewalks, ie alone the edge beams with the result of intensive water seepage, which sets off the process of deterioration of the edge structures (Fig 11). The edges of waterproofing membrane always are the very vulnerable points.

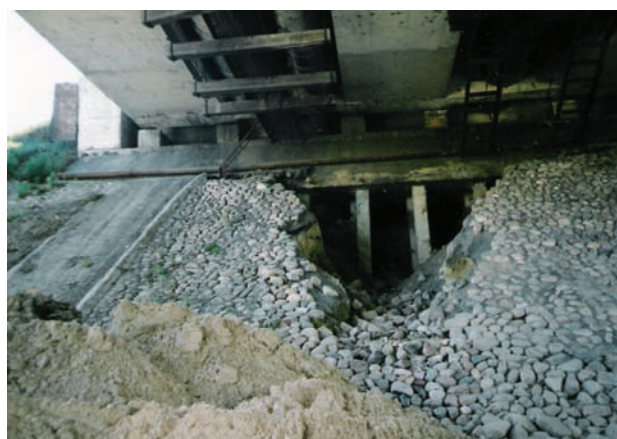
Fig 12. Erosion at the abutment base due to a poor drainage

Drainage inlets or typical bridge scuppers are easily clogged by debris and dirt. They should be inspected and cleaned periodically. Drains and downspouts generally are made of iron, which have not performed well in the presence of de-icing salts. Another poor drainage impact is erosion of the earths' surface by water flowing away from the bridge deck (Fig 12).
