THE ANALYSIS OF REINFORCED CONCRETE BOX GIRDER VIADUCT
DEFECTS AND THEIR ESTIMATIONMindaugas Augonis¹✉, Saulius Zadlauskas², Žymantas Rudžionis³, Algis Pakalnis⁴^{1, 2, 3}Kaunas University of Technology, Studentų g. 48, 51367 Kaunas, Lithuania⁴SE “Transport and Road Research Institute”, I. Kanto g. 25, P.O. Box 2082, 44009 Kaunas, LithuaniaE-mails: ¹mindaugas.augonis@ktu.lt; ²saulius.zadlauskas@stud.ktu.lt;³zymantas.rudzionis@ktu.lt; ⁴a.pakalnis@tkti.lt

Abstract. The article describes the main damages of box girder viaducts constructed in Lithuania and discusses the reasons for their occurrence. Several viaducts are examined in more detail with regard to their design data and experimental results. Using finite element software “Midas Civil” the distribution of the main stresses was determined in the box and reduced girders of the Pareizgupis viaduct caused by symmetrical and asymmetrical loads. The widths of flexural cracks in the Pareizgupis viaduct are analyzed evaluating the behaviour of prestressed reinforcement suffered from corrosion. The above mentioned program was used to calculate the deflection of viaduct when damage of reinforcement is estimated. The paper examines the

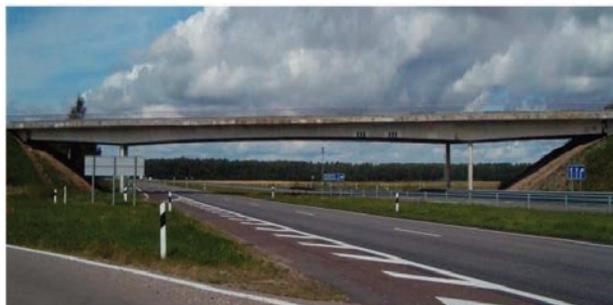
Fig. 1. General view of the Pareizgupis viaduct

The paper pays more attention to the defects and damages of the Pareizgupis viaduct (Fig. 1) conducting its thorough theoretical and analytical research, the results of which are described in the following chapters.

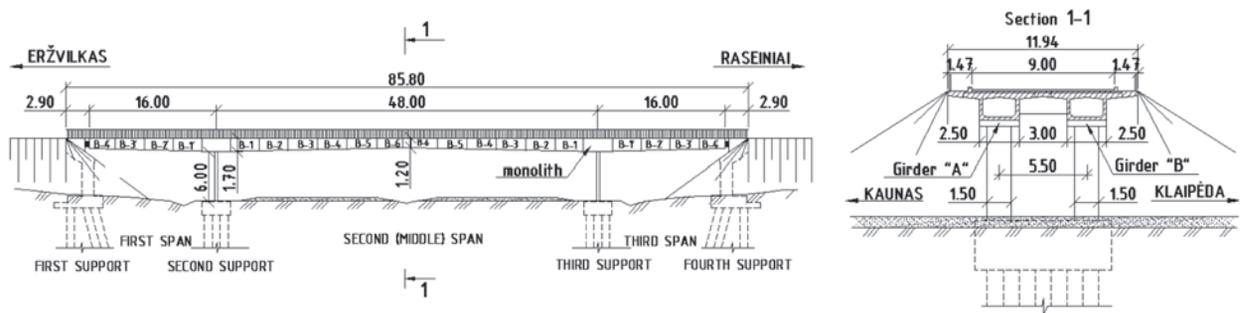
Fig. 2. The Pareizgupis viaduct plan, segment numeration and cross section, in meters

The viaduct piers are the columns of oval cross-section with 38 cm in thickness and 150 cm in width. Thin supports were designed in order to get relatively low bending moments in them resulting from the temperature and plastic deformations of a span construction. The prestressed wire bunch consists of 24 high-strength wires. There are 24 prestressed high-strength wire bunches at the bottom of the span in one box girder and 40 at the top of the support. The Pareizgupis viaduct plan and segment numeration are presented in Fig. 2.

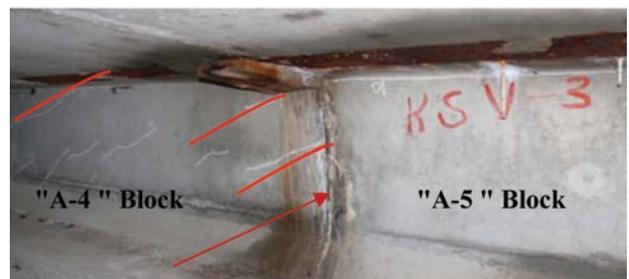
Fig. 3. Leakage in the segment joint between blocks 4 and 5

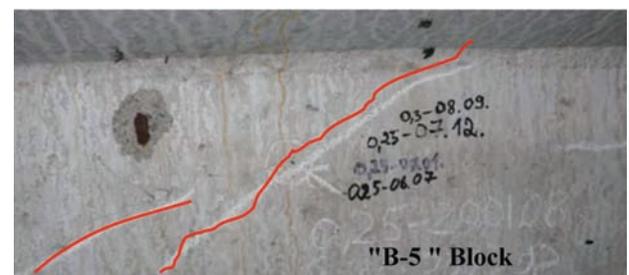
Fig. 4. Shear crack in the internal web of a box girder

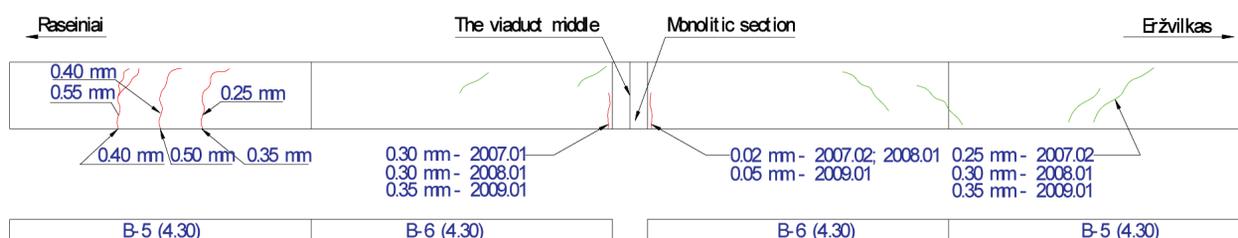
Fig. 5. Girder "B" of the Pareizgupis viaduct in Klaipėda direction. The opened vertical and shear cracks

detailed inspection of the Pareizgupis viaduct, it was found that dangerous flexural cracks opened in the 5th segment of girder "B" of the mid-span (Fig. 5, B-5 block). Having measured the crack width in different places, it was determined that the crack varied from 0.25 mm to 0.50 mm in height. The max crack width (0.50 mm) was recorded at the bottom of the fifth segment flange. This crack occurs along the entire bottom of the box. Having inspected the fifth segment wires of girder "B" of the mid-span, 48 fully broken wires (2 wire bunches) were found, another two wire bunches were greatly subject to corrosion. The cross-section of wires decreased from 5 mm to 3 mm in the corrosive parts (Fig. 6). Additionally, around 20 wires were released but were not broken. After the visual evaluation and summing up of all the deteriorated wires, it was determined that from 60 to 80 wires were detrimental to the performance of the viaduct, which constituted about 3–4 wire bunches.

As can be seen in Fig. 5, shear cracks are also opened in the central part of the viaduct (blocks 6), therefore the aim was set to determine the main concrete stresses in the mid-span. The same problem was also analyzed in the article of

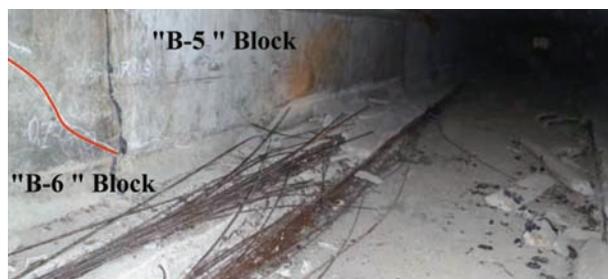
Fig. 6. The view of wires in the places of crack opening

It can be seen in Fig. 17 that flexural cracks are likely to open when nearly 8 wires were broken, whereas during the visual inspection it was determined that 48 wires (2 wire bunches) were already fully broken and others were damaged by corrosion or released (Fig. 6).

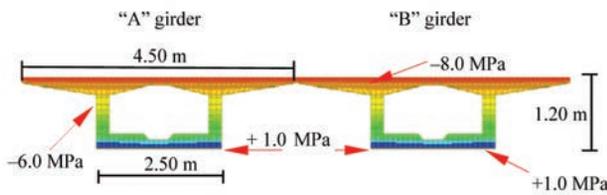
Fig. 8. Distribution of the main stresses in the middle section of the mid-span under the symmetrical design H-30 load and the total permanent loads

Having calculated, according to the above mentioned code, the main stresses of reduced cross-section in the middle of the bottom flange, the middle of the top flange and the web middle of the central part, it was determined that the main compression stresses did not exceed 14 MPa and the main tensile stresses did not exceed 2 MPa. The main concrete tensile and compressive stresses resulting from the design H-30 load and the total permanent loads, calculated according to the FEM, are presented in Fig. 8, and the stresses resulting from the design HK-80 applied on the middle part of cross section and the total permanent loads are presented in Fig. 9.

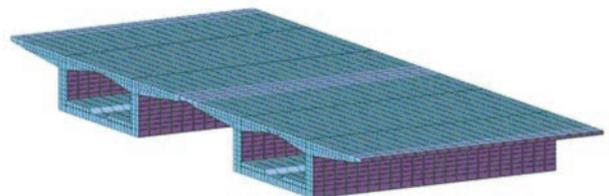
Fig. 12. The segment of girders "A" and "B" of the simulated Pareizgupis viaduct

codes, the reduced I-section (Fig. 11) and the box section (Fig. 12) of the Pareizgupis viaduct were simulated.

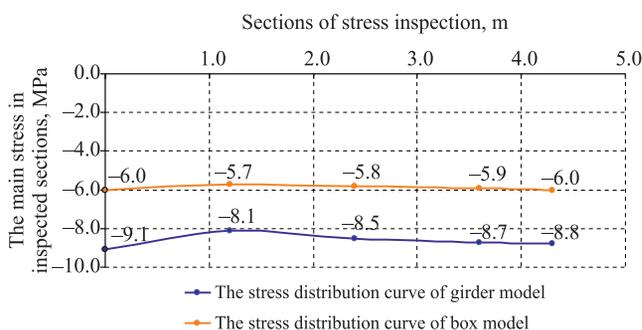
Fig. 13. Distribution curves of the main stresses of the girder and box models in the junction of the web and the top flange

The distribution curves of both simulated cross-sections main stresses according to distance from viaduct middle were completed. The main stresses of these models in the junction of the web and the top flange are presented in Fig. 13, in the middle of web – in Fig. 14, in the junction of the web and the bottom flange – in Fig. 15, and in the bottom of the bottom flange – in Fig. 16.

It can be seen in the presented diagrams that the distribution of the main stresses is different at the same point in the box section and I-section under the same load. The largest difference in compressive stresses is noticeable in the top flange. The major disagreement of the main stresses occurs in the junction of the web and bottom flange and the bottom of the bottom flange. The main compressive stresses dominate across all the length in I-section of the web middle and in the box section the main stresses change from compressive stresses to tensile stresses.

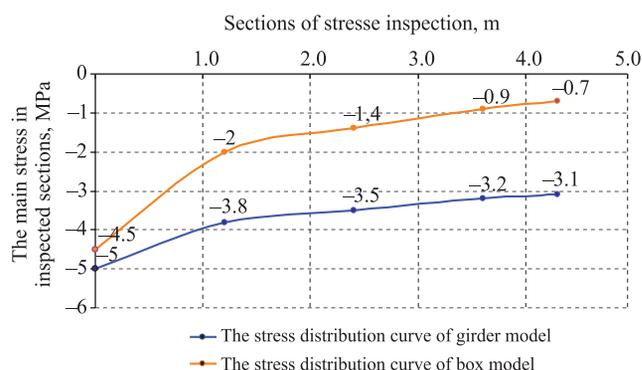
Fig. 15. Distribution curves of the main stresses of girder and box models in the junction of the web and the bottom flange

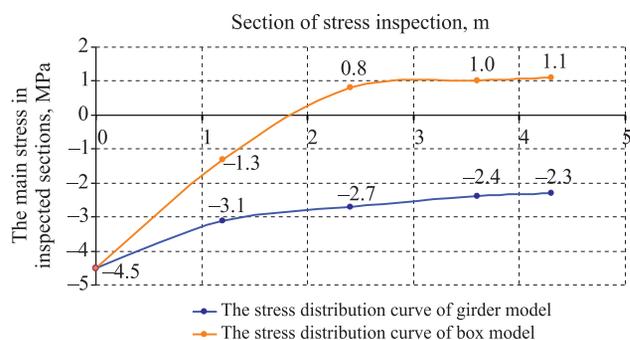
Fig. 16. Distribution curves of the main stresses of girder and box models in the bottom of the bottom flange

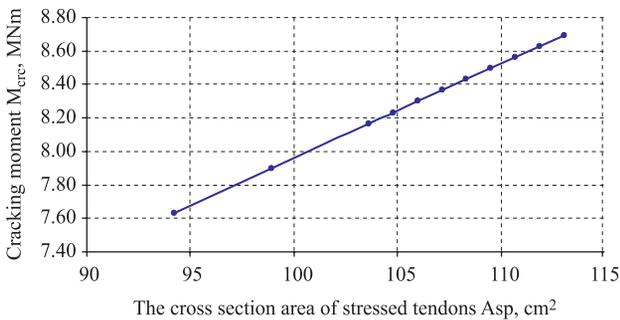
Fig. 17. The dependence of cracking moment on the cross-sectional area of prestressed wires after the evaluation of their breaks (according to *STR 2.05.05:2005*)

Firstly, the crack width, cracking moment and stresses in wire bunches were calculated for all wires, then up to four wire bunches were broken and it was determined how the calculated parameters changed. The dependence of parameters on the cross-sectional area of stressed wires is presented in Figs 17 and 18.

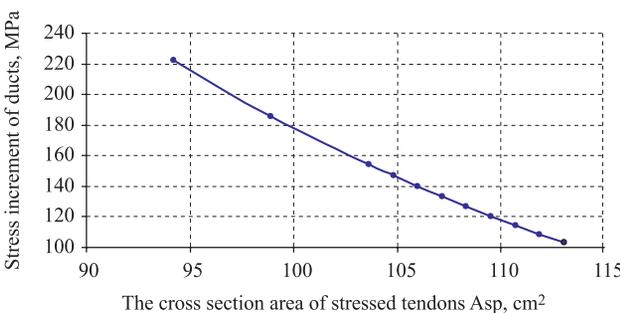
Fig. 18. The dependence curve of stresses in wire bunches on the cross-sectional area of wires after the evaluation of their breaks (according to *STR 2.05.05:2005*)

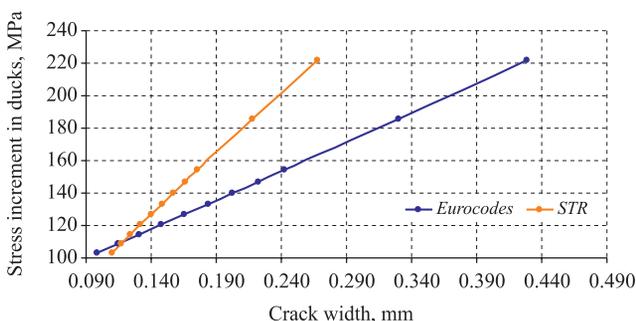
Fig. 19. The curves of dependence of the stresses in wire bunches on the crack width calculated according to the methods of *STR 2.05.05:2005* and *ENV 1992-2:1996* after the evaluation of wires breaks

The variation in crack width, calculated according to the methods of the *STR 2.05.05:2005* and *ENV 1992-2:1996* with regard to the increment of stresses in wire bunches is presented in Fig. 19.

According to *STR 2.05.05:2005* the real crack (0.35 mm) will open when reinforcement stress increment will be ~280 MPa. From the stress increment equation (*STR 2.05.05:2005*), such value (external bending moment is equal to 8.59 MNm, chapter 3) is obtained if cross sectional area of prestressed reinforcement decreases by ~5.2 wire bunches. According to *ENV 1992-2:1996*, at the real crack width the reinforcement stress increment should be ~195 MPa. From the same equation (*STR 2.05.05:2005*), the obtained decrease of prestressed reinforcement is ~3.2 wire bunches.

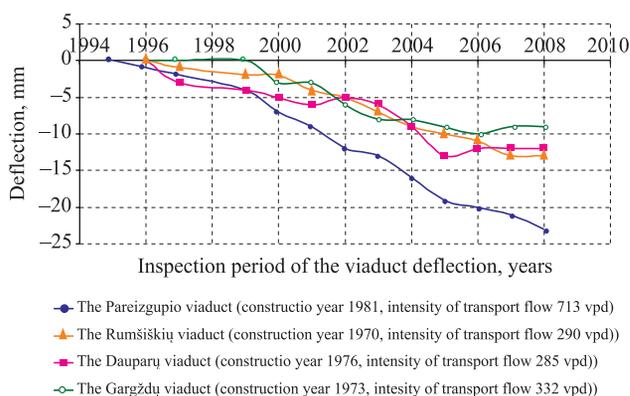
Fig. 20. Deflection variation curves of the viaducts during the inspection period

intensively from all the unreinforced viaducts. The deflection variation curves of the four viaducts during the inspection period and the flows of heavy traffic on each viaduct per day were presented for the analysis (Fig. 20). It can be seen in Fig. 20 that viaduct deflections depend on its transport flow.

Having evaluated the average values of results (Fig. 20), it was obtained that the increment of deflection $v_{f,m} = 1.015$ mm/year, its dispersion $\sigma^2 v_f = 0.204$ mm²/(year)². The average critical deflection assumed $f_{crit} = 25$ mm and distribution dispersion $\sigma^2 f_{crit} = 1.4$ mm². Having calculated the dispersion of deflection, it was obtained $\sigma^2 f = 1.259$ mm².

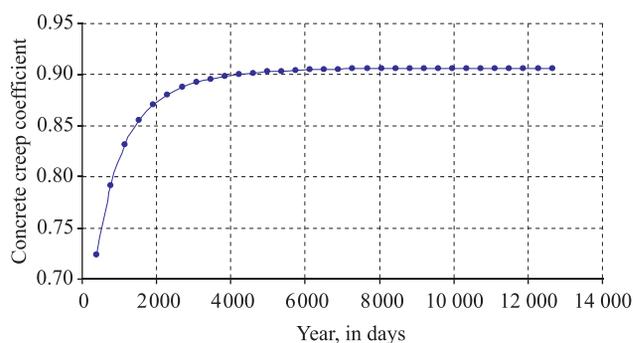
Fig. 21. The variation curve of creep coefficient

In order to evaluate the potential effect of creep, which is damped in the course of time, on the deflections of analyzed viaducts, creep coefficient and modulus of deformation of M400 mark concrete (design based concrete of the viaduct deck) with regard to its composition were calculated according to the method proposed by Bažant and Baweja (1995). The concrete composition is the following: cement – 425 kg/m³, sand – 820 kg/m³, crushed granit – 975 kg/m³, water and cement ratio – 0.40. The obtained variation curves of creep coefficient and deformation modulus for the period of 30 years are presented in Figs 21 and 22.

Having calculated, according to the method proposed by Bažant and Baweja (1995), deformation modulus for the M400 mark concrete composition, it was obtained that deformation modulus decreased by 30% in 21 years due to concrete creep, when design based elasticity modulus was equal to 32 000 MPa. The most intensive variations in deformation modulus occurred in the first three years, and then variation stabilized in 14 years and changed only marginally. Since the analyzed viaducts were started to be inspected after 20 years, the effect of creep on deflection was minimal.

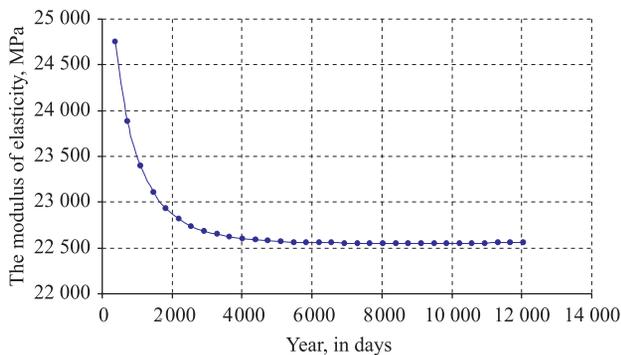
Fig. 22. The variation curve of deformation modulus
