## INFLUENCE OF FUNCTIONALLY OBSOLETE BRIDGES ON THE EFFICIENCY OF ROAD NETWORK. PART II: CASE STUDIES

**Abstract.** This study is the first practical step in Lithuania to identify the characteristics causing the bridges to be functionally obsolete. A bridge of which current deck geometric characteristics, safety barriers or railings, underclearances, and roadway approach alignment are deficient and not consistent with current design standards (or traffic demands) can be considered as functionally obsolete. In Part I of this paper the criteria of functionally obsolete bridges, deficiency categories and assessment of deficient structures are presented. The Part II reports experience in city bridge stock of 83 structures for a short period of 2–5 years on this subject. Surveying revealed that 58.5% of bridge stock shows minor or obvious signs of functional aging. Evaluation and rating of city bridge stock was undertaken. Illustrative examples of functionally obsolete bridges are presented. Recommendations for improvement of the geometrical characteristics of bridges in existing Lithuanian design codes are envisaged.

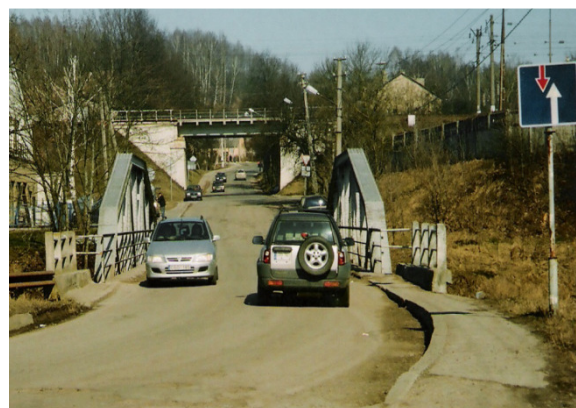
There are 13 narrow historical bridges. Any bridge built before 1962 is likely to be lacking breakdown shoulders. A very good example is the bridge built in 1930 (Fig. 2). As the picture shows, the bridge is so narrow that people are reluctant to be on the bridge when a truck is crossing the bridge in the opposite direction. It accentuates the delays caused by accidents, makes staging of resurfacing and repairs more difficult, and can add chokepoints or bottlenecks.

Fig. 2. Urban steel bridge (1930) restricted to one-way traffic in opposite directions: narrow clear roadway (5.8 m) and sidewalks (0.5 m); no shoulders, no sidewalks and lane markings along the bridge

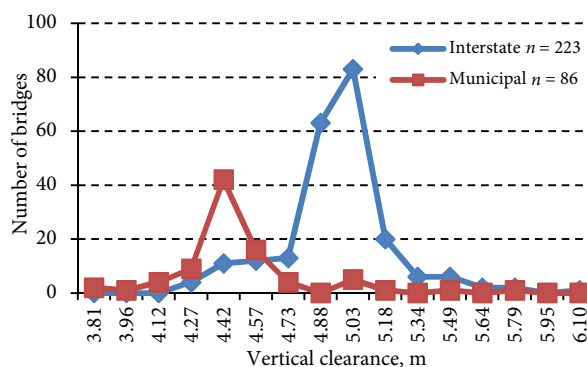
Fig. 3. Vertical clearance of bridges struck by over-height vehicles

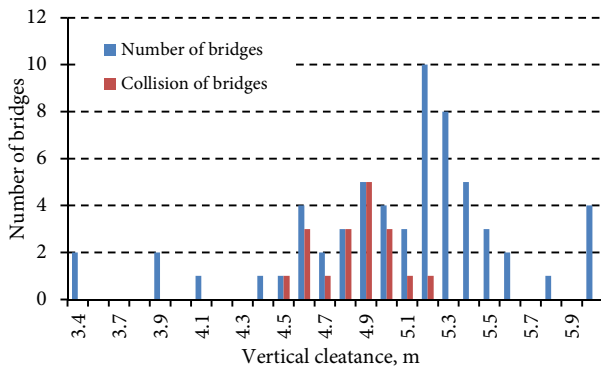
The bridges inspected in this study (Fig. 4) included 65 on the overpasses between them 25 (38.5%) that have limited overhead clearance and could be involved in

over-height collision. A total of 15 (23%) bridges were found to have some degree of impact damage, between them 8 include serious collisions and had repair made at some point in time (Fig. 5). The most common height of bridges that are struck is that with a clearance between 4.5 and 5.0 m. As a rule all these bridges are built before 1972. Note, that min vertical design clearance for new overpasses in Lithuania since 1984 is  $\geq 5.0$  m.

**Fig. 4.** Total number of inspected bridges and number of bridges damaged by over-height vehicle accidents versus vertical clearance of obsolete bridges

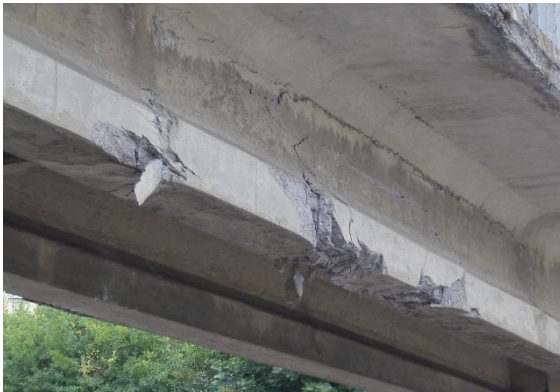
**Fig. 5.** Collision damage of concrete footbridge with vertical clearance of 4.97 m

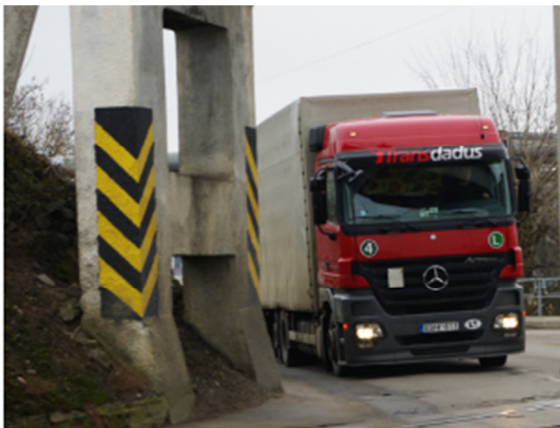
**Fig. 6.** Example of the bridge with insufficient lateral under-clearance

Horizontal or lateral clearances are measured from the through roadway to the substructure and are evaluated unless the bridge is over highway or railroad. Example of the bridge with restricted lateral underclearance that causes the collision risk between passing vehicles and the bridge piers is shown in Fig. 6. Average Daily Traffic ADT = 13 140 vpd (vehicles per day). Speed is reduced from 60 km/h to 40 km/h at the distance of 200 m to the underclearance restricted bridge. In this simple case the road user delay time (Eq (3) Kamaitis 2012) is of 12 620 hpy (hour per year) and vehicle operating delay time is of 15 850 hpy.

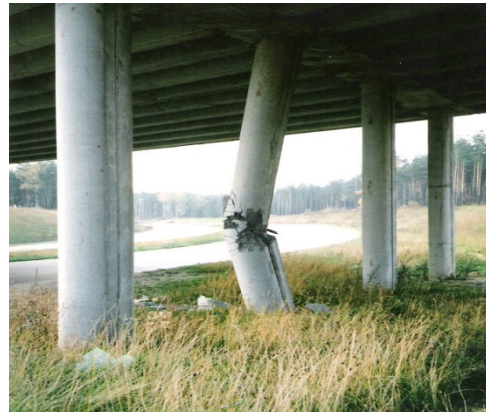
Although the vehicle collisions with bridge piers are rare comparing to all truck collisions with bridges, the example of this type of damage is presented in Fig. 7. It was found that under geometry – lateral clearance of 7 (10.8%) inspected bridges are functionally obsolete in this category.

Fig. 7. Collision damage of bridge pier column

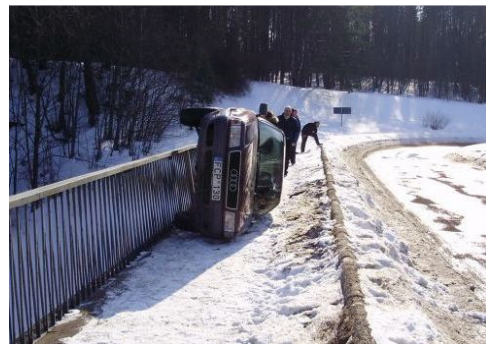
Fig. 8. Car accident on the bridge built on sharp street bend and insufficient parapet height (photo from Delphi)

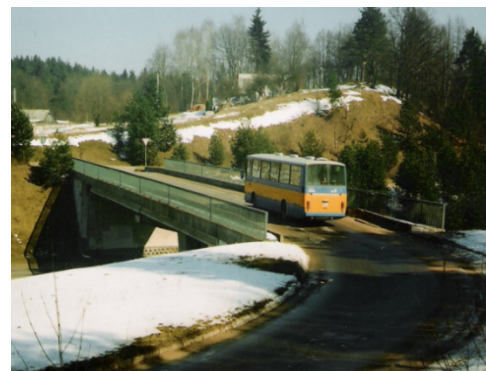
However, the number of cases exists when crossing the bridge requires a major speed reduction due to the presence of intersections near the bridge or horizontal or vertical curvature of the roadway at the bridge reducing sight distances for vehicles. The driver will find himself constrained to slow down, to avoid flying off at a tangent and sliding downward across the pavement when the surface is slippery from rain, snow or ice. Fig. 9 shows an example of the bridge on the “S” shaped street over the main road. The photo shows that there is a severe bend in the road and the reduction of allowable traffic speed from 70 km/h to 40 km/h is envisaged by signing.

Fig. 9. Example of the bridge on the severe bend in the road and as result with posted traffic speed

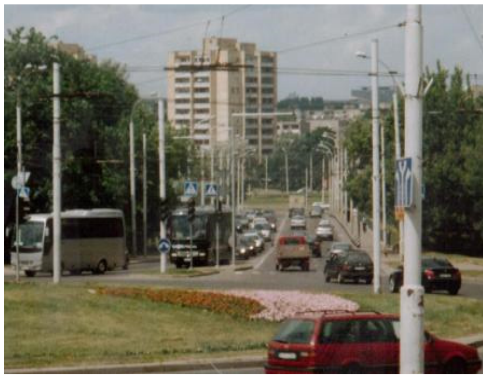
Another example – the bridges connected with approach street circle interchanges that are very frequently found in the city street network. The advantages and disadvantages of traffic circles at unsignalized city or road intersections are discussed in many publications (e.g. Çalışkanelli *et al.* 2009; Daunoras *et al.* 2008; Dell’Acqua, Russo 2010; Jurevičius, Bogdevičius 2007; Žilionienė *et al.* 2010 among others). These had their origin in city plan in the past and their drawbacks became apparent. Traffic is slowed by the curve of the circle and then by the vehicles entering or leaving a bridge. Frequently, during peak traffic periods a complex situation on the bridges is created. As an example, the river bridge of two way four lane, 14 m wide and 174 m long with the average ADT = 16 100 vpd is considered (Fig. 10). The bridge and interchanges adequacy was evaluated based on the average speed of vehicles (individual cars, commercial vehicles – light and heavy, buses/trolleybuses) and traffic delay on the bridge during the traffic jams. It was observed that the bridge experiences traffic jams almost all day (from 6:00 to 22:00). Traffic congestion causes a delay approximately 9500 of vehicle-hours and 21 150 of user-hours each year. The user cost related to traffic jam on the bridge reaches about €528 thousand each year. If we assume that socio-economic losses are about 50% of user costs a total of approximately of €800 thousand are lost every year. It is evident that traffic congestion increases the cost of mobility to everyone and reduces the possibilities of using bridge resources as the bridge is not functioning as intended.

Fig. 10. Illustration of circle-shape unsignalized intersection in the bridge area leading to bridge-bottleneck and traffic jam formation

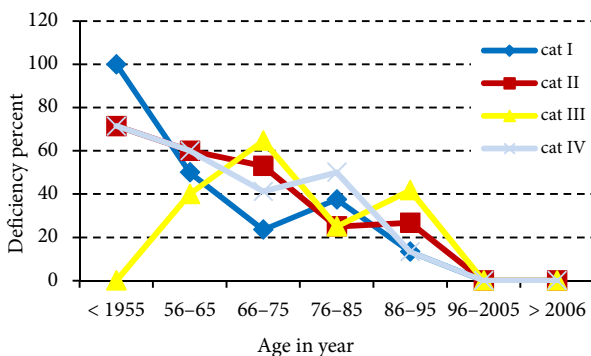
Fig. 12. Functionally obsolete bridges by geometrical category and age group

The relationship between functional obsolescence categories and bridge’s age is shown in Fig. 12. The results show that functional deficiencies decrease as age of bridges also decreases. Older bridges are more likely to be functionally obsolete than newer ones. For example, the proportion of functionally obsolete bridges is above 20% in 15 to 25 years old category, over 60% in 45 to 55 years old category. Fig. 12 also shows that new recent bridges being constructed after 1996 are not deficient in any category.
