AN ANALYSIS OF ROAD PAVEMENT COLLAPSES AND TRAFFIC SAFETY HAZARDS RESULTING FROM LEAKY SEWERS

Abstract. In this paper, road pavement collapses resulting from sewer leakage are divided into six categories: negligible, marginal, considerable, serious, very serious and catastrophic, with the categorization being based on two criteria, both related to traffic safety, i.e., the number of fatalities caused by sinkholes, and the extent of the road pavement damage. The causes of road pavement collapses are also discussed. The study involved analyzing the deterioration of sewer pipes with long service lives, focusing on the most common materials, i.e., concrete and vitrified clay. The results of the sewer inspections performed by the Kielce University of Technology suggest that the spot and linear defects detected in sewers of this type can be divided into three groups. The findings were used to formulate some recommendations on how to improve road traffic safety by preventing road pavement collapses.

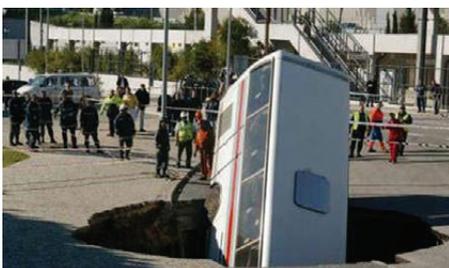
Fig. 1. Road pavement collapse with a swallowed bus

The categorization of road pavement collapses due to damaged or leaky sewers (Figs 1–2) is based on a study of over 100 recorded cases.

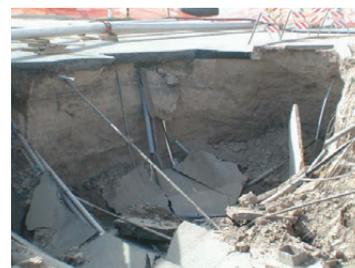
Fig. 2. Road pavement collapse with visible damaged cables and pipes

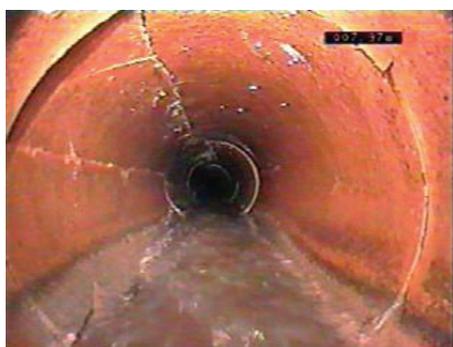
Road pavement collapses are mainly due to defects of sewer pipes resulting in leakage (e.g., sealing gasket intrusions and radial joint displacements), including structural defects (e.g., corrosion and cracks). Corrosion, abrasion or overloading are responsible for longitudinal cracking of pipes at the bottom and top and on the sides, where stress concentration is the highest (Fig. 3). The cracked pieces

Fig. 3. Longitudinal cracks

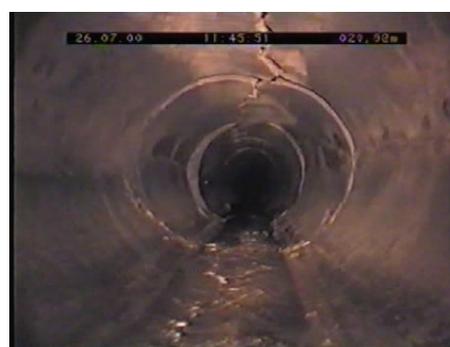
Fig. 4. Vertical deformation of a cracked pipe

may break off (Fig. 4), which will eventually cause a sewer collapse (Fig. 5). Other hazards include displaced joints (Fig. 6) and missing wall pieces with air voids and soil visible beyond the defects (Fig. 7). Gradual subsidence of soil above a sewer leads to a road pavement collapse.

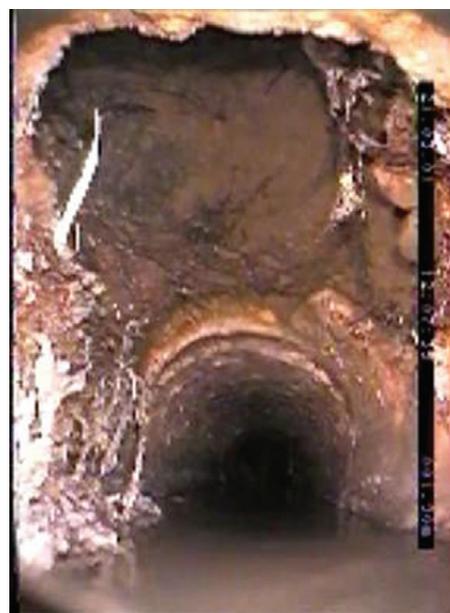
Fig. 5. Sewer collapse, an air void visible above the missing fragment of the sewer wall

is more shallow. The mechanism of infiltration and exfiltration in cohesive soils is identical to that in non-cohesive soil. The difference lies in that in cohesive soils air voids form directly above the damaged sewer (Figs 5, 10). The

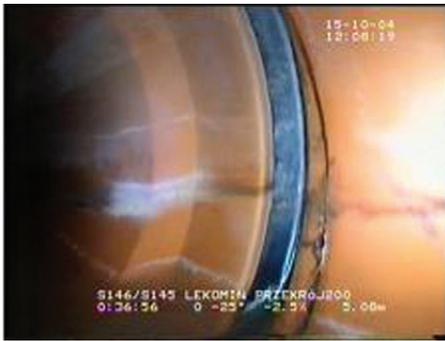
Fig. 6. Longitudinally displaced joint with a visible gasket

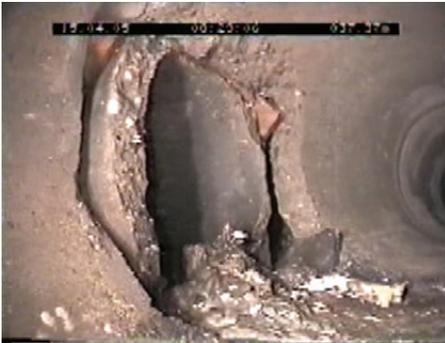
Fig. 7. Defective connection with visible air voids beyond the sewer wall

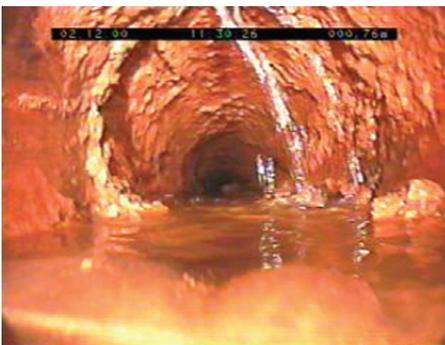
Infiltration of groundwater with soil particles into a sewer (Fig. 8) remains the greatest threat to road traffic safety. The scale of the phenomenon is assessed by determining the geometrical dimensions of leaky spots, the soil type (grain size), and the degree of soil compaction in the pipe zone. When infiltration of groundwater into a pipe occurs in a non-cohesive soil, finer soil particles are washed out until the leak is covered with coarser soil particles. This ‘filter’ can be damaged when the pipe operates under pressure, for instance, during heavy rainfall, as is the case of a storm water or combined drain. Storm water may then exfiltrate from a leaking pipe into the soil. When the rain stops and the flow of storm water in the pipeline decreases, groundwater with soil particles enters the pipe again causing the soil underneath to subside. The process results in the formation of air voids in the soil directly below the road pavement. These increase with time (Fig. 9), contributing to the subsidence or collapse of the road pavement. Such failures are generally less dangerous in non-cohesive soils than in cohesive soils, because air voids are smaller and the subsidence of the damaged road pavement

Fig. 8. Infiltration of groundwater into the sewer

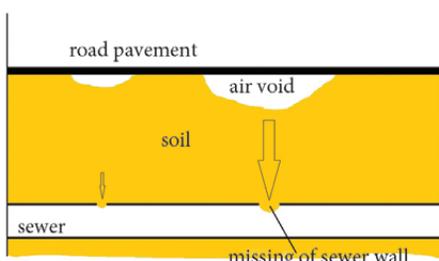
Fig. 9. Air voids above a leaky sewer in a non-cohesive soil

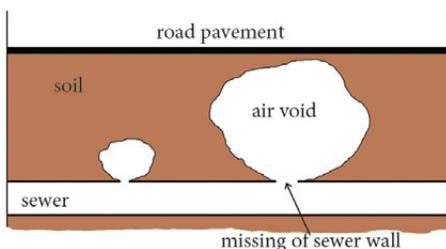
Fig. 10. Air voids above a leaky sewer in a cohesive soil

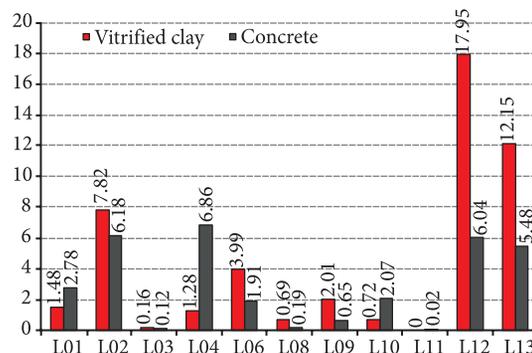
The CCTV inspections were performed for concrete and vitrified clay sewer pipes with long service lives. Figs 11 and 12 show defects posing a threat to road surface integrity, which are spot and linear defects, respectively.

In vitrified clay pipes, the most frequent spot defects responsible for the loss of leak tightness are radial joint

Fig. 11. Frequency of spot defects in vitrified clay and concrete sewers, in number per 100 m

displacements L12 (17.95 defects/100 m), while the most common linear defects are longitudinal cracks L07, observed along 1.96% of the pipe length. Defects classified as group A, posing the greatest threat to road surface integrity, comprise:

- infiltration of groundwater into a leaky sewer (L01), with 1.48 defects/100 m;
- post infiltration encrustation (L02), with 7.82 defects/100 m;
- sealing gasket intrusions(L03), with 0.16 defects/100 m;
- missing wall pieces (L04), with 1.28 defects/100 m;
- deformation or collapse of a cracked rigid sewer (L05), 0.33%.

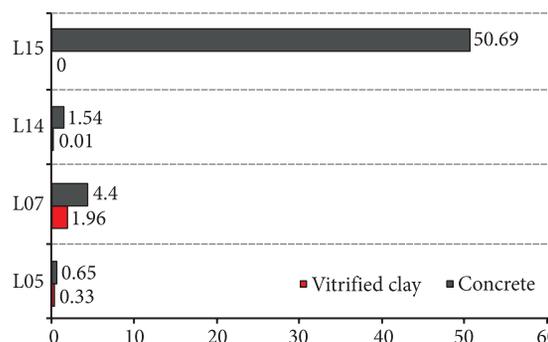
Fig. 12. Summary of linear defects in vitrified clay and concrete sewers, in percentage

In concrete pipes, the predominant linear defect contributing to a loss of leak tightness is internal corrosion (L15), occurring along 50.69% of the length of the pipes studied. The major causes of spot defects, on the other hand, are post-infiltration encrustation (L02), with 6.18 defects/100 m, missing wall pieces (L04), with 6.86 defects/100 m, radial joint displacements (L12), with 6.04 defects/100 m, and longitudinal joint displacement (L13), with 5.48 defects/100 m. The first and second of the spot defects are group A defects, i.e., ones posing the greatest threat to road surface integrity. This group also includes:

- infiltration of groundwater into a leaky sewer (L01), with 2.78 defects/100 m;
- sealing gasket intrusions(L03), with 0.12 defects/100 m;
- deformation or collapse of a cracked rigid sewer (L05), 0.65%.
