INVESTIGATION OF LONGITUDINAL CRACKING IN WIDENED CONCRETE PAVEMENTS

SHUO YANG¹, YANG ZHANG¹,
ORHAN KAYA¹, HALIL CEYLAN¹, SUNGHWAN KIM²

Abstract. Widened slabs, widely employed in many US states in concrete pavements, have suffered from unexpected longitudinal cracks. These cracks suddenly appeared within 0.60 m to 1.20 m from widened slab edges and could be detrimental to the long-term pavement performance. The primary objective of this study was to identify possible causes for such longitudinal cracking observed on widened concrete pavements. Both field investigation and Finite Element Analysis were performed. Degrees of curling and warping were measured using a Terrestrial Laser Scanner. Concrete cores were also extracted to achieve a better understanding of how the cracking had developed. Field survey and numerical simulation results indicate that such longitudinal cracks could be primarily caused by a combination of excessive traffic loads, a high degree of curling and warping, inadequate support from underlying layers,

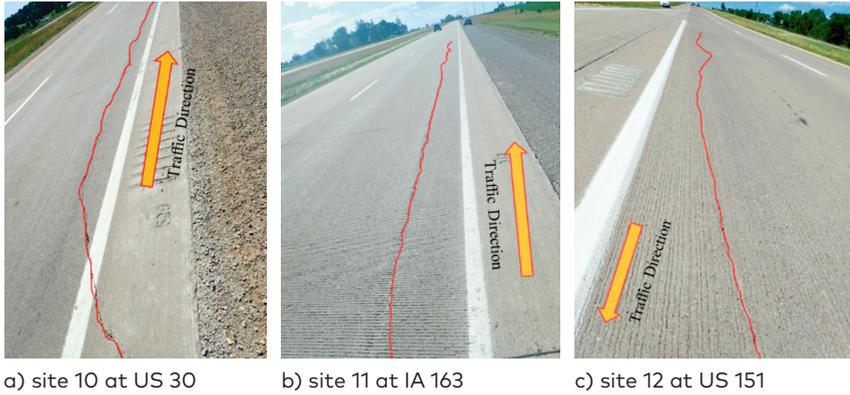
Figure 1. Longitudinal cracking observed in the field

At least one two-mile pavement section at each site was surveyed to record relevant information, including slab geometry, shoulder type, joint condition, amount and location of cracks, and severity level of cracks, following Distress Identification Manual for LTPP for Pavement Performance Assessment (Miller & Bellinger, 2014). Drainage systems were also investigated by checking for the blockage of subsurface drainage system outlets. Other documentation, such as pavement construction reports, design plans, and historical pavement performance data, were also carefully reviewed and summarised. Figure 1 provides typical pictures of longitudinal cracking observed at site 10, site 11, and site 12, respectively.

The survey results indicated that the majority of observed longitudinal cracks typically were initiated from transverse joints in traffic lanes within distances of 0.60 m (2 ft.) to 1.20 m (4 ft.) from the slab edges. These cracks were near right wheel paths and parallel to pavement centrelines, and over time, they usually extended across two to three slabs. Longitudinal cracks beginning at the middle of the vertical edges in concrete patching areas were also observed; there is a possibility that such near-patching cracks had already existed before patching was performed. It was also noticed that while no cracks were found at site 1 during the survey conducted during the summer of 2017, a few longitudinal hairline cracks were found to have been initiated at

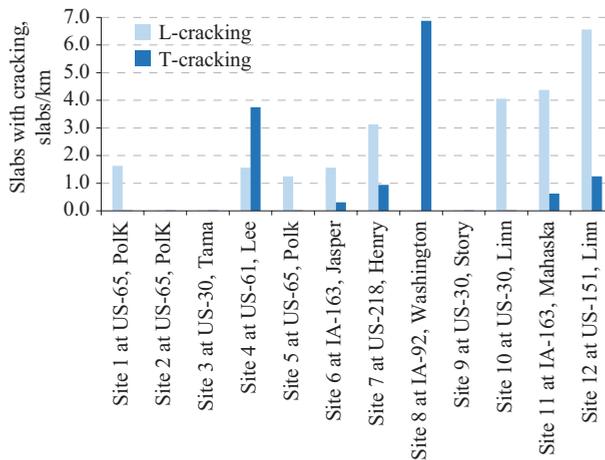
Figure 2. Number of slabs with longitudinal and transverse cracks

Figure 2 and Figure 3 describe the crack survey results in terms of the number of slabs cracked and total cracking length per kilometre, respectively. It indicates that longitudinal cracks are more dominant at most of the selected sites. Site 10, site 11, and site 12 exhibited a high level of longitudinal cracks (total length of cracking no less than 20 m/km), and site 4 through site 7 exhibited a moderate level of longitudinal cracks (total lengths of cracking more than 5 m/km and below 20 m/km), and site 1 through site 3, site 8, and site 9 exhibited a low level of longitudinal cracks (total length of cracking below 5 m/km).

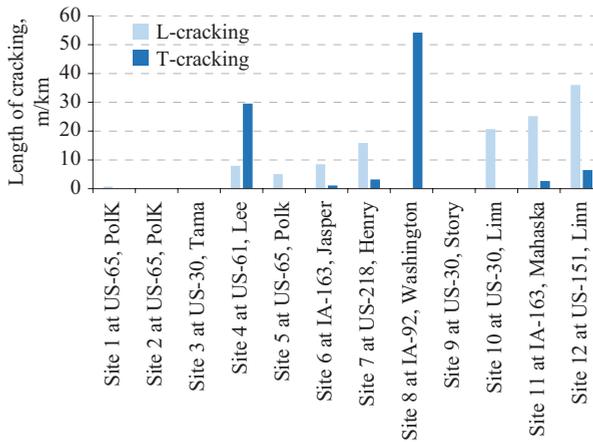
Figure 3. The total length of cracking at each site

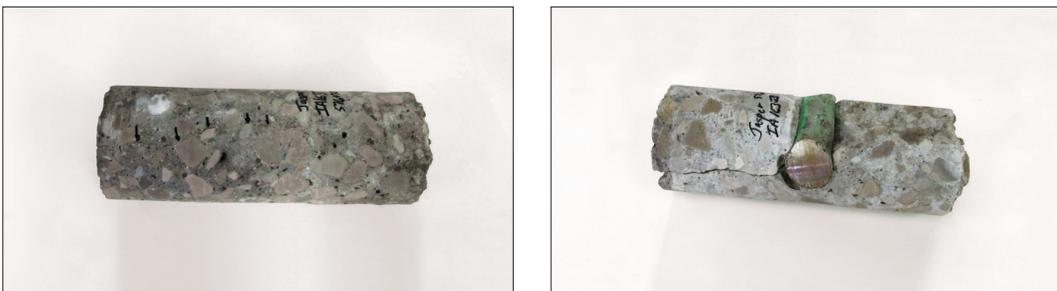
Figure 4. Concrete cores from site 6 at IA 163

To seek a better understanding of the development process of such longitudinal cracks, concrete cores were obtained by Iowa Dept of Transportation (Iowa DOT) crews from selected sites at crack locations and then examined. Figure 4 through Figure 6 show some representative cores taken from sites 6, 10, and 12, respectively. The cores examined from these sites revealed that most cracks were top-down cracking, and some other cores exhibited full-depth cracking and split open upon being extracted. Although it was usually thought that bottom-up cracking resulting from edge loading was the principal failure mode for JPCPs, these studies indicated that top-down cracking could also be a dominant

Additionally, the team of researchers did not observe visible aggregate segregation, vibrator trails, or excessive entrapped air voids by examining the concrete cores, which exhibited uniformly-distributed aggregates in their mixes, excluded vibration as a cause of the cracking problem. There were also no issues found that were associated with concrete early-age strength, because the cracks in the cores crossed the aggregate, in agreement with construction report results that all the concrete had satisfied strength-test requirements. Additionally, dowel bars were properly aligned at the middle depth of the PCC layer, perpendicular to the transverse joints.

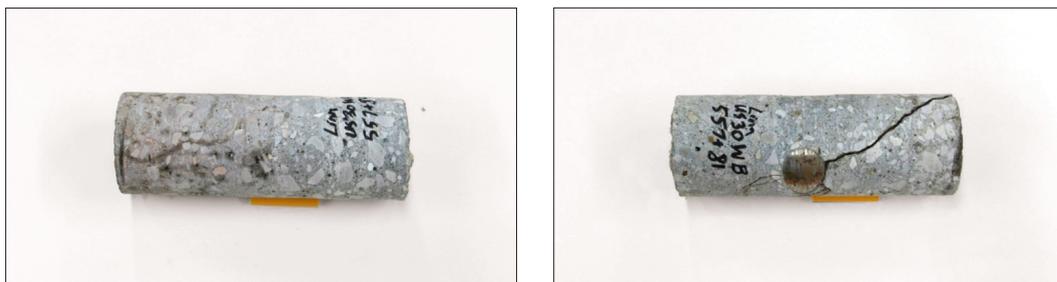
Figure 5. Concrete cores from site 10 at US 30

Some arc-shapes longitudinal cracks were also found at site 4, site 7, site 10, and site 12; these were most likely caused by loss of support from underlying layers (Figure 1a). Since these sites also exhibited corner cracks, it seems reasonable to assume that they suffered from a combination of excessive traffic loads and loss of support from subgrade. In addition, since all the sites used granular subbase, friction was not the main cause of longitudinal cracking. Previous core examinations indicated the small likelihood of such cracks resulting from improper vibration and dowel bar misalignment.

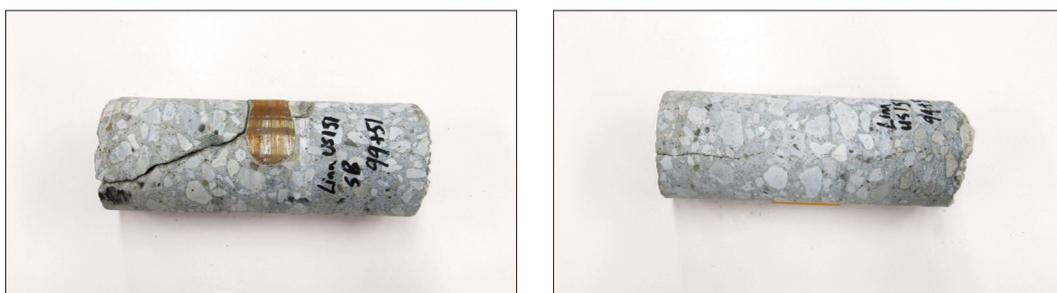
Figure 6. Concrete cores from site 12 at US 151

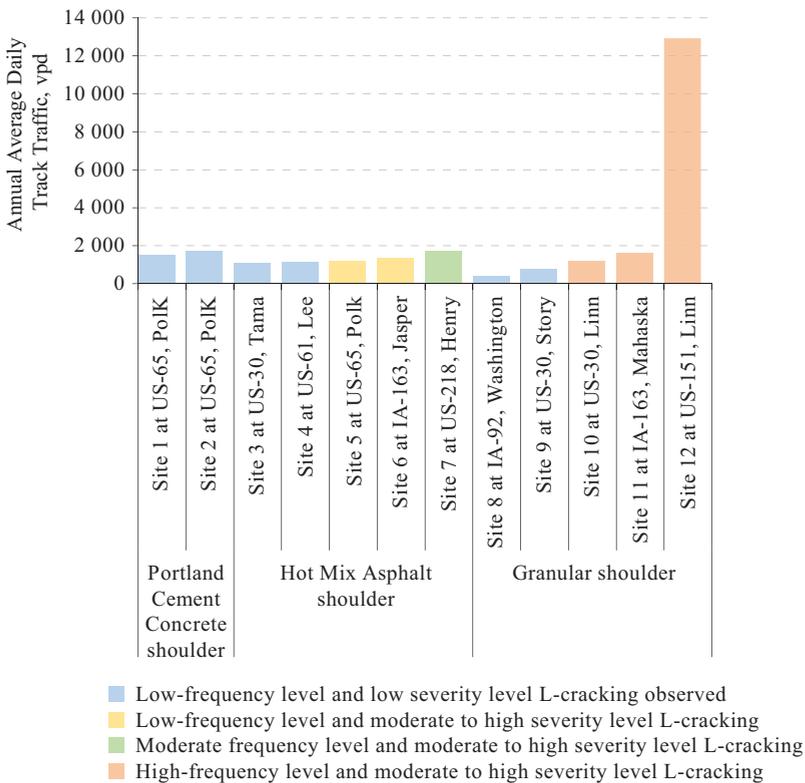
Figure 7. Frequency and severity level of widened slabs having longitudinal cracks

Figure 7 shows the frequency and severity level of longitudinal cracks observed at the sites, based on total lengths of cracks and definitions following the LTPP distress manual (Miller & Bellinger, 2014). The sites were ranked based on Average Annual Daily Truck Traffic volume ($AADT_T$, vpd) and categorised by shoulder type: tied PCC shoulder, HMA shoulder, and granular shoulder. It is generally concluded that higher truck traffic volume directly leads to a more significant number of more severe longitudinal cracks. Excessive traffic loads and passing activity will result in the rapid development of transverse

have fewer longitudinal cracks than those with HMA shoulders or granular shoulders (Figure 7). This finding is attributed to several factors. First, in addition to a significant number of longitudinal cracks observed at Louisiana sites with tied PCC shoulders, there were also a significant number of corner breaks at those sites. The corner breaks imply that these sites probably suffered from the large load traffic accompanied by loss of support and poor joint load transfer capability, possibly associated with a great likelihood of longitudinal cracks (Xiao & Wu, 2018). Differing from the 4.30 m (14 ft.) widened slabs used for JPCPs in Iowa, Louisiana highways usually used 4.60 m (15 ft.) slab width with tied PCC shoulders, so a higher degree of curling and warping occurs due to greater slab width (Ceylan, Gopalakrishnan, Kim, Taylor, Alhasan, & Yang, 2016; Rao & Roesler, 2005). Yu, Smith, & Darter (1995) also recommended 4.30 m (14 ft.) for slab width of widened pavements, because the widening of slabs by below 0.60 m (2 ft.) provided too less stress reduction to improve pavement performance significantly. Widening of slabs by more than 0.60 m (2 ft.) lead to excessive curling stresses in the transverse direction that produces additional longitudinal cracks. This recommendation agrees with the findings of Owusu-Ababio & Schmitt (2013) that 4.30 m (14 ft.) widened slabs experienced less longitudinal cracking than other widened slab sizes.

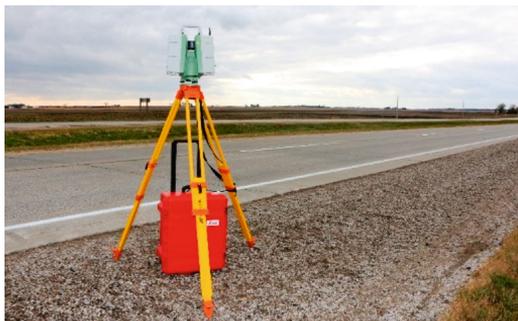
Figure 8. Terrestrial laser scanner used for curling and warping measurements at site 9 at US 30

Curling and warping at the selected sites (sites 3, 9, 10, 12) were measured using a Terrestrial laser scanner during late fall 2015 (Figure 8). These sites were selected because sites 3 and 9 did not exhibit visible cracks, and site 10 and 12 exhibited a more significant number of longitudinal cracks. Terrestrial laser scanner provides slab profiling as accurate as a class 1 profiler (Chin & Olsen, 2014; Yang, Alhasan, Ceylan, & Kim, 2018) by producing three-dimensional (3D) point clouds that will be further modelled and visualized, enabling conduct of maximum deflection measurements along diagonal lines without necessity for traffic control in the field. In this study, morning and afternoon measurements were taken, and the degree of curling and warping were represented as curvature degree (Eq. (1)) to account for the rate of slope change along the slab length (Asbahan & Vandenbossche, 2011; Byrum, 2005, 2009; Lederle, Lothschutz, & Hiller, 2011; Vandenbossche & Snyder, 2005; Yang, Ceylan, Alhasan, & Kim, 2018). The detailed data collection process and calculation algorithm used have been explained in more details in previous studies (Yang, Alhasan, Ceylan, & Kim, 2018, Yang, Ceylan, Alhasan, & Kim, 2018; Yang, Ceylan, Gopalakrishnan, Kim, Taylor, & Alhasan, 2018). Table 2 summarises the survey results for curling and warping measurements in terms of average curvature degree of scanned slabs along to different directions, where a positive value represents an upward slab curvature shape, and a negative value represents a downward slab curvature shape.

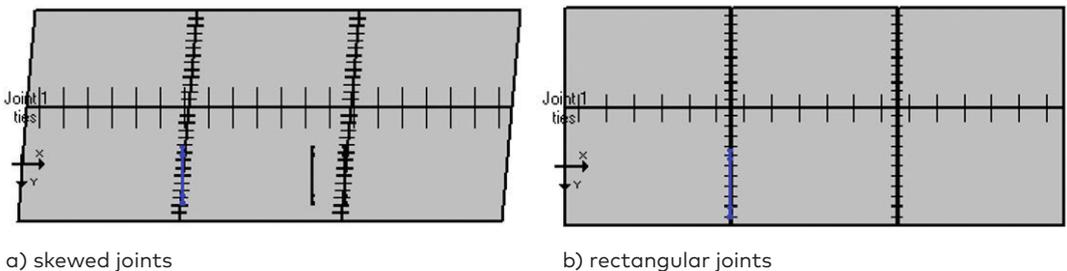
Figure 9. Modelled Jointed Plain Concrete Pavements in EverFE 2.25

The longitudinal cracking potential between skewed and rectangular joints for JPCPs was assessed using 3D Finite Element Analyses (FEA). EverFE 2.25 software was chosen because it supports skewed joint modelling, aggregate interlock, joint shear transfer, and dowel joint shear transfer as well as temperature nonlinearities. Both 4.30 m (14 ft.) widened slabs with skewed and rectangular joints were modelled, and the joint spacing was set up as 6.10 m (20 ft.) for all cases. Three-axle truckloads with both a single wheel (20 kips) and a tandem wheel (34 kips) were simulated. Axles were placed at different distances from slab edges and transverse joint to identify critical loading locations (see Figure 9). Temperature loads were applied by adjusting the temperature difference between the slab surface and bottom. The design parameters used for modelling are listed in Table 3.

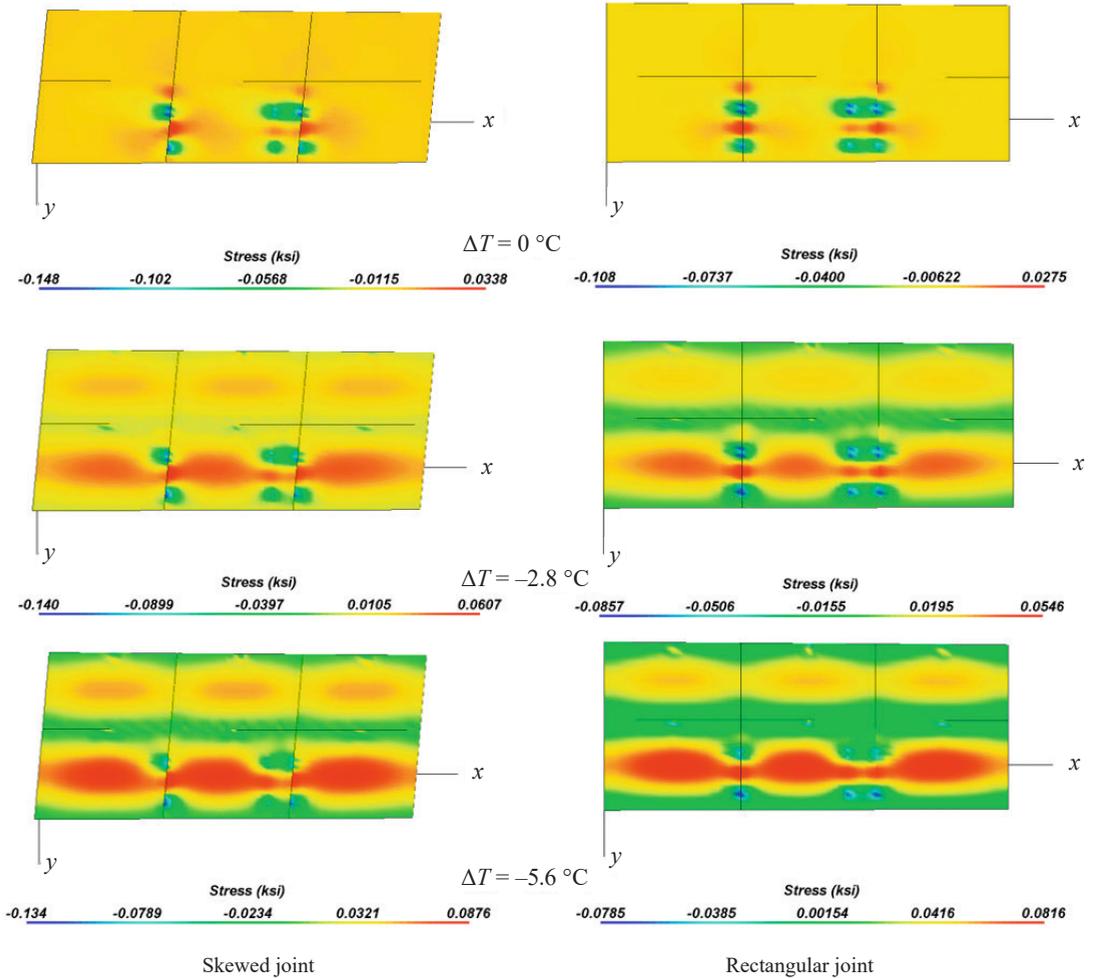
Figure 10. Comparison of stresses distributions between skewed and rectangular jointed slabs

Figure 10 shows the top tensile-stress distributions for skewed and rectangular-jointed widened JPCP cases. Three loading scenarios were compared: mechanical-load-only ($\Delta T = 0^\circ\text{C}$), mechanical load with temperature difference $\Delta T = -2.8^\circ\text{C}$ (-5°F), and mechanical load with temperature difference $\Delta T = -5.6^\circ\text{C}$ (-10°F). A red contour colour represents tensile stresses, and a blue contour colour represents compressive stresses. Numerical simulation results indicated that

critical stress positions were at transverse joints of the widened slabs at the lane edge. Maximum tensile stresses were induced at this critical position when half of the single and the back axles of the tandem axle were applied on the approaching slab and the other half on the leaving slabs. According to Figure 10, widened slabs with skewed joints generally exerted about 10% to 20% higher top tensile stresses compared to widened slab rectangular joints under the same loading scenarios. Tensile stresses also increased when the negative temperature gradient increased. The maximum tensile stresses were

approximately increased by 2.6 times and 3 times when the temperature difference changed from 0°C to -5.6°C for skewed joint and rectangular joint scenarios, respectively. This FEA results substantiated the fact that JPCPs with skewed joints have higher potential for longitudinal cracking. The load cantilever generated from skewed joints contributes to this finding because it corresponds to imparting excessive tensile strain within the slab. Consequently, in combination with widened slabs and excessive truck traffic, JPCPs with skewed joints increase cracking potential.
