# TRAFFIC REORGANISATION IN LARGE ROUNABOUTS OF VILNIUS AND ITS INFLUENCE ON TRAFFIC SAFETY

VYTAUTAS GRIGONIS<sup>1\*</sup>, IVETA STANEVIČIŪTĖ,  
VYTAUTAS DUMBLIAUSKAS<sup>3</sup>

<sup>1</sup>*Road Research Institute, Faculty of Environmental Engineering,  
Vilnius Gediminas Technical University, Vilnius, Lithuania*

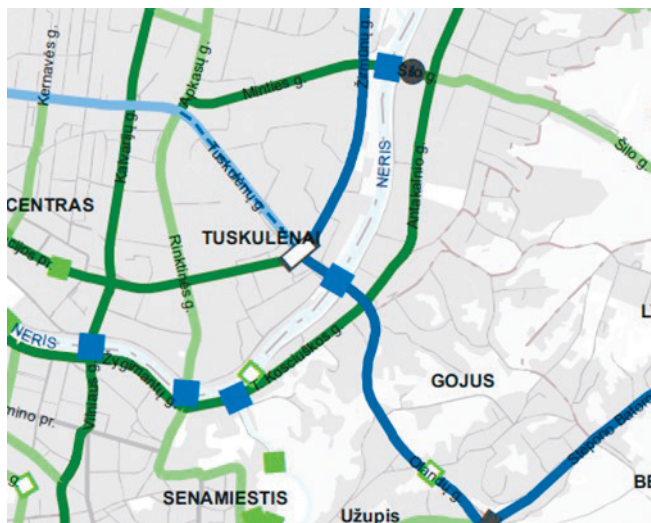
Figure 2. Street categories according to the master plan of Vilnius

According to the master plan of Vilnius city municipality (2019), the street network categories are rated as follows: Olandai and Žirmūnų streets are higher B category, Tuskulėnų street are lower B category, T. Kosčiuškos, Antakalnio and Šeimyniškių streets are higher C category (Figure 2).

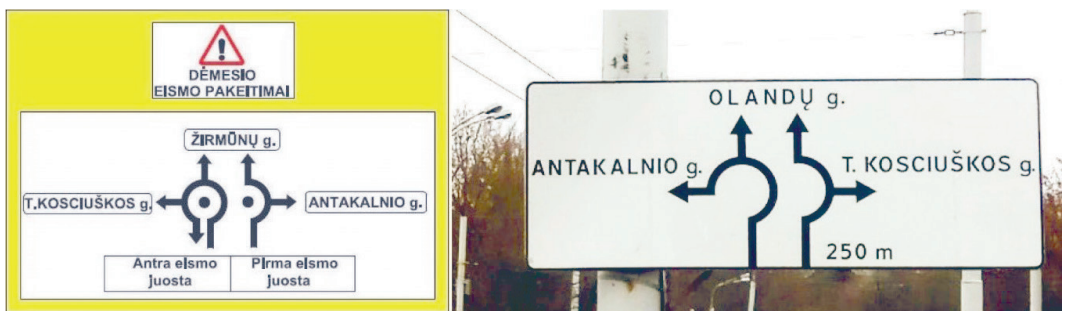
**Figure 6.** Temporary (on the left) and permanent informative road signs (on the right) informing about traffic organisation changes

As drivers approach such spiral roundabouts, they have to choose the right approaching lane for their desired exit. The information concerning such a right lane is displayed in signboards (Figure 6), along with road signs and a marked driveway. All the drivers have to follow the road signs and the requirements of the Road Traffic Code.

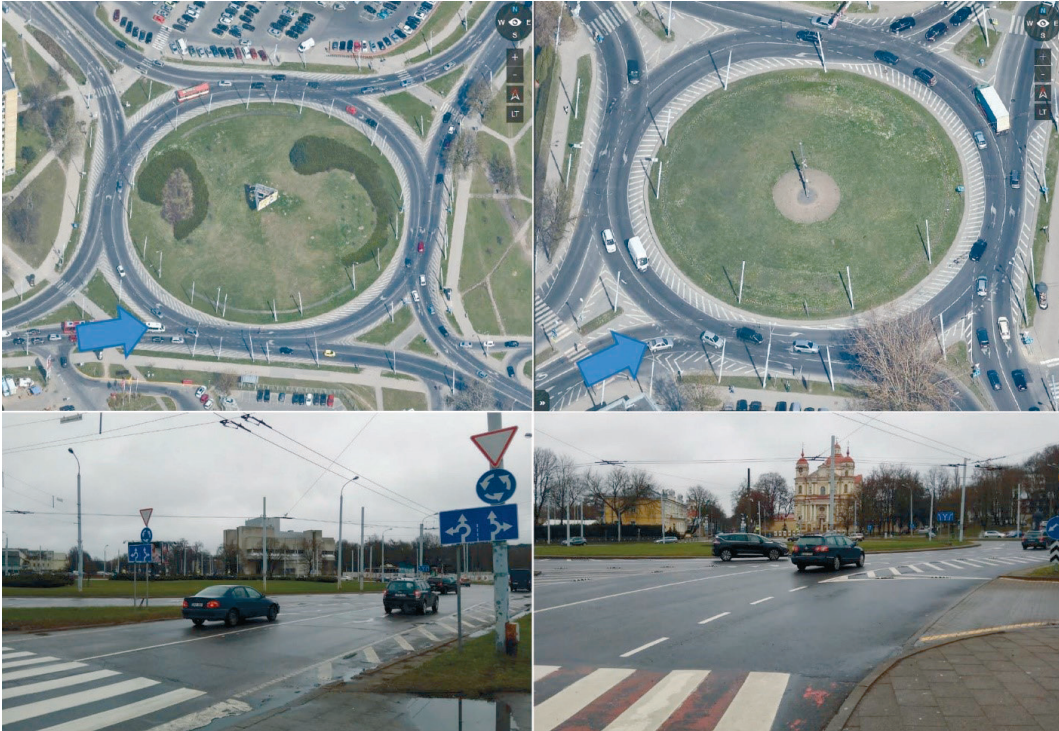
**Figure 7.** Aerial and local view at roundabouts after traffic reorganisation (arrow in aerial view shows the direction of local view, "Žirmūnai Roundabout" on the left side and "Olandai Roundabout" on the right side)

After introduction of new traffic organization schemes on 6 August 2016, both roundabouts have two lanes in the circulatory roadway with two approaching and exit lines (Figure 7). The lines in the roundabouts were marked with single solid lines removing the possibility to change lanes in a circulatory roadway; clear trajectories by narrowing the carriageway were provided. One pedestrian crossing on the boundary of "Žirmūnai Roundabout" and a bridge were removed as it had the lowest pedestrian volume (88 per hour). Later on, small rubber bumps were introduced in a circulatory roadway to improve the visibility of the spiral lines. The usual blue road signs with white arrows showed which lanes were dedicated to leave the roundabout or stay in the circulatory area.
