MEASUREMENT OF TEMPERATURE DISTRIBUTION WITHIN STEEL BOX GIRDER OF VISTULA RIVER BRIDGE IN CENTRAL EUROPE

MACIEJ HILDEBRAND*, ŁUKASZ NOWAK

*Faculty of Civil Engineering, Wrocław University of Science and Technology,
Wrocław, Poland*

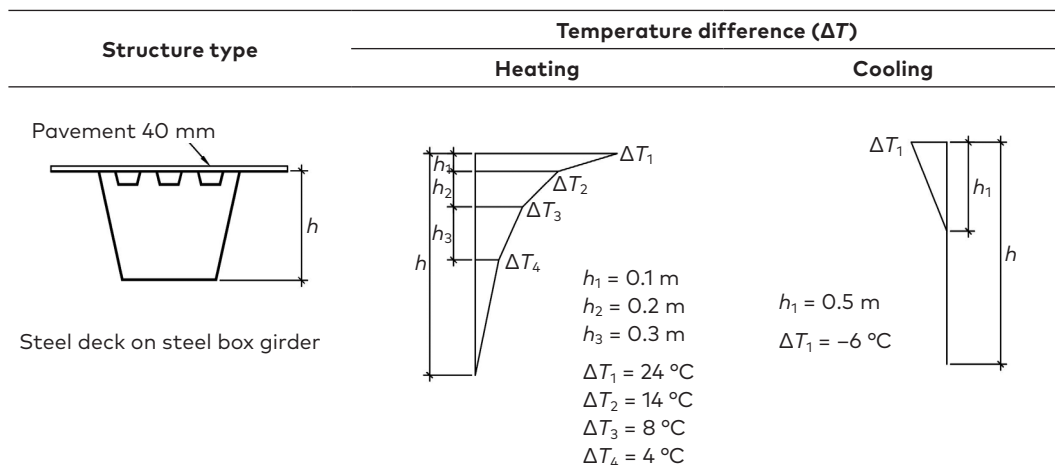
Figure 1 taken from Eurocode shows the suggested temperature profile between the upper and lower surface of the girder with regard of the nonlinear component of temperature difference.

Figure 1. Recommended profile of temperature difference in a steel girder in vertical direction acc. to Eurocode 1 (2005) (refers to situation when the bridge pavement is 40 mm thick)

In view of Figure 1 from Eurocode 1, it is worth mentioning that thermal action of solar radiation during steel girder heating comprises the elements, which are situated in relatively shallow position below the bridge deck, i.e. several dozens of centimetres. When considering the spans of structural height 3 m to 4 m, an essential thermal effect covers usually less than 20% of the cross-section height.

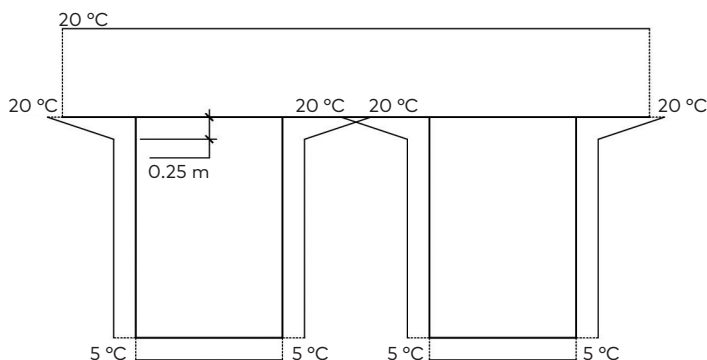
Figure 2. Temperature diagram of Rio-Niteroi bridge, recommended for climatic region of Rio de Janeiro, based on Ostapenko, (1975)

An interesting work on the considered issue was published by Ostapenko (1975), examining a large steel box bridge located close to Rio de Janeiro at latitude of 22.5° S. According to field examinations of the bridge connecting Rio de Janeiro with Niteroi Town, it was found that essential effect of heating the steel structural elements reaches no deeper than about 25 cm below the bridge deck, and the temperature increment of the top slab during its heating in a day amounts to about 20 °C. At the same time, the temperature increase of the bottom slab of the box girder is merely 5 °C. However, we need to take into consideration that although the bridge is located in the hot climate zone, it is located right on the seashore of the Atlantic Ocean, which soothes the temperature of the surrounding air. The key conclusion of the tests is the fact that temperature profile creates a straight line almost along the full height of girders, excluding the above-mentioned 25 cm (Figure 2). It is worth adding that Chen (2008) investigated a series of bridges under similar insolation conditions, although in the northern hemisphere.

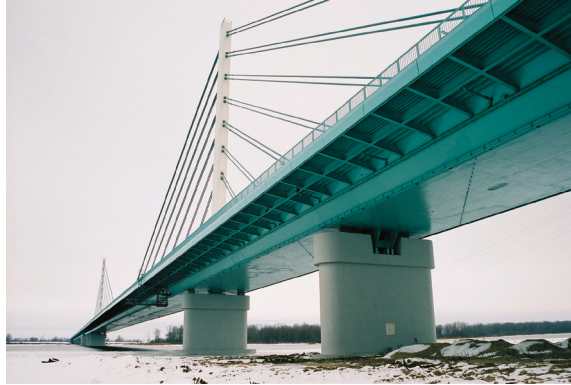
Figure 3. General view of the bridge

The bridge is composed of a 585 m long multi-span beam part on the left-bank flood plain, 615 m long main part with cable-stayed spans and 510 m long multi-span beam part over the land on the right bank. A single steel box three-cell girder, 27 m wide and about 3.5 m high, was used in the cable-stayed part including five spans. The main part of the river crossing is supported with stays positioned in a single plane. Elements of spans and both pylons are made totally

out of orthotropic plates. Two roadways and two bicycle/pedestrian paths are arranged on the bridge deck. The Vistula River runs in one compact riverbed about 460 m wide within the crossing, and both river banks are partially wooded or shrubby, the steel structure is painted in light green. The pavements of roadways and median strip are bituminous, while bicycle/pedestrian paths have a resin surface. Span underside is about 12 m above water table. General view of the bridge is given in Figures 3 and 4.

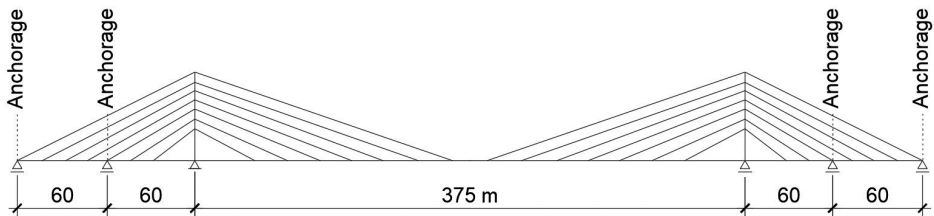
Figure 4. Static scheme of the cable-stayed part of the bridge with span sizes, units in m

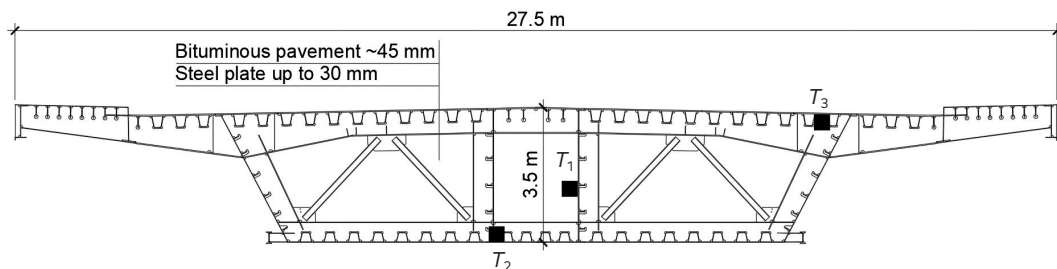
Temperature of the steel structure is continuously taken in two points on the deck plate (T_3) and bottom plate (T_2) of the main girder, while air temperature is measured in the central cell of the girder

Figure 5. Location of permanent temperature sensors in the girder

(Figure 5). The T_3 , T_2 and T_1 thermometers are located in the main span. Horizontal distance from the thermometers to the left river bank is over 60 m. The T_3 and T_2 thermometers are directly attached to the surfaces of the upper and lower plates covered with anti-corrosive coating, both on the internal side of the box girder.

On the deck above the measurement points, from the top side, i.e. opposite to the temperature sensor, there are primer, intermediate layer, bonding layer and hard gussasphalt surface 45 mm thick. On the bottom side of the steel plate, i.e. from the side of temperature sensor, there is a three-layer paint coating.

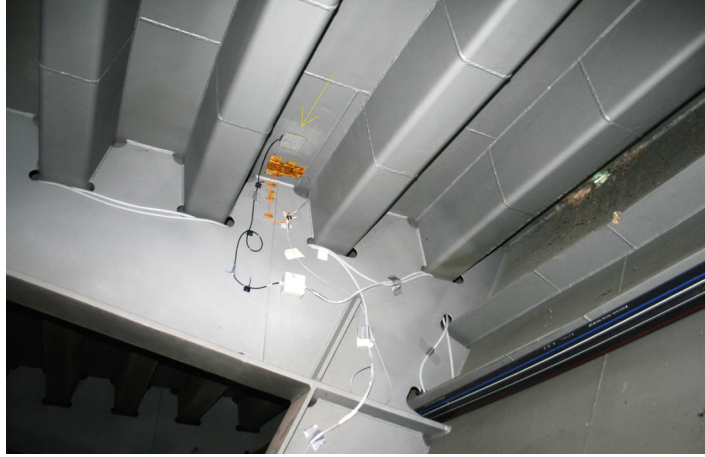
Figure 8. Photo of girder interior (connection of the top slab with external slanted wall), arrow shows point-wise temperature sensor of the top slab T_3

Figure 8 shows a photo of a structural node, i.e. a joint of the top slab with the internal transverse rib and external slanted wall, while Figure 9 provides an example of the thermogram made late in the evening of 31 March 2019.

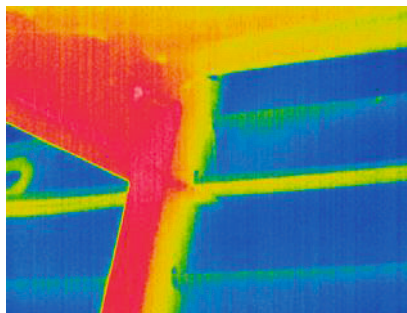
An exemplary thermogram in Figure 9 clearly shows local temperature distribution close to the structural node inside the box girder. Heat accumulated during the day in construction elements is moved to atmosphere, the plates of external sheathing cool at the highest speed. When the photo was taken (night, time 23:00), it was a cloudless

Figure 9. Thermovision photo of girder interior (cf. Figure 8). The photo taken on 31 March 2019 at about 23:00. Blue colour denotes cooler areas than those in yellow or red. Plates of the slanted wall of the girder dissipate heat outside faster than internal constructional elements like ribs

weather, external temperature was about $+5.0\text{ }^{\circ}\text{C}$, air temperature inside the box girder was $+11.5\text{ }^{\circ}\text{C}$, temperature of the top slab was $+9.6\text{ }^{\circ}\text{C}$, and that of the bottom slab $+8.5\text{ }^{\circ}\text{C}$.

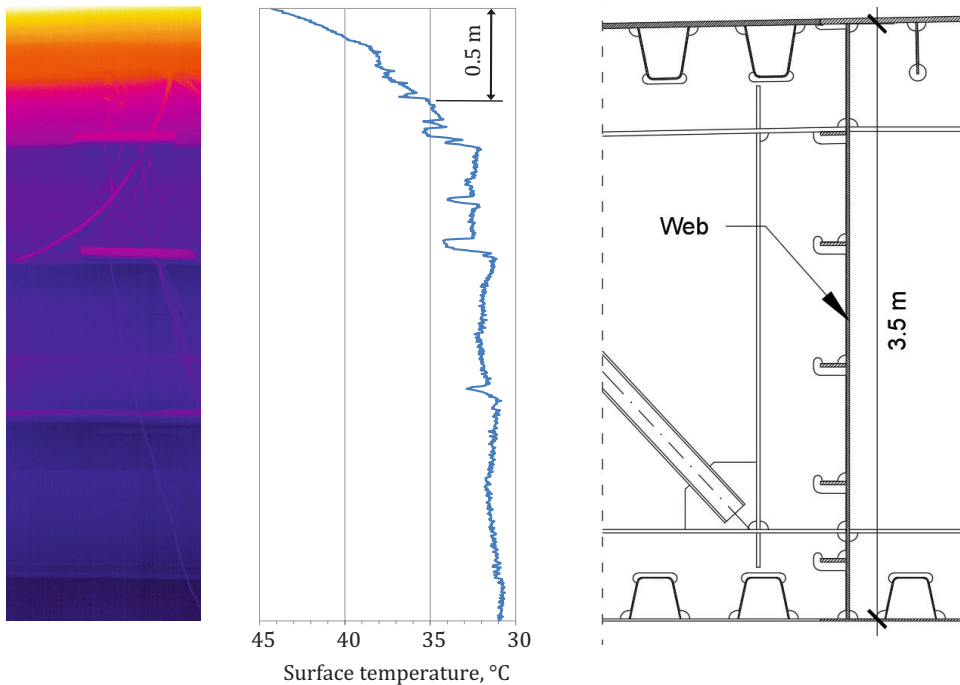
Figure 11. Thermogram and temperature profile of the internal web, 26 June 2019, time 13:30. Visible effect of solar heating – high temperature in the upper part of the web

In order to determine temperature distribution during the day at the beginning of warm season, thermographic photos were taken on 26 June 2019 at 13:30 in sunny weather; external temperature was about +33°C, while air temperature inside the box girder was +30.4 °C. Spot measurements made with thermometers (T_3 and T_2) showed +45.4 °C for the top slab and +29.8 °C for the bottom slab. Thermographic photo taken under these conditions is shown in Figure 11 together with temperature profile determined from this photo. Thus, it is clear that for the greater part of the web – close to $\frac{3}{4}$ of its total height – temperature ranged from +31.0 °C to +33.0 °C. In the top part of the web, about 0.5 m high, the temperature was from +35 °C to +45 °C. Temperature of the middle and bottom part of the web and the bottom slab was not substantially different from external air temperature.

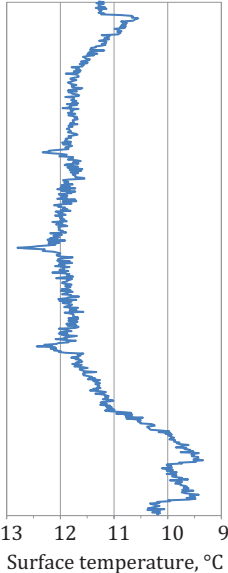
<p>Comment on the profile: Temperature along the total height of the web is within the range of 3.0 °C. The effect of evening chilling of both bottom and top slabs together with adjoining parts of the web is visible</p>
1 April 2019 7:00 h	1.8	4.3	6.5	-2.5	-1.0	Cloudless 0/10

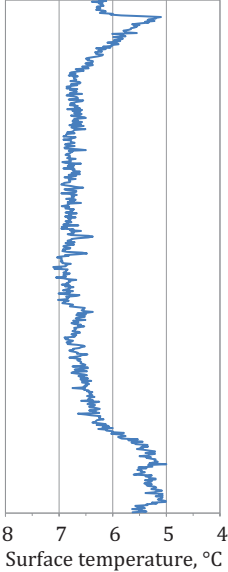
<p>Comment on the profile: Temperature along the total height of the web is within the range of 2.0 °C. The effect of morning chilling of both bottom and top slabs together with adjoining parts of the web is visible. Temperature decrease from late evening to morning (about 8.5 h) is about 5.0 °C</p>

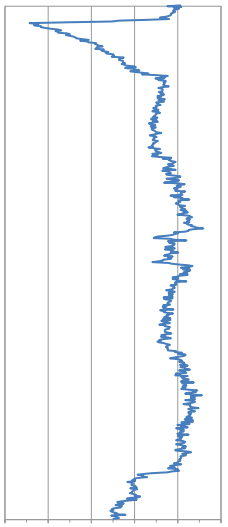
<p>Comment on the profile: Temperature rise of the top part of the web due to solar radiation is visible. Temperature of the top slab with immediately adjacent part of the web was not recorded on the thermogram. Area of increased temperature embraces a part about 0.5 m high. The lower part of girder is also heated up probably due to radiation reflected from the river water surface.</p>
26 June 2019 0:00 h	29.3	27.6	31.5	1.7	25.0	Cloudless 0/10

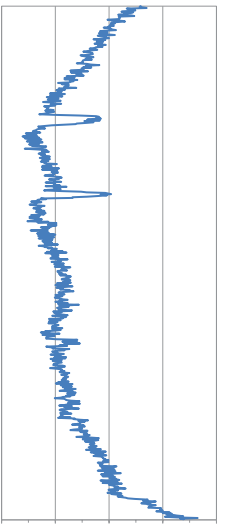
<p>Comment on the profile: High temperature in the range of 3.0 °C appears along the whole height of the web. Effect of night chilling of both top and bottom parts of the girder is visible</p>

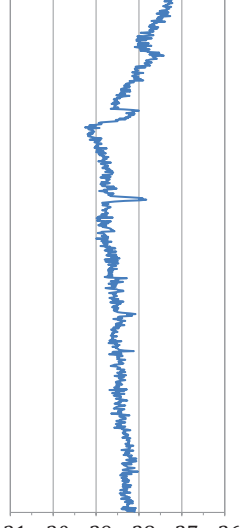
<p>31 30 29 28 27 26 Surface temperature, °C</p>
<p>Comment on the profile: Temperature in the range of 2.0 °C appears along the whole height of the web. Effect of heat radiation from the top slab is visible. Decrease of the highest temperature from midnight to sunrise (over c. 4.5 h) amounts to c. 2.0 °C</p>							
26 June 2019 13:30 h	44.8	29.6	31.2	15.2	33.0	Ci 3/10

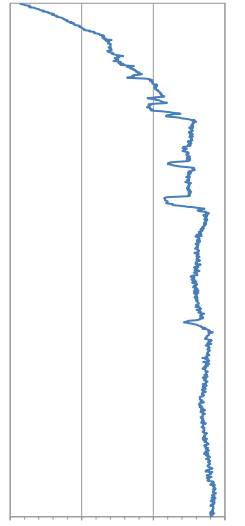
<p>45 40 35 30 Surface temperature, °C</p>
<p>Comment on the profile: In the central and lower part of the web, the temperature is almost uniform within the range of about +31 °C to +32 °C. In the upper part of the web, including a zone of about 0.5 m high, temperature reached about +44 °C due to solar radiation.</p>

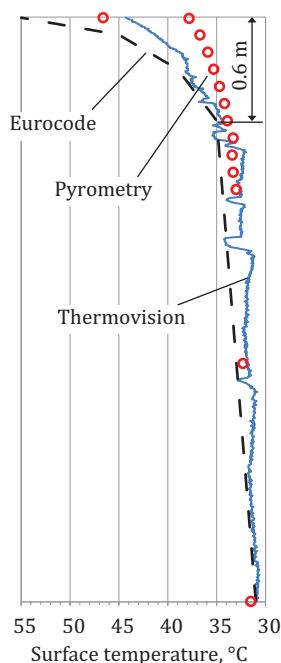
Diagram of particular temperatures is shown in Figure 12; the results of measurement are marked with red circles. It should be noted that while the maximum measured temperature, i.e. +46.6 °C, is close to that recorded in the monitoring system (i.e. +44.8 °C in T_3 sensor) and similar to that found in thermogram (+44.0 °C), the temperatures recorded at web/slab contact and slightly below are definitely lower. Just +37.8 °C was recorded at web/top slab contact, whereas +44.0 °C was read in the thermogram for this point. This discrepancy is currently being analysed. We can only assume that these discrepancies are caused by local heat radiation reflections.

Figure 12. Comparison of results from thermovision and pyrometry with the model of Eurocode, 26 June 2019, time 13:30, in relation of girder heating

It should be noted that the results reached are generally consistent with the model of thermal load included in Eurocode. This consistency first and foremost refers to the size of the top area of the bridge girder subjected to heating. According to this model, temperature rise diagram is non-linear in the neighbourhood of the top slab; it covers girder area

0.6 m high as measured from the top slab, and the maximum value of the increment is +24.0 °C. Thermovision testing outlined in this paper also found the non-linear nature of temperature increase for the area covering about 0.5 m, at the maximum value of +13.0 °C according to thermovision, and +7.0 °C as per pyrometry (Figure 12). It can be pointed out that above mentioned measurements of temperature rise were taken at the highest position of the sun over the horizon, both on the scale of a day and the whole year, as they were made on the first days of summer. Furthermore, the weather was almost cloudless, i.e. there were cirrus clouds covering 3/10 of the sky and there was no substantial wind (1 m/s to 5 m/s).

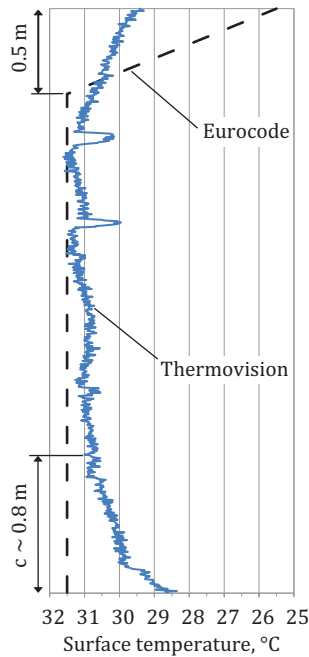
model from Eurocode, temperature reduction diagram covers the girder area 0.5 m high as measured from the top slab, the extreme value of temperature reduction is $-6.0\text{ }^{\circ}\text{C}$.

Thermovision examinations have shown that certainly there is a cooled down zone of about 0.5 m high in the upper part of the span, but there is also a cooled down zone of about 0.8 m high in the lower part of the span. The difference of temperatures between the bottom slab and the central part of the web is similar to that between the central part of the web and the upper plate (Figure 13). This phenomenon was also mentioned in Chen's dissertation (2008).

Figure 13. Comparison of testing results with the model from Eurocode based on thermogram of 26 June 2019, time 0:00, in relation to girder chilling

This phenomenon is not mentioned in the model given in Eurocode either. Likewise, no information was given about possible heating of the main girder in its lower zone, which was found in the examinations presented above. It should also be noted that there are disturbances corresponding to the longitudinal ribs of the web under investigation in the thermograms taken.
