# EQUIPMENT CONDITION FOR ZEBRA CROSSING NIGHT-TIME SAFETY PERFORMANCE IN LATVIA

**Abstract.** According to road traffic accident (hereinafter referred to as RTA) statistics, the vulnerable road users are pedestrians in Latvia. The aim of this study is to investigate and analyse technical equipment used on non-signalled pedestrian crossings (zebra crossings) in Latvia and to make suggestions for measures that would increase road traffic safety on zebra crossings. RTAs involving collisions with pedestrians were filtered from the Ministry of the Interior database for a three-year period from 2016 to 2018. Thirty-two zebra crossings with a higher number of accidents with pedestrians were observed on the spot during the daylight and at night in several cities of Latvia. The main emphasis during the observation was placed on traffic signs and zebra road marking performance. Pedestrian crossings were observed from car driver's view by taking photographs during day-time and night-time observations. Most attention was paid to road sign and road marking visibility from driver's seat position. Retroreflection coefficient

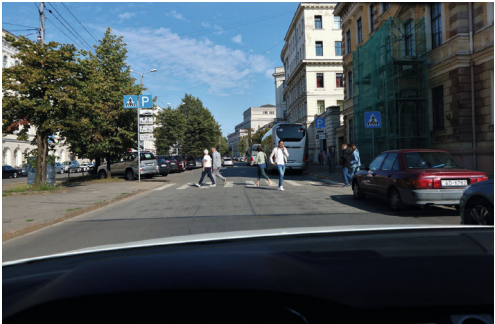
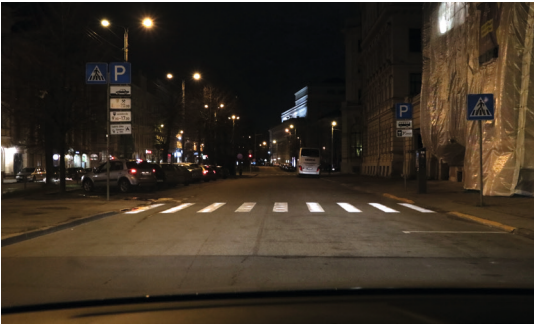
Driver's view at the selected crossings during the daylight was observed from VW Passat B8 car and photo shots were taken from a longer distance around 30 meters and a closer distance of 10 to 15 meters (Fig. 2a and 2b) using photo camera Canon EOS M100, BK M15-45 S.

Observation of pedestrian crossings during night time was done from a car equipped with modern LED headlamps. Repeated observation tour for 13 crossings in the city of Riga was done at night with the

Figure 2a. Driver's view during daytime

Figure 2b. Driver's view at night

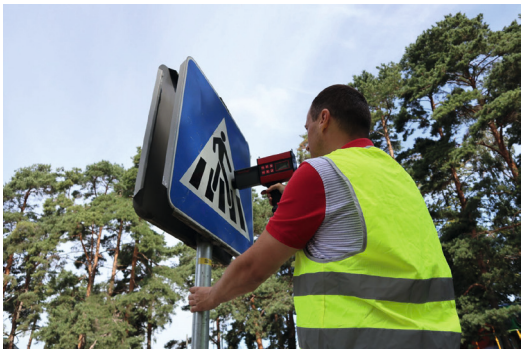
Detailed information was collected about the pedestrian crossing signs on the selected crossings: age of the sign, condition, retroreflection class and reflective sheeting type (glass beaded or micro-prismatic) used in sign manufacturing. Measurements of retroreflection coefficient of pedestrian crossing signs No. 535 and No. 536 by Latvia road traffic rules were made by a handheld measuring instrument Delta RetroSign (Fig. 3). The data obtained were compared with regulatory standard (EN 12899-1:2007 Fixed vertical road traffic signs - Part 1: Fixed signs, 2007) tables of minimum requirements for retroreflection coefficient  $R'$  ( $\text{cd lux}^{-1} \text{m}^{-2}$ ) at observation angle  $\alpha = 20'$  and entrance angle  $\beta = +5^\circ$ .

**Figure 3.** Measuring the road sign retroreflection

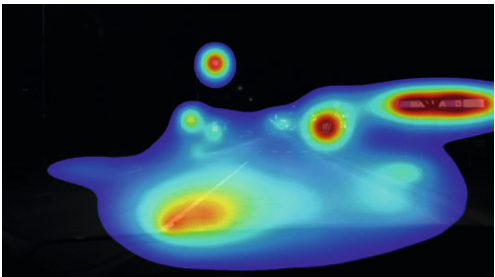
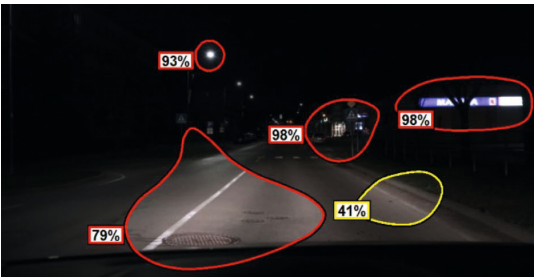
The photographs (see samples in Fig. 4a and Fig. 4b) taken during the night-time observations were uploaded into 3M Visual Attention Software (3M Visual Attention Software, 2020) to obtain information on which areas human eyes were tracking most when approaching the pedestrian crossing by a car and to detect if there were any circumstances in the infrastructure which could affect visibility of the pedestrian crossing. The option of outdoor/distant view was chosen for the analysis of the photographs in 3M VAS software. The general purpose of this software is not to assess road infrastructure but to analyse human eye attention to the outdoor advertisings within first 3–5 seconds. For this study, 3M VAS worked as a helping tool to identify potential factors to distract drivers’ attention in order to timely recognise non-signalled pedestrian crossings. Yellow to red areas are most likely to draw immediate attention, but blue and green areas are less likely to draw immediate attention (Fig. 4a). Red regions evaluated

**Figure 4a.** 3M VAS heatmap analysis

**Figure 4b.** 3M VAS region analysis

by 70–99% intensity mean high probability and blue to green regions with 20–69% intensity mean medium probability of human eye tracking (Fig. 4b).

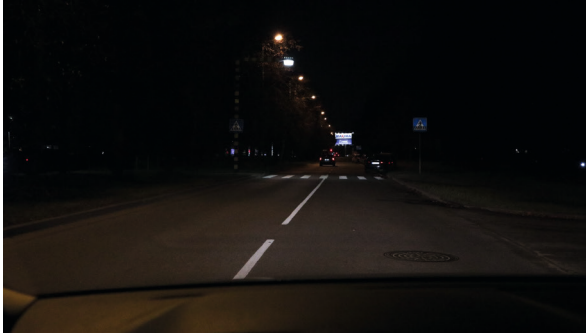
**Figure 5.** Pedestrian crossing with additional illumination.  
Driver's view at night

several other crossing safety enhancement solutions are more widely represented. The most popular additional equipment is illumination above the pedestrian crossing (Fig. 5). It is installed on 14 out of 32 pedestrian crossings observed. 13 of the total 28 RTAs during the night-time occurred on the crossings with additional illumination. This means that the division between RTAs on illuminated and non-illuminated pedestrian crossings is very similar; 13 and 15 collisions with pedestrians during the dark hours of the day. In order to attract the attention of drivers during the daytime, some illumination poles are mounted with contrasting painting metal plates.

The most commonly recognised problematic issue on the illuminated pedestrian crossings is the ground cover by the illumination or the light cone. Quite often it illuminates just the carriageway and there is a lack of light in the areas where pedestrians approach crossing. Due to this reason, the risk of non-noticing the pedestrians increases essentially.

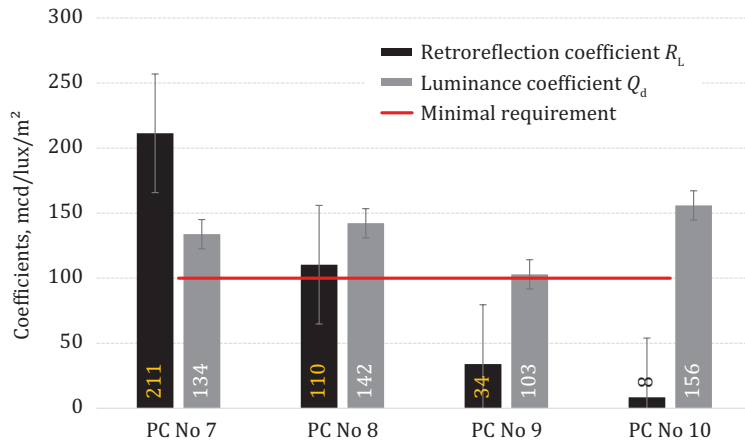
Road marking retroreflection coefficient measurement results from the investigation in Liepaja on pedestrian crossings (PC) 7 to 10 show different results for different types of road marking materials (Fig. 6).

**Figure 6.** Average retroreflection luminance coefficients per crossing in Liepaja

On all crossings measured, the luminance coefficient under diffuse illumination  $Q_d$  was within the standard norms. At the same time, nonconformity was recognised for retroreflection coefficient  $R_L$  on two pedestrian crossings where paint marking type was in use. On crossing No. 9 (O. Kalpaka Str, Liepaja) the average retroreflection coefficient  $R_L$  as  $34 \text{ mcd m}^{-2} \text{ lux}^{-1}$  only at minimum requirement  $100 \text{ mcd m}^{-2} \text{ lux}^{-1}$ .

Due to the rainfall before the measurements on crossing No. 10 (O. Kalpaka str, Liepaja), the retroreflection coefficient obtained cannot be legally matched against the Latvian standard requirement because it does not set requirements for road markings under wetness. The average retroreflection values on the wet zebra markings were found at very low level of  $8 \text{ mcd m}^{-2} \text{ lux}^{-1}$ .

The second recommendation can be made for the width of the zebra marking. The existing regulation in Latvia allows both 40 cm and 50 cm width. However, none of the 32 observed crossings were marked with 50 cm lines. It can be stated that a general rule for 50 cm wide markings would improve night-time visibility. Another cost-effective solution is all-weather visible road markings. ERF recommendations (ERF, European Union Road Federation, 2018) for the minimum requirement on road markings in use are  $150 \text{ mcd lux}^{-1} \text{ m}^{-2}$  in dry weather conditions and  $35 \text{ mcd lux}^{-1} \text{ m}^{-2}$  in wet and rainy conditions.

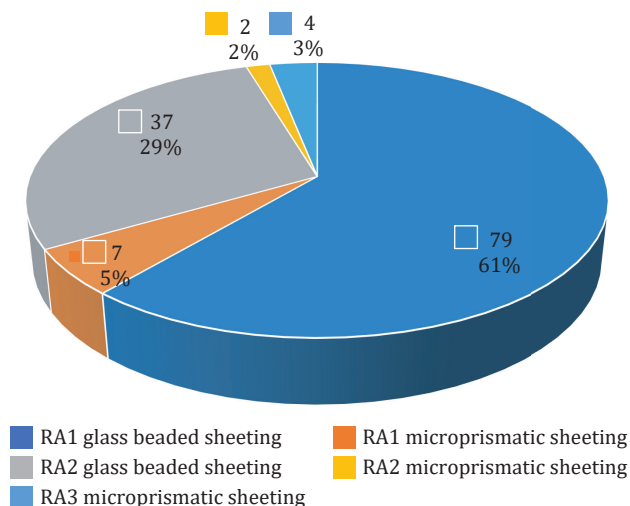
Traffic signs No. 535 and No. 536 (pedestrian crossing) were inspected in detail for all observed crossings. There is no requirement to install pedestrian crossing signs from higher retroreflection class RA2 or RA3 in Latvia; therefore, the lowest performing type RA1 (Engineer grade reflective sheeting) is commonly used for traffic signs No. 535 and No. 536. The chart below (Fig. 7) shows all observed pedestrian crossing signs split by retroreflective class and sheeting type.

At the time of inspection, the average pedestrian crossing sign age was 11.4 years. The highest average age was found for class RA1 glass

**Figure 7.** Pedestrian crossing signs by RA class and sheeting type

beaded sheeting signs. At the time of inspection, it was close to 15 years. Six crossings had traffic signs with at least 20 years of age. The high performing type signs produced from micro-prismatic reflective sheeting class RA2 and RA3 were recognised on 2 pedestrian crossings only, both of them in Riga. Noteworthy that out of seven RTAs with pedestrians none happened on these two crossings during the dark hours.

In order to increase traffic safety on the non-signalled pedestrian crossings in Latvia, it is worth starting with efficient low-cost solutions. It is recommended to improve visibility of pedestrian crossings from the driver's view by increasing the performance levels of pedestrian crossing equipment, such as wet reflective pavement markings and higher retroreflection classes for traffic signs. The respective requirements in Latvian standards should be raised to internationally recommended levels. A technically easy improvement is to implement traffic sign upgrade program from RA1 class beaded sheeting to RA3 class pedestrian crossing signs.

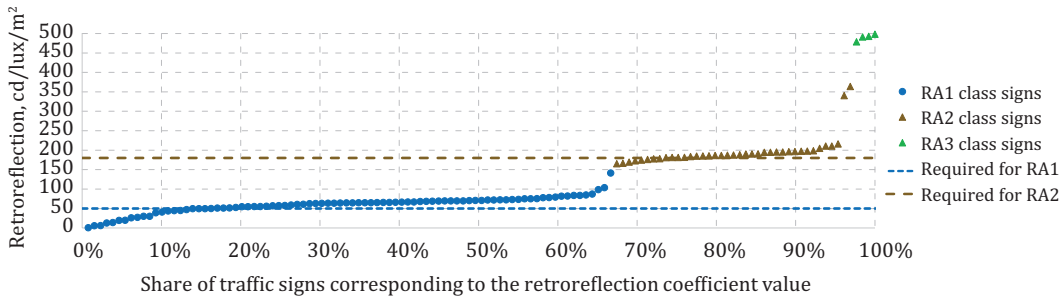
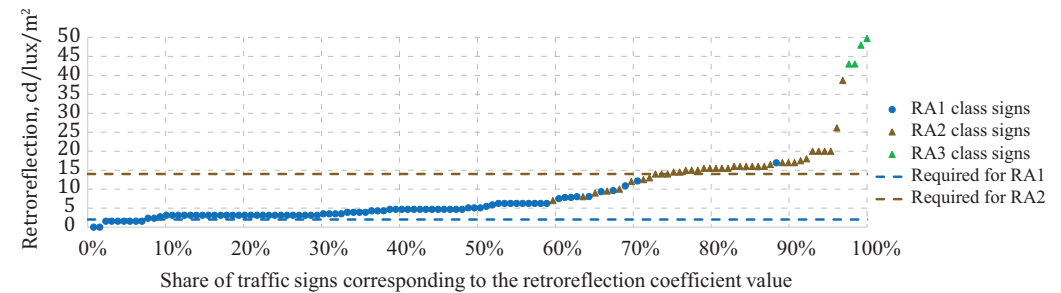
**Figure 8.** Traffic sign retroreflection coefficient for the white colour

**Figure 9.** Traffic signs retroreflection coefficient for the blue colour

additionally the retroreflection coefficient conformity to existing standards was checked. Nonconformity to the minimum retroreflection coefficient required for the white colour was found on 29 signs (22.5% of 129 signs observed) (Fig. 8) and for the blue colour on 17 (13.2%) traffic signs (Fig. 9).

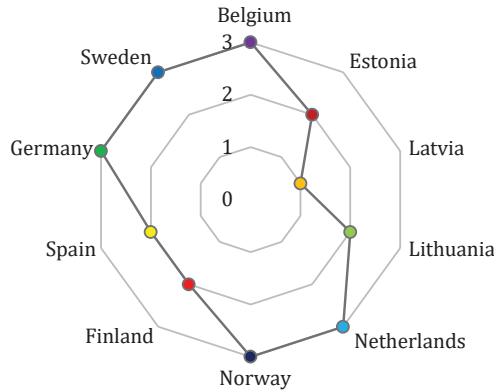
The minimal requirements for pedestrian crossing sign retroreflection performance class were compared to other neighbouring countries and some countries with the highest road safety level in Europe. Figure 10 shows that Latvia is the only country from the ones compared where it is legal to install RA1 class (Engineer grade) traffic signs on the pedestrian crossings.

**Figure 10.** Comparison of pedestrian crossing sign RA class minimum requirement among countries

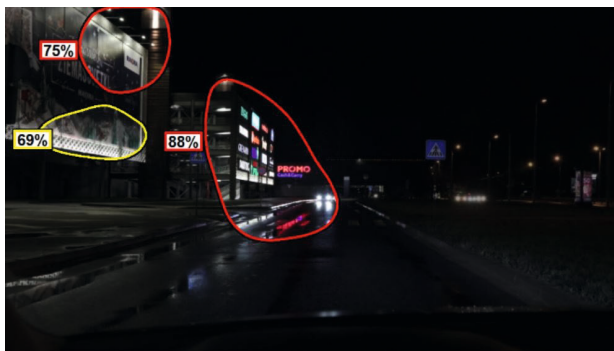
During the night-time observations, several infrastructure elements which could influence driver's ability to detect pedestrian crossings were recognised. Even if the crossings are noticed, they diminish the ability to notice pedestrians within a safe stopping distance. The street illumination and illuminated outdoor advertising are taking the most of human eye attention (Fig. 11).

Zebra crossing signs do not provide good enough illuminance in a particular infrastructure environment; traffic signs may be hardly noticeable to drivers. As shown in the 3M VAS analyser, most of the human eye attention goes to the illuminated advertisement of the shopping mall, software does not recognise zebra crossing signs and road marking stripes at all. Road markings do not provide retroreflection (Fig. 11) during rainy condition at night; therefore, they

**Figure 11.** Driver's view at night by 3M VAS photography analyser

During the night-time observation and analysis with the Visual Attention Software, there were several locations where street illumination and illuminated outdoor advertising took most of the human eye attention. Driver's attention is distracted, and drivers are not able to see pedestrians within a safe distance. It is recommended to put more emphasis on the surrounding conditions, in which pedestrian crossings are placed.

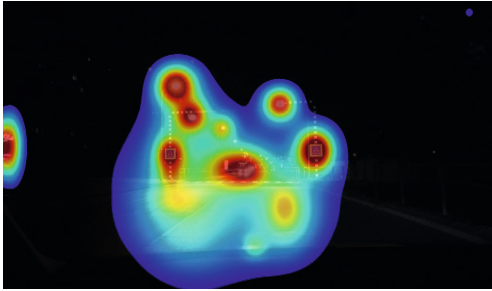
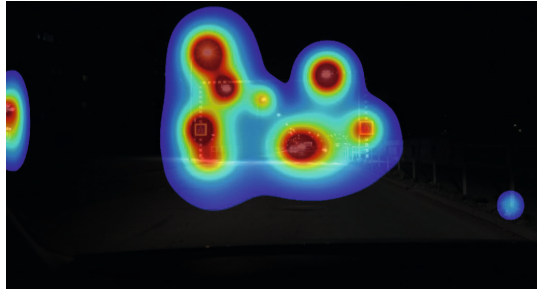
**Figure 12a.** 3M VAS heatmap analysis;  
LED lamps

**Figure 12b.** 3M VAS heatmap analysis;  
Halogen lamps

It was not clear if the software gave different results to LED headlamps and Tungsten-Halogen lamps. That was the main reason why night-time observation from car was done twice – with the same car model (VW Passat B8) but different headlamp types. Photographs were analysed in 3M Visual Attention Software (3M Visual Attention Software, 2020). Outcomes from 3M VAS show (Fig. 12a and Fig. 12b) that classic Halogen lamp light cone is more scattered and traffic signs are more illuminated, but LED light beam provides more focus on road, while the analysis software in both cases showed the same spots to be attracted by the human eye.
