# ASSESSMENT OF REINFORCED CONCRETE BRIDGE DEFICIENCIES UNDER SERVICE LOADS

**Keywords:** assessment, bridges, defects, inspection.

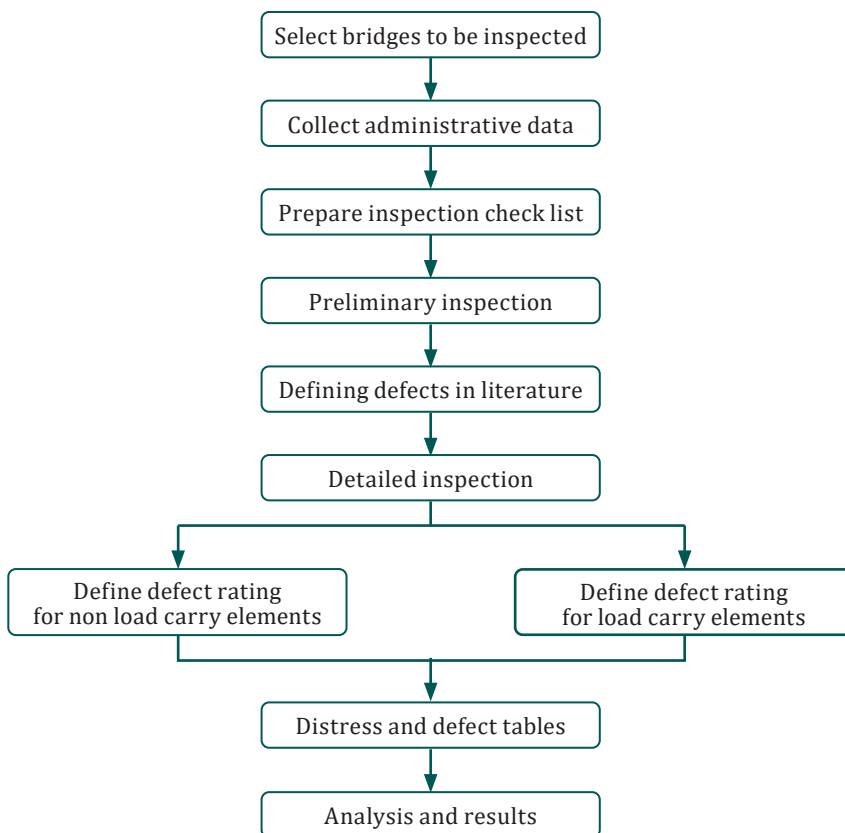
**Figure 3.** Outline of the methodology

Outline framework of the adopted methodology is presented in Figure 3. A comprehensive literature review was carried out to identify the problems commonly encountered in reinforced concrete bridges. Data collection and relevant people interviews helped the authors to make bridge selection and prepare an adequate inspection check list. A preliminary inspection was carried out on 104 bridges in Albania to identify their current defects and distresses. Defects and distresses found in preliminary inspection were studied. Similar defects were defined from literature to enlighten the defect types and perform detailed inspection. Detailed inspection is the final stage of the field work and specified all the types of defects and distresses found on an inspected existing bridge structure.

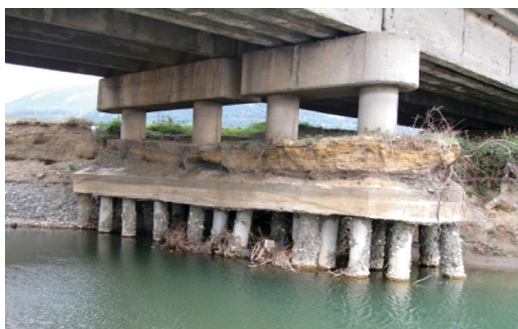
During the investigation of some bridges, heavy scours were reported mainly. The high flow rate, lack of design detail, poor workmanship and last but not least lack of maintenance result in a different level of scour in 60 inspected bridges. Bridges that have shallow foundations are the ones in the worst conditions. Due to scouring, differential settlement of foundation have caused problems to substructure and superstructure. Scouring problems are seen in deep foundations as well. One of the most sever scour problem was recorded at Mat Bridge. Scour height on these piles changes from 0.5 m to 4.5 m. Heavy scouring was monitored at some part of the foundation as shown in Figure 5a. Due to insufficient concrete cover and poor workmanship, reinforcements of pile cap were exposed and rusted. Additionally, significant amount of soil was observed in pile cap; a significant amount of soil was observed in pile concrete, proving poor construction workmanship. Exposed steel bars were detected because of concrete deteriorations on piles (Figure 5b). Insufficient foundation depth, human intervention, high river flow are detected as the main causes of scouring.

(a) Heavy scour

**Figure 5.** Scour problems in Mat bridge

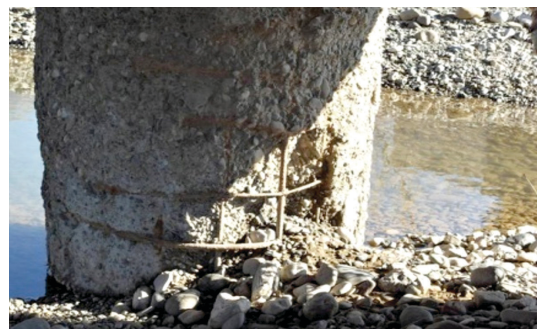
(b) Exposed steel bars

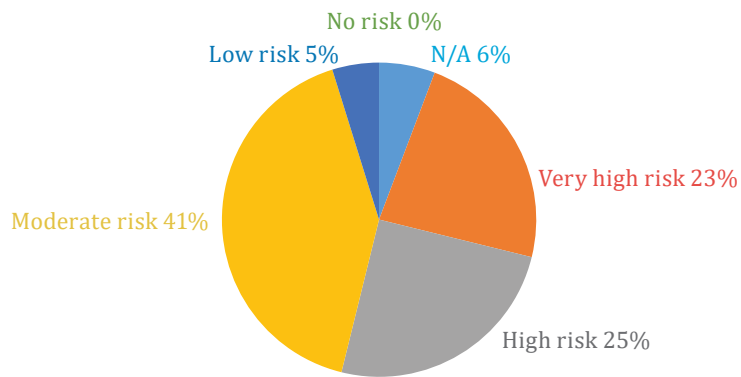
**Figure 6.** Rating of bridge distress (Chemical attack)

Concrete cover is specified in bridge standards. However, the main reason of carbonation observed on inspected bridges in Albania is insufficient concrete cover and poor concrete quality. Poor concrete quality has allowed the water to penetrate into; as a result, steel bars have been corroded. Corroded steel bars have then led to the spalls in concrete. Out of 104 inspected bridges, only 5 or 4.8% have no chemical attack risk, 69 of them or 66.3% have a low or moderate chemical attack risk and 30 bridges or 28.9% are at a high or very high risk (Figure 6). Chemical attack on a reinforced concrete bridge can be seen in Figure 7.

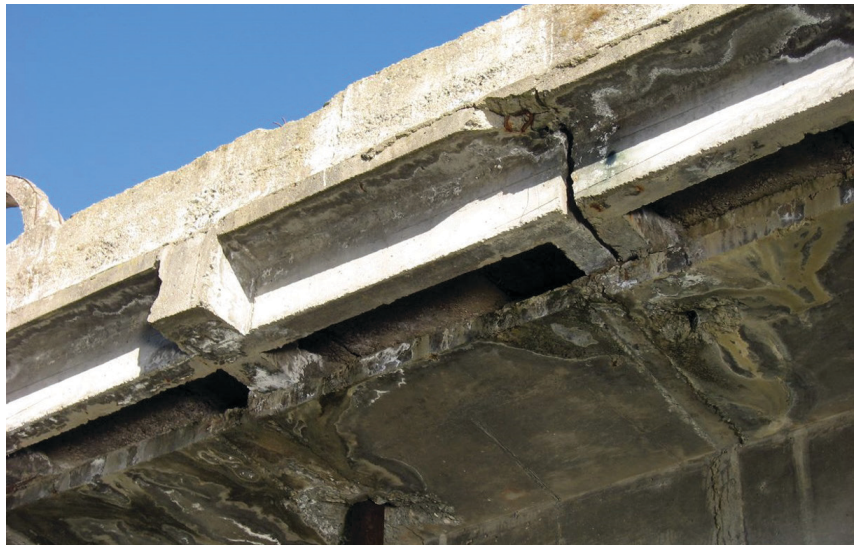
**Figure 7.** Chemical attack on a reinforced concrete bridge

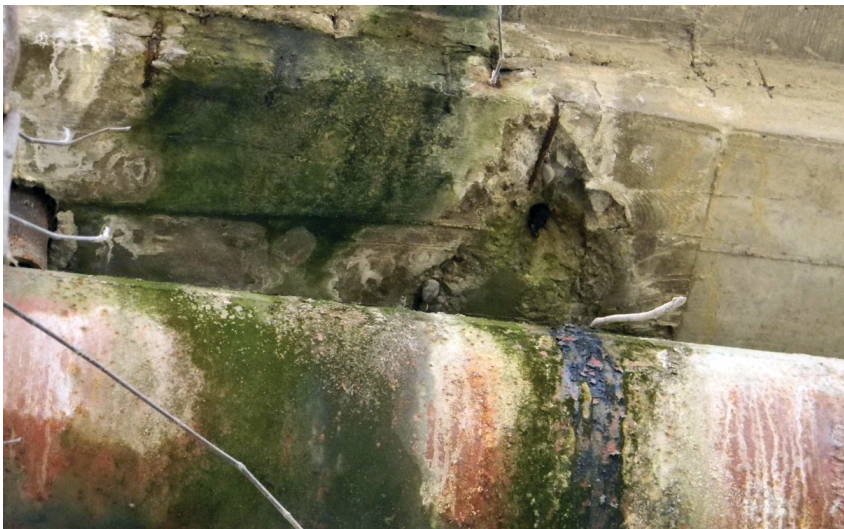
Water leakage is caused from bridge non-functional elements, especially drainage systems and expansion joint. Out of all inspected bridges, only 1 has no water leakage risk, 72 of them or 69.2% have a low or moderate water leakage risk and 31 bridges or 29.8% are at a high or very high risk (Figure 8). Water leakage resulting from non-functional drainage systems and expansion joint has led to extreme rust on steel bars, spalls in concrete and complex problems to bridge elements. The main causes of water leakage are the following: totally out of function drainage systems, non-functional expansion joints, lack of design details and maintenance. A typical water leakage is shown in Figure 9.

**Figure 9.** A typical water leakage

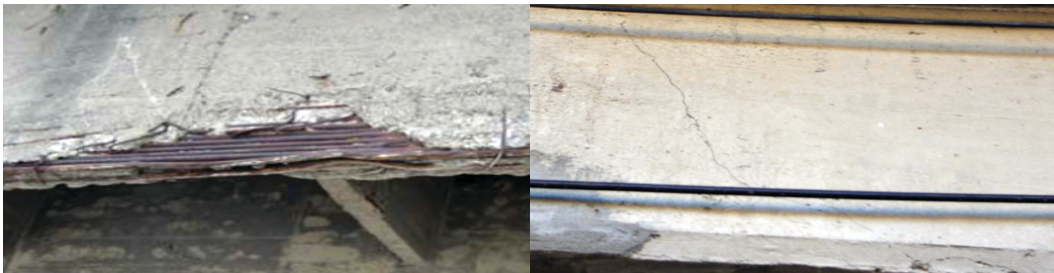
Cracks are the language of a reinforced concrete structure. It is very important to analyse them in order to understand behaviour and defects of the structures. Special attention needs to be paid to structural cracks. From exposed steel bars (Figure 10a), it is seen that the Albanian bridges are over-reinforced. Therefore, it is not common to meet flexural cracks. Types of cracks mostly seen in the bridges are shear cracks, long-term shrinkage crack and plastic shrinkage cracks. Shear cracks are the most delicate structural cracks found on the inspected bridges (Figure 10b). The steel bars used in design to resist moment are very dense but not the same attention is shown to stirrups. They are far from each other, sometimes more than 50 cm, and are of small diameter. Long-term plastic shrinkage cracks are mostly seen in abutments and sometimes in piers (Figure 10c).

(a) Dense reinforcement

(b) Shear crack at beams

**Figure 10.** Concrete cracks

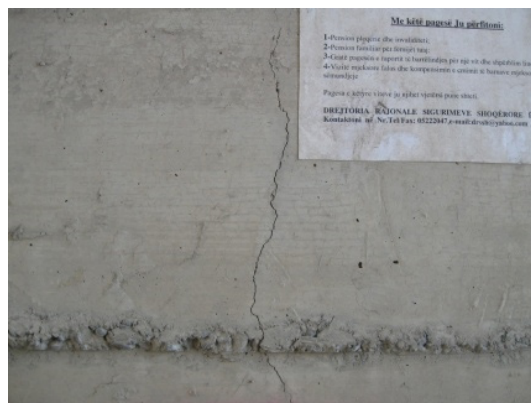
(c) Plastic shear crack at abutments

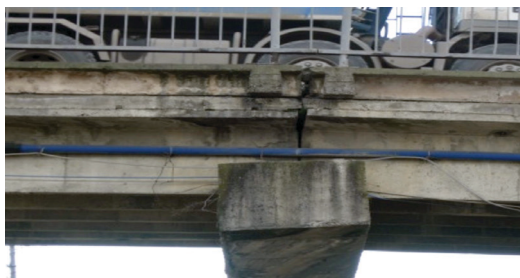
Various defects have been observed in the upper structure in many examined bridges. More serious defects have been identified especially in the bridges built before 1990 due to the aging factor. It has been determined that many bridges have poor workmanship problems, including obvious false frame work and insufficient concrete coating (Figure 12).

**(a)** Wrong connection and slope

**Figure 12.** Superstructure defects

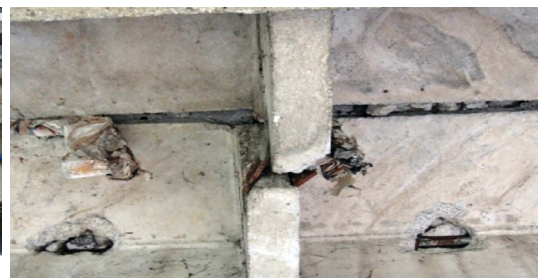
**(b)** Poor workmanship misalignment

Diaphragms which are essential components should be positioned on beams on a line. Nevertheless, it has been observed that the position of some diaphragms in the examined bridges deviates. More than 50 mm eccentricity failure of alignments has been monitored on some of the diaphragms.

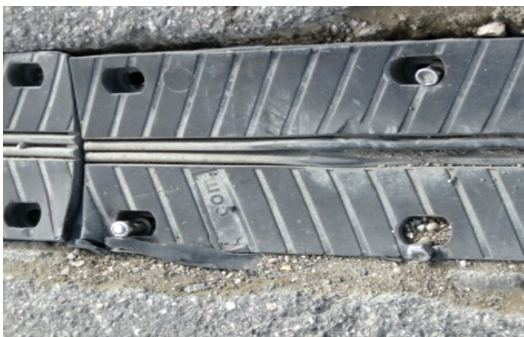
(a) Out of function expansion joint

It has been determined that the elements that provide the fixing of expansion joints such as bolts and welds are non-functional (Figure 13a). In addition, cracks and spalls were reported on the edges of asphalt or concrete adjacent to these joints. In addition, the lack of many expansion joints or its elements that create unexpected problems to other components such as bearings and other infrastructure elements was noted (Figure 13b).

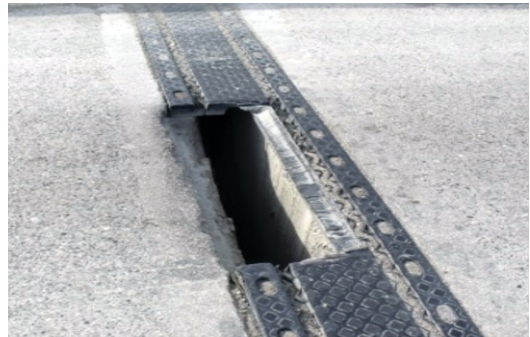
(b) Partly missing expansion joint

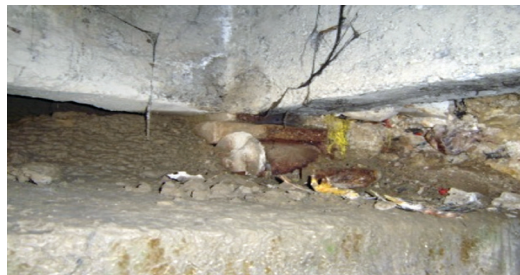
It has been observed that metal bearings in some bridges are corroded and the horizontal movement is limited by soil debris (Figure 15a).

(a) Corroded and clogged bearing

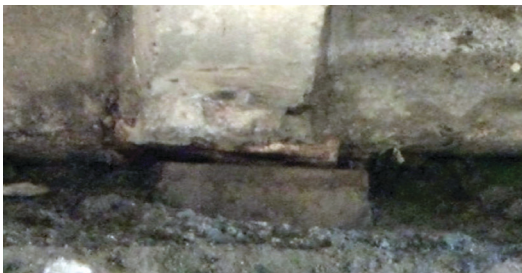
Moreover, it has been found that some sliding bearings are not properly aligned and thus lose their functionality.

As it is clearly seen in Figure 15b, the contact between the bearings and the slide plates has disappeared and this essential system, which is the support joint of the bridge, has become inoperable. Many of

(b) Misalignment of sliding bearing

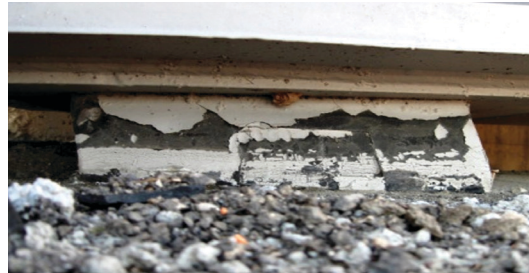
(c) Offset on elastomeric bearing

the problematic elastomeric laminated bearings had offset problems (Figure 15c) and it was measured that the offset angle in the elastomeric bearings ranged from 15° to 20°.

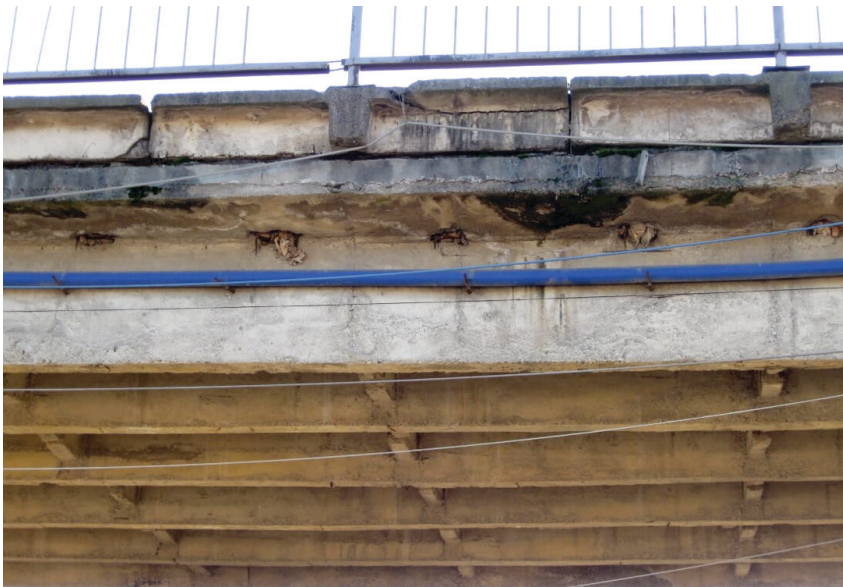
Defects found on bridge rail are broken connections and missing elements. Bridges built in the period of 1944–1911 have generally concrete parapets. Due to concrete degradation, the parapets were defected seriously. A parapet defect can be seen clearly in Figure 19. Bridges built in last two decades have metallic rails. Among the inspected bridges, 12 or 11.5% have no bridge rail defect risk, 63 of them or 60.6% have a low or moderate bridge rail defect risk and 29 bridges or 27.9% are at a high or very high risk (Figure 20). A phenomenon met in some cases is the destruction of these rails for informal profit from careless ruthless. The main causes of bridge rail defects are human intervention, maintenance and lack of design details. Rigid, high strengthened, innovative composite concrete has been designed to resist

**Figure 19.** Parapet defect on reinforced concrete beam
