# STATISTICAL ANALYSIS OF TRACK GEOMETRY PARAMETERS ON TRAMWAY LINE NO. 1 IN BUDAPEST

VIVIEN JOVER, SZABOLCS FISCHER\*

*Department of Transport Infrastructure and Water Resources Engineering,  
Szechenyi Istvan University, Győr, Hungary*

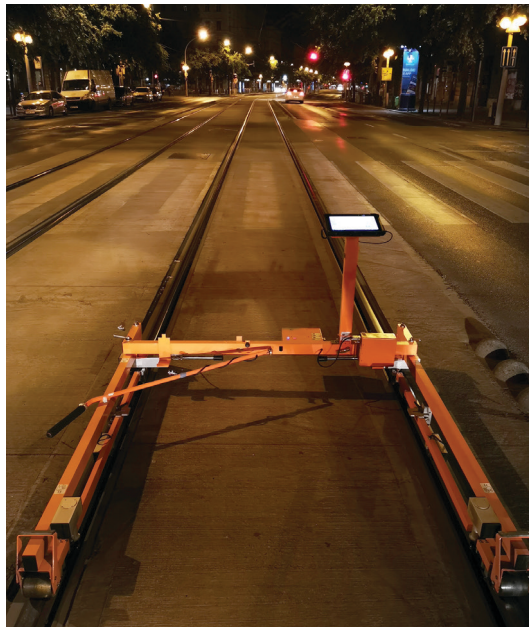
**Figure 1.** TrackScan 4.01 instrument (authors' photo)

In Hungary, TrackScan 4.01 instrument developed by Metalelektro Mérés-technika Kft is currently used to measure the geometrical characteristics of tramway tracks (see Figure 1). The description of the instrument and its characteristics are described in Chapter 2.3.

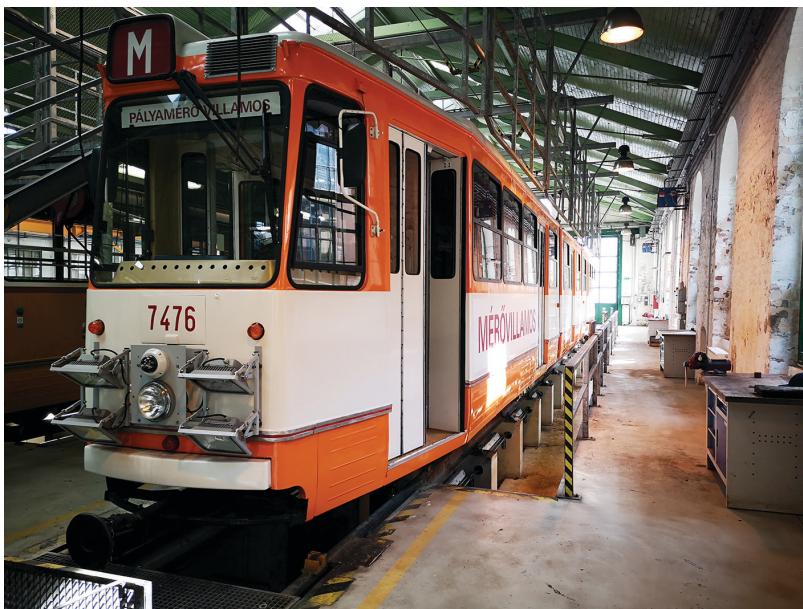
**Figure 2.** Instrumented in-service vehicle by BKV Zrt. and Metalelektro Méréstechnika Kft. (authors' photo)

In addition, to study the geometrical characteristics of tramway tracks, it is also essential to observe the dynamic characteristics, as the assessment and deterioration of the track condition are directly related to the speed of vehicles running on the line (Madejski, 2005). The railway track condition can be monitored almost continuously with sensors mounted on vehicles in Germany. Furthermore, separating the resonance signals from the measurements, it is possible to deduce the deterioration of the track (Baasch et al., 2019). In Hungary, the measurement of dynamic characteristics is currently performed with the so-called instrumented in-service vehicle, developed and manufactured by BKV Zrt and Metalelektro Méréstechnika Kft (see Figure 2). The dynamic measurement system was installed on an articulated GANZ type tram with eight axles, its ID number is 7476. To

measure the parameters, digital 3-axis accelerometers are mounted on the wheel, the frame of the bogie, as well as the car body, allowing the system to detect multi-level dynamic effects. Compared to TrackScan 4.01 instrument, the advantage of the instrumented in-service vehicle is that it provides the dynamic characteristics of the track to be measured with a loaded vehicle (Metalelektro Méréstechnika Kft, 2016). It is important to mention that the measurement results of dynamic characteristics cannot be related to geometrical characteristics yet. They allow detecting disadvantageous track condition and structural problems only (Bocz et al., 2018).

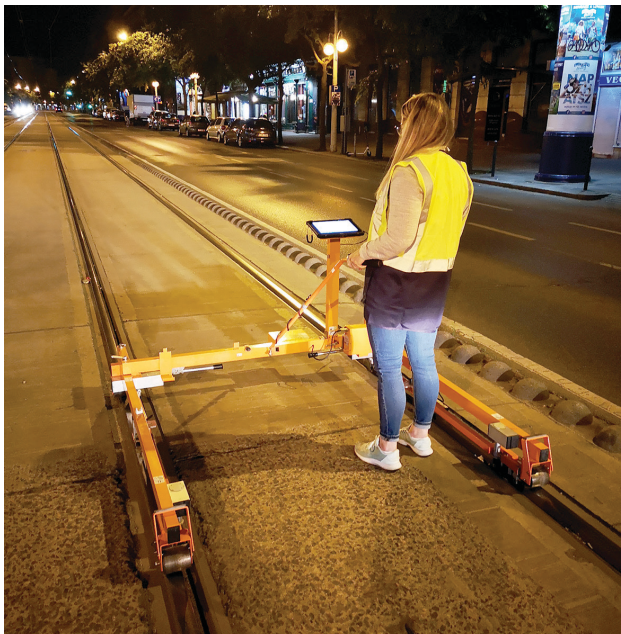
**Figure 15.** Geometrical measurement in Budapest (authors' photo)

The authors performed the geometrical measurements of the selected standard sections in the fall of 2019, 2020, and in the spring of 2021 on the right track (according to chainage) at night (see Figure 15).

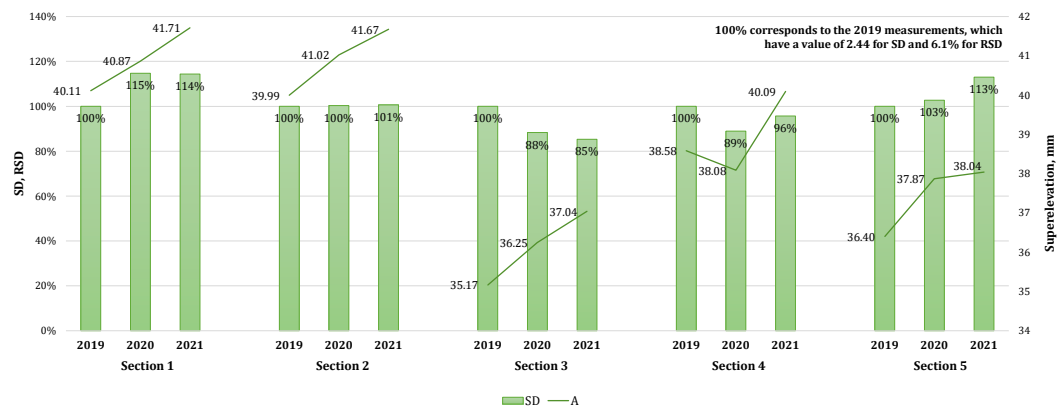
**Figure 20.** Statistical characteristics of the superelevation values of the selected sections

Figure 20 shows the results obtained from the evaluation of the measurements. Similar to the track gauge parameter, the basis of the standard deviation (SD) values is made by the results of measurement in year 2019. The change of the average values of superelevation is shown as the second axis 'y' in the diagram. The relative standard deviation (RSD) values were not monitored in case of superelevation parameter, because shifting these values would make them unrealistically high.

The superelevation values for the examined sections – except Section 4 – increase by approximately one millimeter per year, which means that the inside rail ‘sinks’ by one millimeter per year compared to the outside rail on average. The average of superelevation values of Section 4 decreased by only half a millimeter during the second measurement. However, the average value of the third-year measurement increased by two millimeters compared to the measurement of the first year. So, in this case, the annual increase of one-millimeter average elevation may be true.

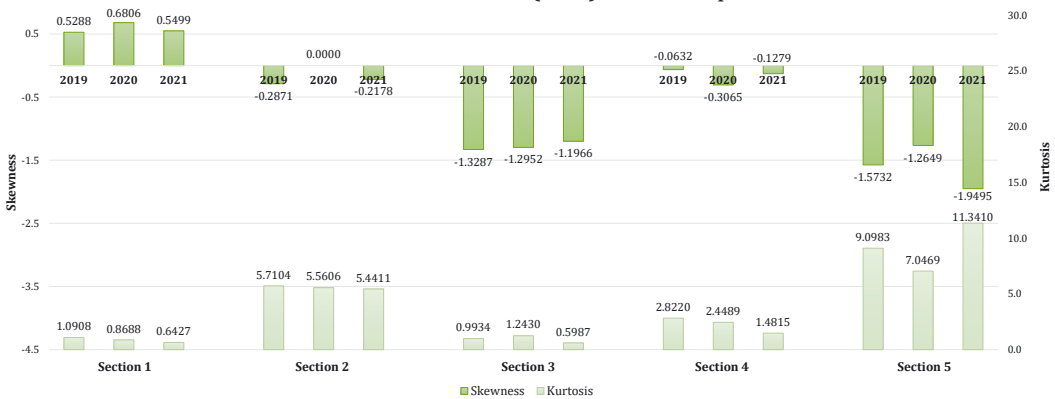
**Figure 21.** The change of the superelevation values of the selected sections over time, considering the skewness and kurtosis indicators

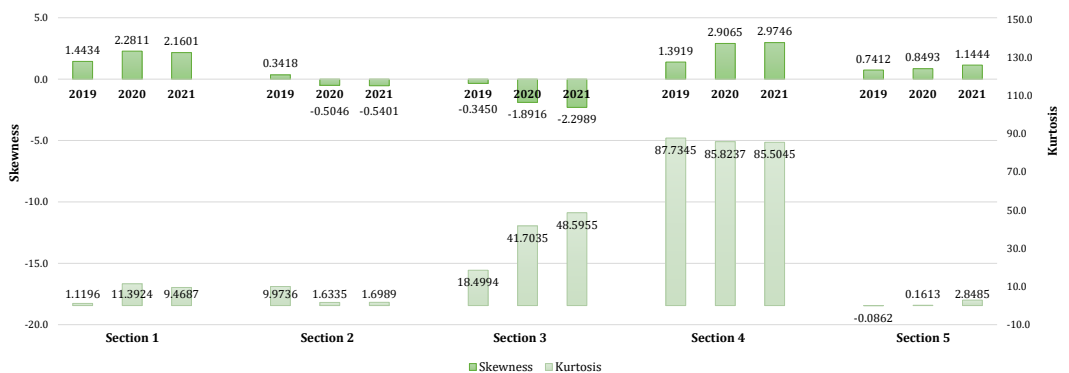
**Figure 23.** The change of the alignment parameter values of the selected sections over time, considering the skewness and kurtosis indicators

Analyzing the alignment parameter values, the skewness and kurtosis indicators were examined by the original measurement results (negative or positive signs). Every selected section value of kurtosis demonstrates a positive sign, so the distribution is more peaked than normal (see Figure 23). The values of skewness of Section 2 and 4 have a negative sign every year, so in these cases, the distribution is skewed to the left. It means that the average is less than the median. For the other sections, the values are positive, so the distribution is skewed to the right, the average is more than the median.

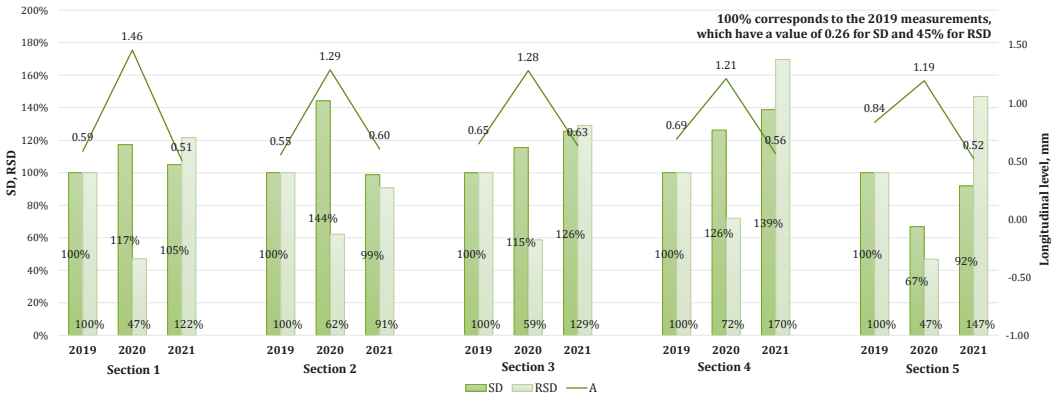
**Figure 24.** Statistical characteristics of the longitudinal level values of the selected sections

The change of the average values of the longitudinal level parameter in absolute terms is shown as the second axis 'y' in the diagram (see Figure 24).

The average values of longitudinal level parameters for each section doubled on average between the measurement results of the first
