# MULTI-SCALE DECAY MECHANISM OF EMULSIFIED ASPHALT COLD RECYCLED MIXTURE UNDER FREEZE-THAW

**Abstract:** The road performance decay law of EACRM under freeze-thaw cycles was studied using laboratory tests on the macroscopic scale in order to comprehensively analyze the serious performance damage mechanism of emulsified asphalt cold recycled mixture (EACRM) in cold regions during the service period. The surface cracking behavior, internal void evolution characteristics, and asphalt mortar morphology damage of EACRM under freeze-thaw cycles were studied by means of digital speckle, industrial CT, and scanning electron microscope (SEM) on the mesoscopic and microscopic scale. The results show that along with the increase in the number of freeze-thaw cycles, the road performance of EACRM decreases significantly. The surface of EACRM obviously cracks, and the width and number of main cracks increase significantly. The fatigue times of the maximum horizontal strain in the whole field gradually decrease. Air voids and the average volume of meso-void visibly

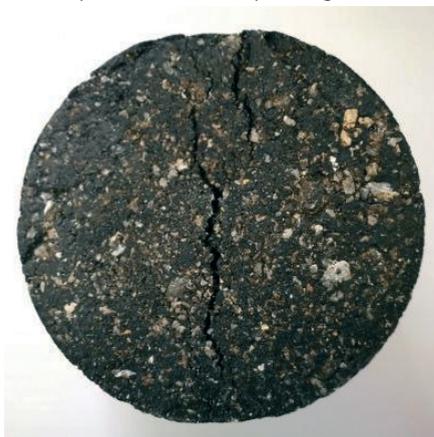
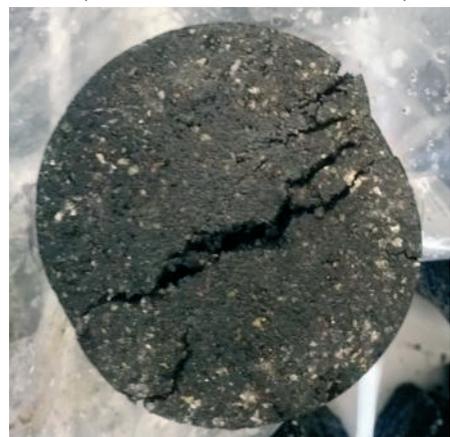
Figure 3. Specimens after test

(a) A specimen after splitting test

(b) A specimen after freeze-thaw splitting test

It can be seen from Figure 3 that the appearance, failure form, and distribution of freeze-thaw test specimens after the split test are basically the same as those of the test pieces without freeze-thaw conditions. The failure forms are mainly manifested through cracks distributed along the radial direction, and each test specimen tends to be consistent. It indicates that the test specimen molding is relatively uniform and the variability is small. However, the cracks of freeze-thaw specimens are also accompanied by several branch joints, and the damage is more serious. This indicates that the freeze-thaw effect has a more significant impact on the strength attenuation of EACRM.
