TECHNICAL ASSESSMENT OF 120-YEAR-OLD RAILWAY RIVETED TRUSS BRIDGE

ANDRZEJ AMBROZIAK*, MACIEJ MALINOWSKI

*Faculty of Civil and Environmental Engineering, Gdansk University of Technology, Gdańsk,
Poland*

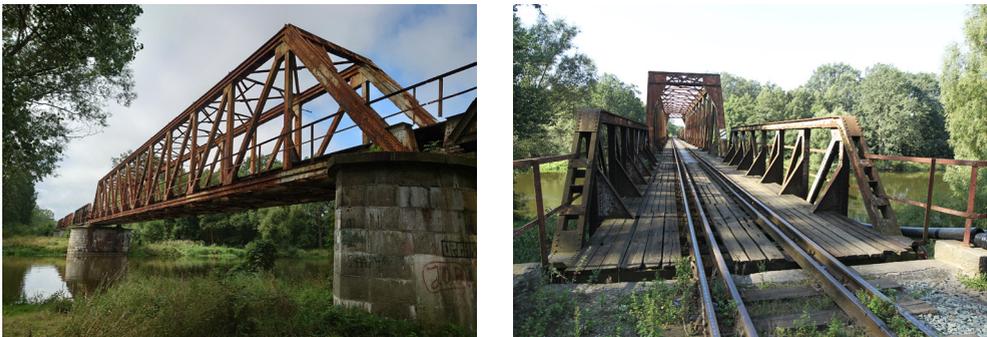
The railway riveted truss bridge (see Figure 1), which is the subject of this study, is located over the Bóbr River, Poland. The year of construction of the bridge was 1904 (see Figure 2), while in 1957 the bridge was completely renovated. The renovation covered cleaning of corrosion and applying protective paint coatings, as well as replacing the deck sheathing. After nearly 50 years of service, it is necessary to verify that the bridge meets today's load requirements in terms of bearing capacity, and serviceability state and make decisions on a range of reconstruction and repairs.

Figure 1. View on railway truss bridge

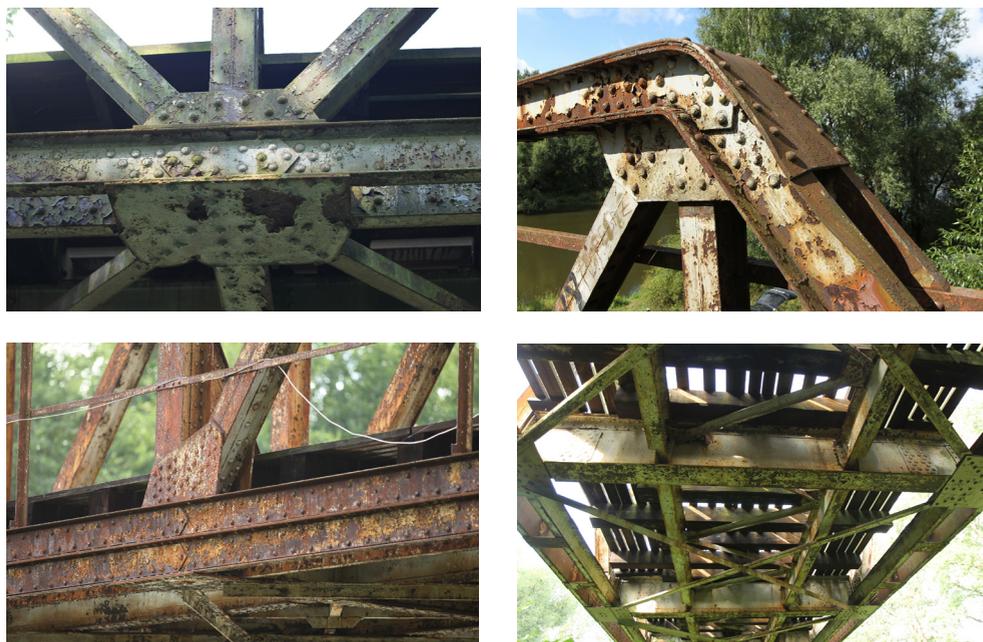
The technical condition of the bearing-capacity structure of the bridge (see Figure 5), after the bridge technical inspection, is assessed as inadequate. The condition of the span structure bridge deck, supports, slopes and embankments are considered sufficient. The railway superstructure condition on the facility is insufficient due to a lack of anti-derailment plates, fire protection plates, and compensating devices, and the profile of the rolling rails was inconsistent with ID-2 (PKP, 2005). Expansion joints are faulty operation because expansion joints jammed – blocking the span structure for the horizontal shift on supports No. 3 and 6. The condition of the railway superstructure on the access roads, the load-bearing structure of the spans – lattice girders (degree of corrosion, local deformations, cracks, losses), bearings (degree of corrosion, contamination, excessive displacement of movable bearings on pillars No. 3, 4, 6), service sidewalks (surface defects) is considered insufficient. The bridge site inspections indicated that the bridge was eligible for repair due to high corrosion, local deformations and cracks of structural elements, which was an issue for the bridge superstructure.

Figure 5. Bridge technical inspection – view on chosen defected elements of the railway truss bridge

- Taking into account the age of the object, its technical condition and the current carrying capacity, a more justified decision from the economic and technical point of view is the decision to replace the object with a new one. This variant is more expensive than the renovation of the facility, but ultimately, a facility with parameters that meet the currently applicable standards and technical requirements is obtained.

- Necessary renovation works can be divided into variants depending on the necessary date of their implementation and the goal that will be achieved after their completion: works necessary to be performed immediately to ensure the safety of use; works to ensure the safety of use and protection of the facility against further degradation; works to ensure the safety of use and restore the functionality and proper load capacity of the facility.

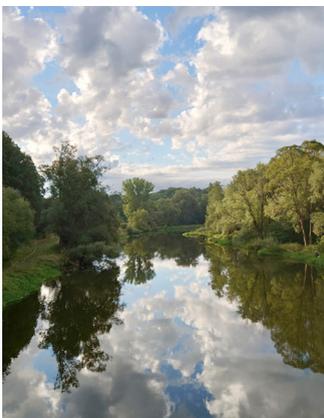
Bathymetric measurements of the riverbed within and in the vicinity of the bridge are performed (see Figure 6). The measurement of the bottom elevation was made with a single-beam HydroBox echo sounder with a 200 kHz transducer. The echo sounder was positioned using the RTK GPS - Leica System1200 satellite positioning system, which used the correction of the position transmitted from the LEICA SMARTNET system. The digital model of the riverbed is created by the grasshopper method, which involves targeted measurements at specific points. Based on measurement points, isobaths and cross-sections are generated. The riverbed digital model is made in a hydrographic program.

Figure 6. The banks of the Bóbr River near the bridge site

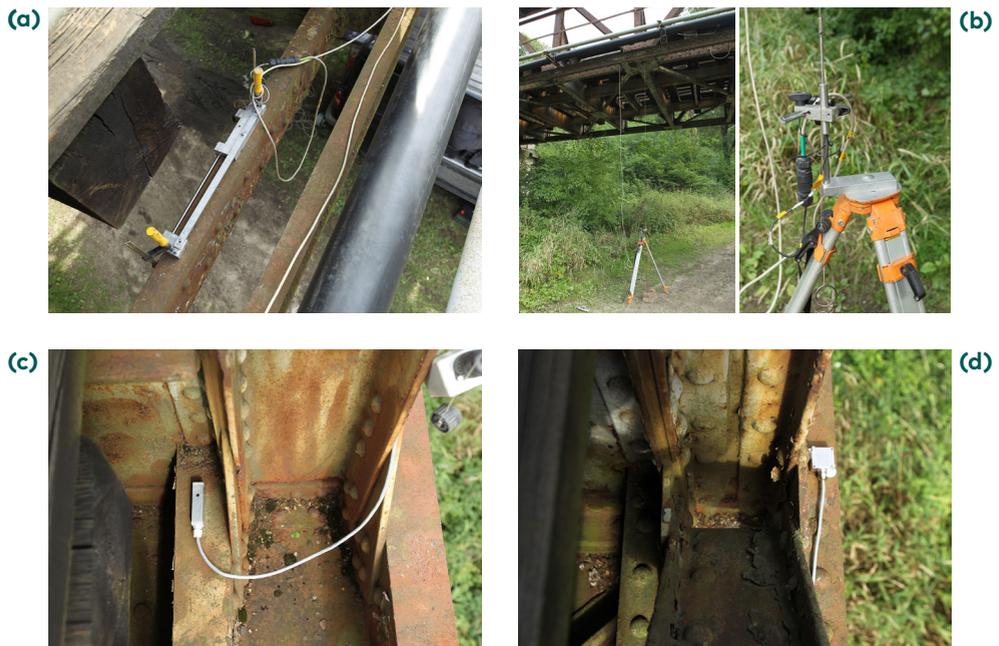
Dynamic measurements of bridge spans under actual service load (passage of trains) were performed. The dynamic analysis of bridges under moving loads requires the determination of the dynamic parameters of bridge spans and moving vehicles (Kilikevičius et al., 2018; Paeglitis & Paeglitis, 2014; Siwowski et al., 2021; Szafranski, 2021; Zoltowski et al., 2022; Zwolski & Bien, 2011). The dynamic tests cover the following: measurements of the vertical and horizontal components of transverse accelerations of span structures; measurements of vertical displacements – deflections of span structures; and measurements of strains and normal stresses in the bottom chords of truss girders (see Figures 9 and 10).

Figure 9. View on chosen measurement points: (a) – Strain measurement point; (b) – Vertical displacement measurement point; (c), (d) – Acceleration measurement points
