AN EXAMPLE OF ROAD DETERIORATION AND STABILIZATION SOLUTIONS WITH BORED PILE: LOCAL LANDSLIDE TRIGGERED BY GYPSUM KARST ON THE ULUYAZI CAMPUS ROAD (ÇANKIRI, TÜRKİYE)

Abstract. A localized landslide that occurred on a specific section of the road to the Uluyazi Campus of Çankırı Karatekin University seriously threatened road safety and disrupted transportation continuity. In this study, the ground conditions of the landslide area were examined in detail. Soil parameters were determined through field observations, drilling, Standard Penetration Test (SPT) data, laboratory experiments, liquefaction potential, bearing capacity, and consolidation behaviour were analysed. The analyses showed that the soil was safe in terms of liquefaction and that the bearing capacity was at a level suitable for road construction and use. However, consolidation settlements and dissolutions in gypsum levels were identified as critical factors that could trigger landslides. To prevent landslides

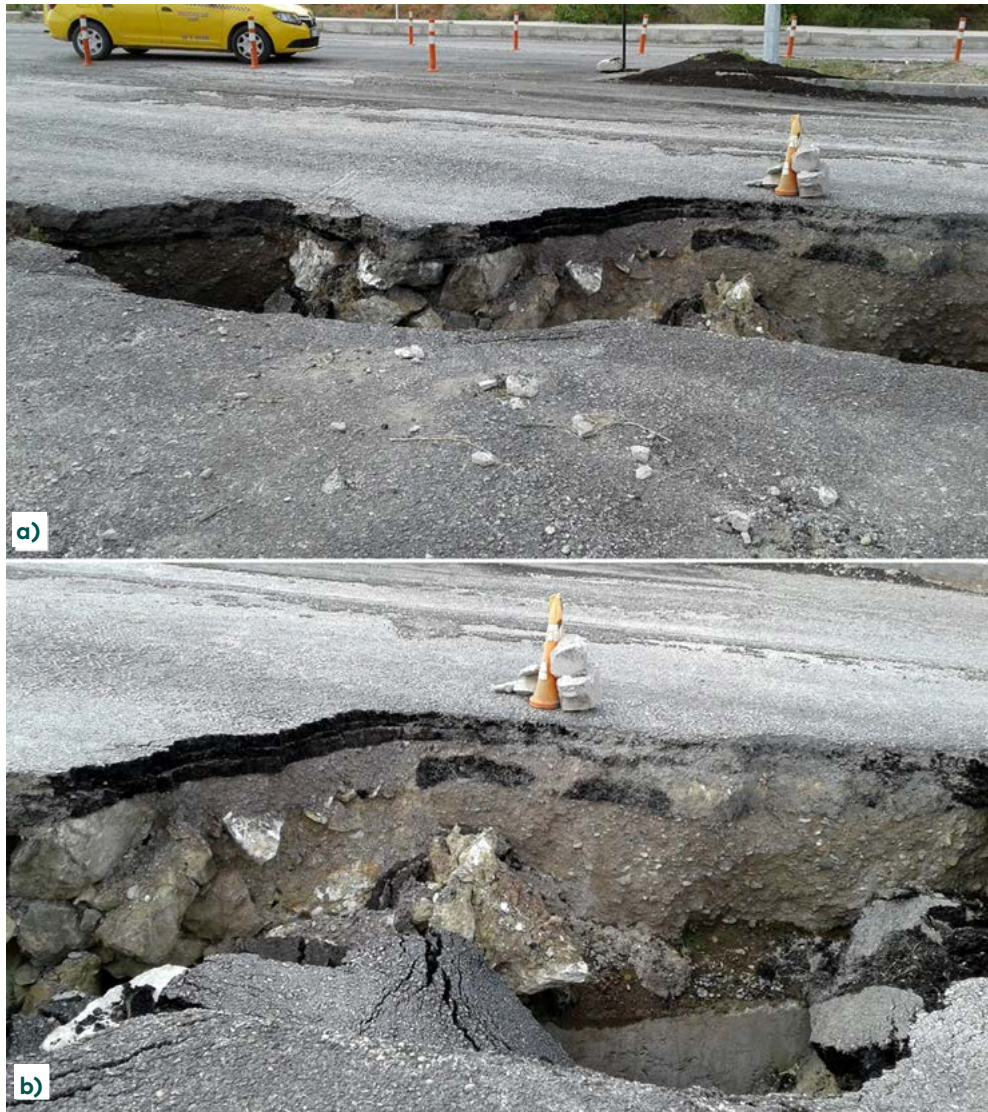
Gypsum levels are the most critical lithological component of the region from an engineering perspective. Gypsum is a mineral that dissolves easily when it comes into contact with water. Therefore, contact between groundwater and rainwater and gypsum layers leads to the development of dissolution voids over time. Dissolution voids disrupt the homogeneity of the ground, reduce its bearing capacity, and cause sudden settlements and local stability losses. This process poses significant risks, especially in the subgrade where road embankments are located. Field observations revealed that different settlements developed under the road embankment, causing cracks and fissures to form on the surface. Examination of the sinkholes revealed that the fill material used in the road subgrade consisted of gypsum blocks taken from the road cut. In addition, the aggregate sizes used in the cross-section area of the road superstructure were also observed (Figure 4).

Figure 4. (a, b) Gypsum block filling material of the road infrastructure in the collapse pits and aggregates used in the road superstructure

In addition, gypsum block material, which is used as road fill material and is prone to melting when it reacts with water, can be replaced with more durable fill material such as andesite or limestone. During road alignment works, the rock debris removed from the excavated road, which is mostly gypsum-based, negatively affects slope stability and drainage conditions. Therefore, rehabilitation works should be carried out by excavating the road alignment area. In summary, the landslide problem in the region stems primarily from the alternating structure of fine-grained clay, silty clay, and sandy clay soils with gypsum layers. Material selection and water management are also influential factors. While the installed piles and beams structurally anchor the road to solid ground, the success of this system depends on diverting water away from the roadbed and replacing the gypsum fill initially used during road construction with durable materials. This holistic approach will extend the road's lifespan and maximise driving safety.

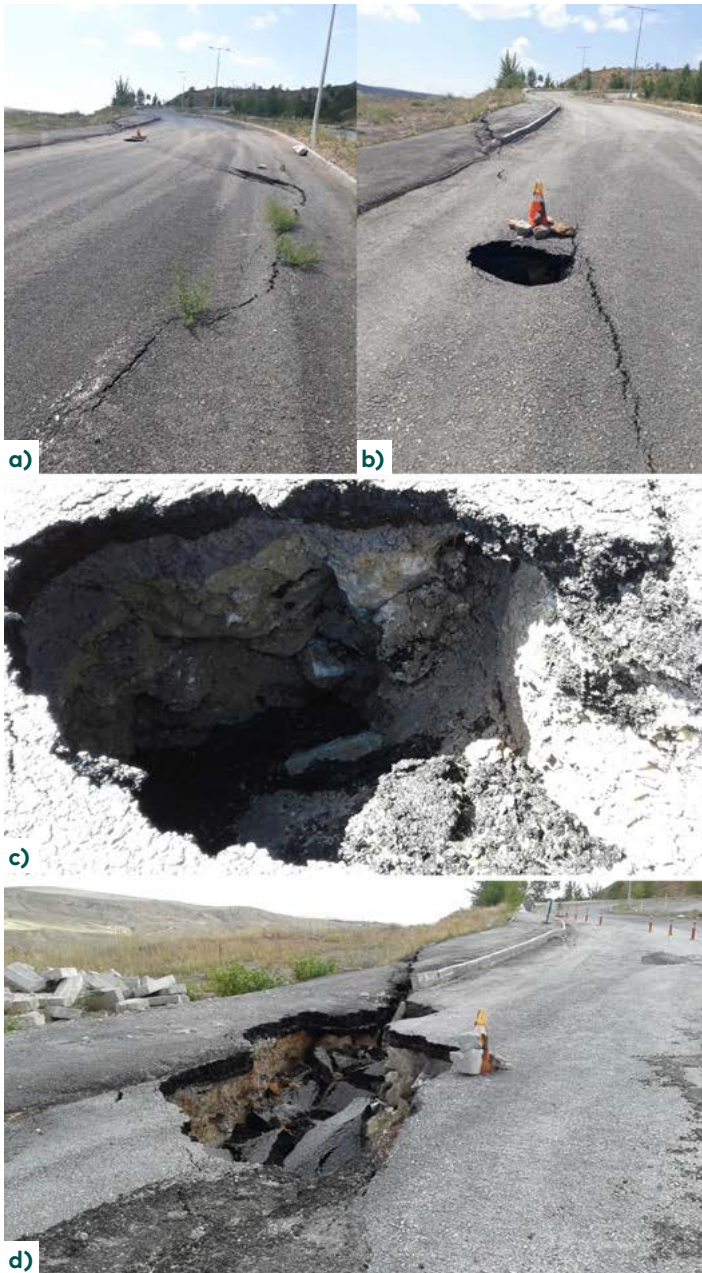
Çankırı Karatekin University, along the Uluşazi campus road, features loose soil characteristics with thin gypsum layers observed in places, consisting of greyish sandy and/or clayey silt (red mudstone) lithological units. Studies have been conducted to investigate a landslide that occurred in a local area along the campus road. The landslide caused subsidence and cracks/fissures in the road surface and deformations in the surrounding area (Figure 5). The subsidence pits grew over time, posing a risk to the road route.

Figure 5. (a, b) Collapse and cracks-fissures on the Ulu yazı campus road surface; (c, d) collapse pits

Based on both field observations and SPT results, it was understood that the ground in the area where the landslide occurred consisted mainly of clay and silty clay. The landslide was defined as a soil slide. The landslide caused subsidence, cracks, and fissures in the road pavement. It was understood that gypsum blocks taken from the road cutting were used as fill material in the road infrastructure. Melting voids occurred as a result of the interaction of gypsum levels with groundwater and surface water. In addition, the rise/swelling of the clayey soil from the base into the sub-base and base materials also triggered the landslide on the road route. This situation indicates that the clayey structure of the ground is facing not only physical but also chemical dissolution. The shallow groundwater level (5.0–6.5 m) gradually dissolved the gypsiferous material in the fill, creating invisible voids beneath the road. Consequently, the combination of swelling pressure from the clayey soil and these melting voids led to inevitable cracks and settlements in the road superstructure.

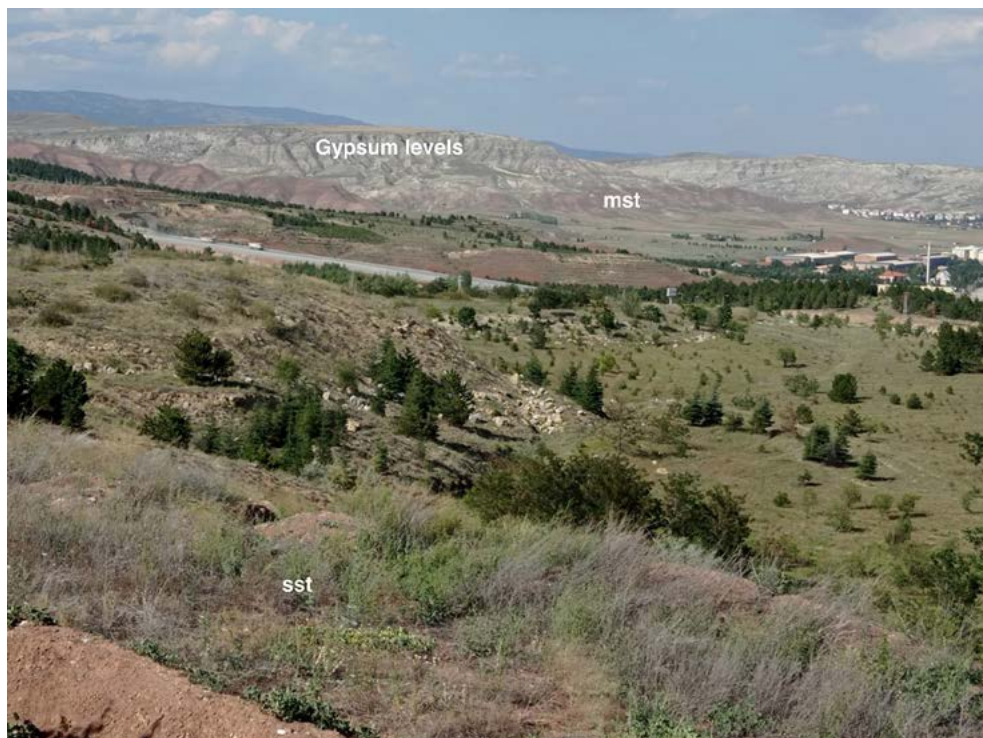
Figure 6. The area where the drilling well is located, silty sandstone (sst), gypsum levels and dark brown-reddish mudstones (mst)

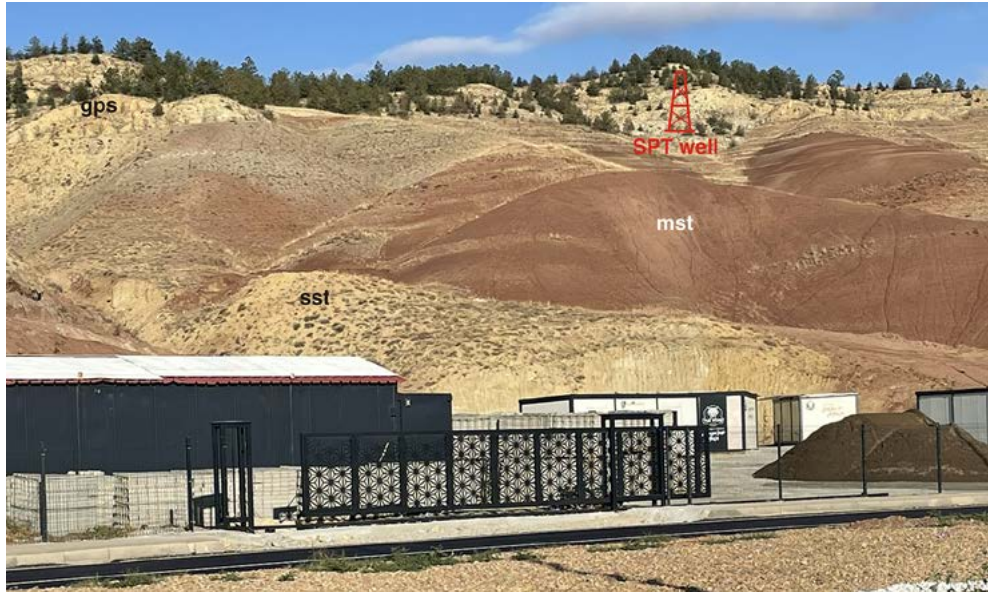
Figure 7. The SPT used in the area located in the dark brown-reddish mudstones (mst) and thin-grain sandstones (sst) containing gypsum (gps) layers

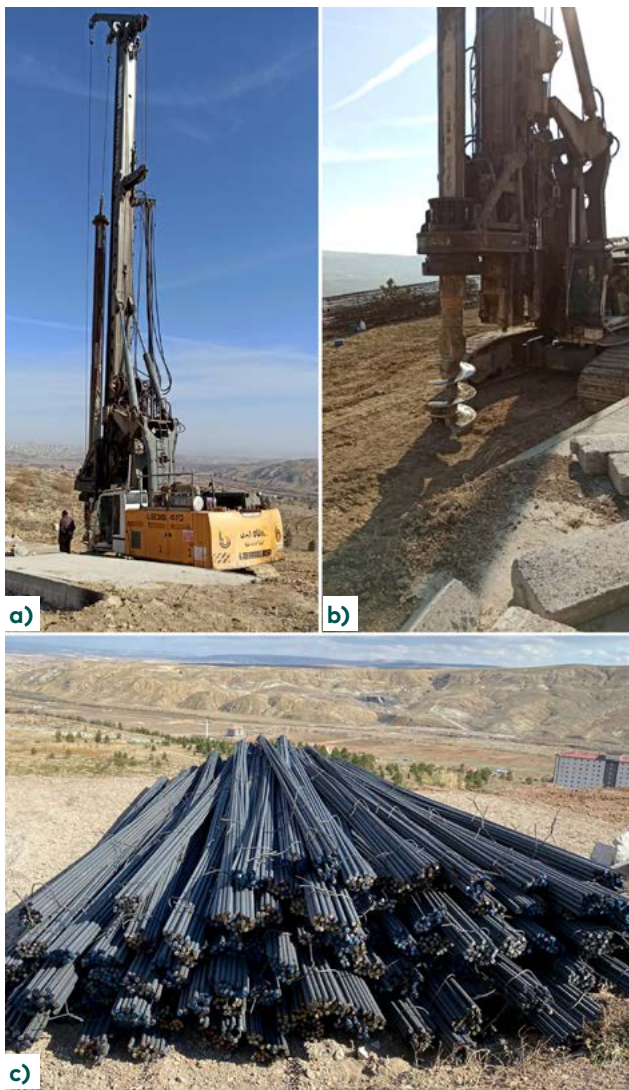
Similarly, in the wells dug for the pile foundation ground improvement application, the first 5 meters consisted of fill gravel, followed by hard clay between 5 and 10 meters, and gypsum-rich claystone and mudstone with low strength between 10 and 35 meters (Figures 9, 10).

Figure 9. (a, b) Drilling work related to bored pile works in the field, (c) Bringing the bored pile reinforcements to the study area

The goal is to ensure ground stability with a 2-row, 120 cm diameter, 1.4-meter spaced, 35-meter-long fore pile support structure. A bored pile consists of 3 woven

reinforcements, each 12 meters long, joined end to end. Thus, the bored pile machine drove 200 piles to a depth of 35 meters. The bored piles are connected to each other by a top-level cap beam. The size of the cap beam is 1.2 m. $\Phi 32$ diameter longitudinal reinforcement (length 12 m); 24 pieces, $\Phi 16$ diameter main stirrups; 6 pieces, $\Phi 10$ diameter auxiliary stirrups; 97 pieces of 1.5 m reinforcement bars spaced 10 cm apart; in each drilling hole: $\Phi 32$ longitudinal reinforcement $\times 3 = 24$ pieces $\times 3 = 72$ pieces; $\Phi 16$ main stirrups $\times 3 = 6 \times 3 = 18$ pieces; $\Phi 10$ auxiliary stirrups $\times 3 = 97 \times 3 = 291$ pieces were used. C30/37 class concrete was poured into the holes dug for the piles.

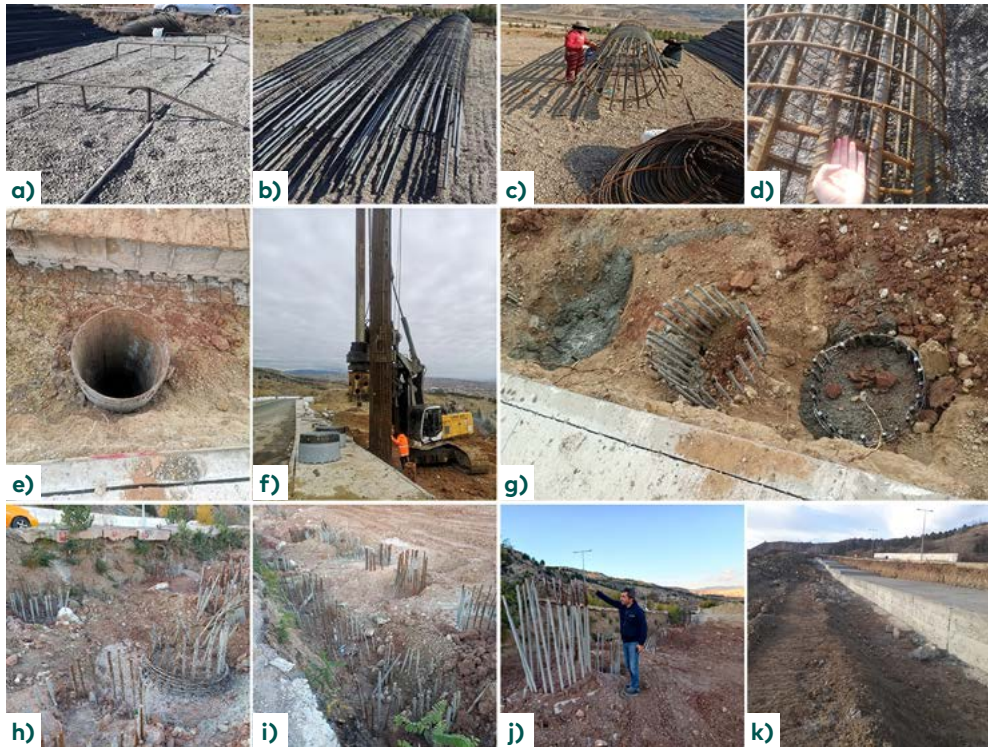
Figure 10. (a) Reinforcement workbench set up in the inspection area; (b, c, d) Preparation of reinforcements with stirrups and steel ties; (e) Circular section drilling for bored pile application; (f) Placement of steel reinforcement in the bored pile hole; (g) Formation of bored piles; (h, i) Application of the bored pile work with two rows; (j, k) Reinforcement and concrete of the cap beam

To prevent landslides, it is essential to reduce the drag force that causes masses to move downhill along the slope or to increase the holding force that prevents the movement of masses. In the study area, the relevant institution and company opted for the use of bored piles to transfer the structural loads from weak soils to more stable soils and to ensure highway safety in the event of natural disasters such as landslides, ground movement, and earthquakes. In this context, as part of the landslide solution proposal, two rows of 200 piles, each 120 cm in diameter, spaced 140 cm apart, and 35 m in length, were installed. Additionally, a 1 m thick cap beam was added.
