THE BALTIC JOURNAL
OF ROAD AND BRIDGE ENGINEERING

PROTECTION OF BRIDGES AGAINST STRAY CURRENT CORROSION

Abstract. A case study of Siennicki Bridge stray current corrosion hazard is presented. A corrosion risk was caused by incorrectly designed tram line traction which goes over the bridge. No dielectric insulation between running rails and bridge steel construction was used. A variety of protection methods against stray currents are described. Characteristics of the endangered bridge were described. Impressed current cathodic protection system against stray currents was proposed and designed at the Department of Electrochemistry, Corrosion and Materials Engineering, Gdansk University of Technology. Coupon technique measurements and potential measurements were performed to verify the effectiveness of the protection system.

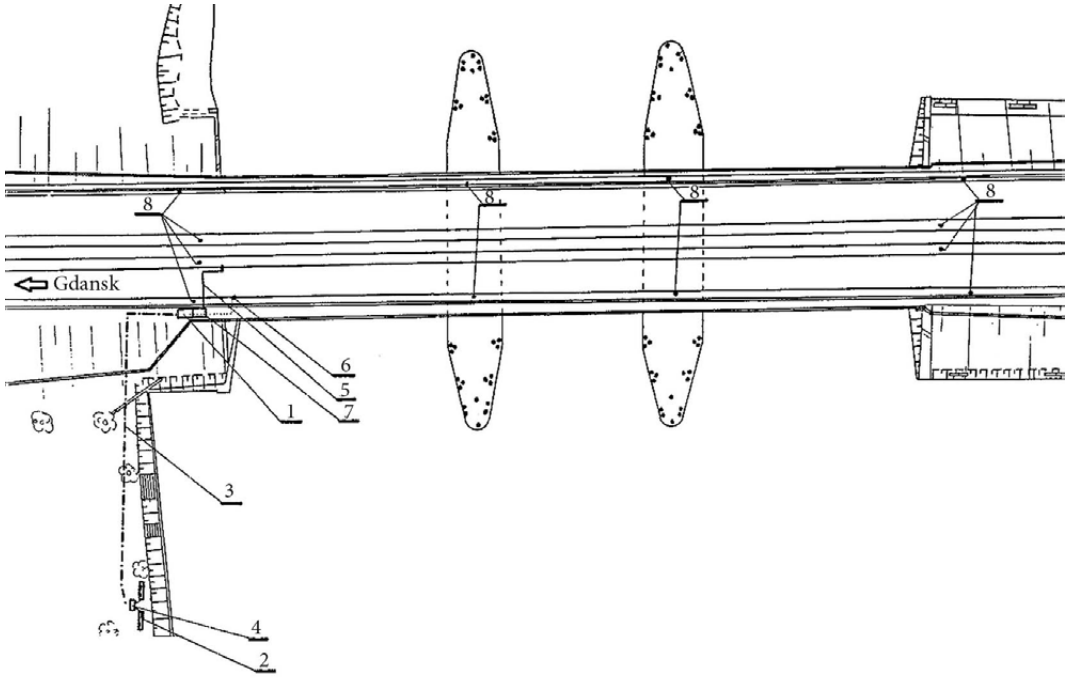
Fig. 2. Simplified scheme of Siennicki Bridge: 1 – cathodic protection station; 2 – multi-anode groundbed; 3 – anode cable; 4 – anode test station; 5 – cathode cable; 6 – potential cap; 7 – remote control system; 8 – permanent zinc reference electrodes

was found that a satisfying stray current protection was reached with one CP station. Anodes were placed at the riverside. The protection current demand was approx 20 A. Cathodic protection system circuit consisted of: cathodic protection station, electrical power supply line, multi-anode groundbed, anode cap and cable, cathode cap and cable. Test and verification circuit consisted of: permanent zinc reference electrodes, pilot $Cu/CuSO_4$ electrode, potential cap and cable, remote control system, anode test station. A simplified scheme of the protection system and its elements placement is shown in Fig. 2. Orientation of the bridge in Figs 1–2 are complaint.

The cathodic protection installation was placed on the left side of the bridge (from Fig. 1 point of view). Parameters of the cathodic protection station were as follows: adjustable current intensity up to 30 A at the maximum output voltage of 40 V. The cathodic protection system was supplied from the bridge electric lighting system. The groundbed was designed as a group of four anodes ϕ50×2000 mm made of high silicon cast iron. Anodes were buried and placed in a graphite-coke backfill in order to lower the current spread resistance. The groundbed was localized approx 50 m away from the bridge. The anode spread resistance equalled 2.15 Ω. Cable YKOXs 1×16 mm^2 (shipboard power cable with cross-linked polyethylene insulation and PVC sheath) connecting CP station to anodes was buried in soil. The cathode cap was made by connecting the cable (YKOXs 1×16 mm^2) from CP station to the steel span of the bridge. Pilot electrode – saturated $Cu/CuSO_4$ electrode of a cylindrical shape (110 mm×250 mm) was connected to the CP station with a buried cable (YKOXs 1×4 mm^2).

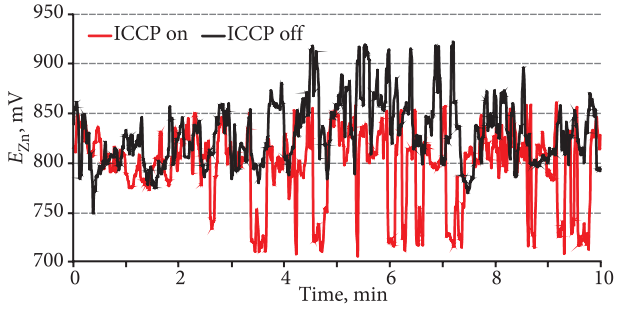
Fig. 3. An example of bridge potential changes

Exemplary registers fragment of bridge potential E_{zn} measured against one of the zinc reference electrodes,

which was placed near the left bridgehead, is presented in Fig. 3. There are plots where protection current is turned on and off. Quick potential shifts are typical for the interaction of dynamic stray currents which originate from the tram traction (Zakowski, Darowicki 2003). When the cathodic protection current was switched on the bridge average daily potential was lowered by about 80 mV. This fact indirectly indicates that the corrosion rate of bridge metal elements was hindered.

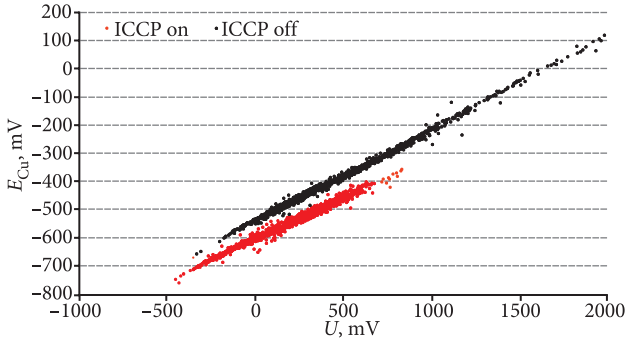
Fig. 4. Potential–voltage correlation spectra measured at the left bridgehead

Furthermore, a correlation plot has been plotted for a relationship between the stray current electric field vector in soil and the bridge potential (Fig. 4). The electric field vector U was measured between two zinc electrodes, the bridge potential E_{Cu} was measured against a portable saturated copper reference electrode. The upper spectra in Fig. 4 corresponds to the ICCP turned off, the lower spectra to the ICCP turned on. The protection effect is visible as the downward shift of the spectra.

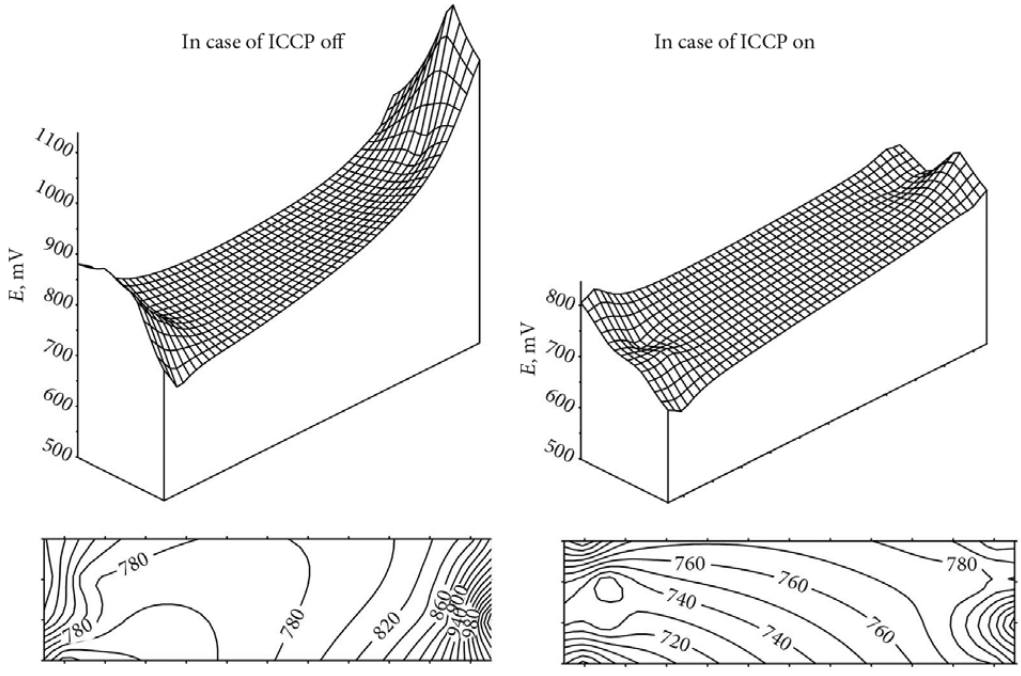
Fig. 5. Potential distributions of the bridge

The left diagram in the Fig. 5 indicates that without the cathodic protection the bridge potential was higher at the right bridgehead. It implies that the anodic polarization of the structure was greater there. This phenomenon was caused by greater stray current density outflow from

the bridge metal parts to the environment. Thus the stray current corrosion hazard was graver at the region of the right bridgehead. Such a potential distribution was caused by the tram substation location. It was located few kilometres away to the right from the bridge. Stray currents flowing out from the bridge tend to flow in the substation direction. When the cathodic protection station was turned on the steepness of the potential distribution surface lowered and the average potential value was also lowered.

Thus, the effect of the ICCP system was the lower value of the bridge potential. The left and the right bridgehead potential were lowered by approx 80 mV and 200 mV, respectively. The protection effect was satisfying. Almost the whole bridge construction met the 100 mV polarization criterion requirement which is given in the European standards *EN-12696:2000 Cathodic Protection of Steel in Concrete* and *EN-14505:2005 Cathodic Protection of Complex Structures.* The magnitude of the potential shift indicates that the cathodic current of greater intensity flew through the right bridgehead. It also indirectly indicates that the spread resistance at the right bridgehead is lower compared to the left bridgehead.
