CONCRETE BRIDGE DETERIORATION CAUSED BY DE-ICING SALTS IN HIGH TRAFFIC VOLUME ROAD ENVIRONMENT IN LATVIA

Kristaps Gode¹, Ainars Paeglitis²✉

Institute of Transport Infrastructure Engineering, Riga Technical University, Kalķu str 1, LV 1658 Riga, Latvia

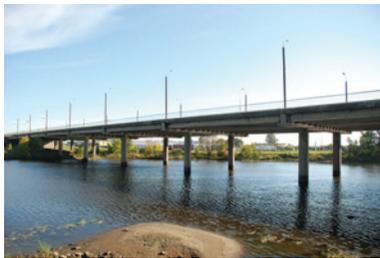
Fig. 4. Bridge over Bieķengrāvis

The bridge over Bieķengrāvis is situated on the left side of the river Daugava in the municipality of Riga and is part of the Salu Bridge complex (Fig. 4). Bridge has six traffic lanes, speed limit of 70 km/h and traffic volume of over 60 000 vpd. The bridge consists of 15 simply-based prestressed girder (bulb-tee beam) spans (concrete class M450) and is 384.7 m in length. This bridge was constructed in 1973.

The bridge above each pier has two joints, which are the weak point of these type structures (Fig. 5). Leaking joints may cause reinforcement corrosion damage to cap beam and tail-end parts of the prestressed bulb-tee beams.

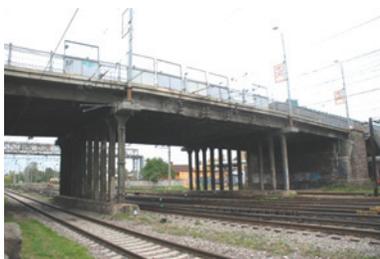
Fig. 6. Bridge over the railroad ("Gaisa tilts") in Riga

This bridge is situated in municipality of Riga, where continuation of highway A2 enters the city centre. The bridge has only two lanes of traffic and two tram lines, which are used as a third traffic lane during rush hours. The speed limit is 30 km/h and traffic volume is over 35 000 vpd. The bridge consists of three simple beam spans which overpasses five railroad tracks (Fig. 6). The superstructure and the middle span piers were built in 1963, whereas the masonry stone abutments were built in 1906. The side spans have 13.24 m long reinforced concrete T-beams (concrete class M300); the middle span has 16.76 m prestressed concrete beams (concrete class M400). The waterproof membrane beneath tram lines has been deteriorated and beams (especially side span beams) are exposed to moisture and de-icing salts.

The bridge has deteriorated and also has leaking waterproof membrane beneath tram lines (Fig. 14). During inspection it was stated that corrosion of reinforcement bars in the beams is developing, what is causing the concrete cover to crack and delaminate. Two samples for chloride

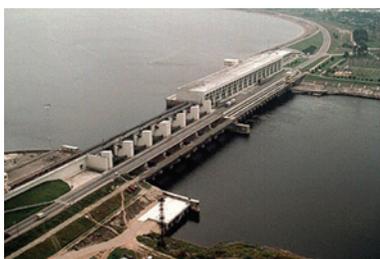
Fig. 7. Bridge over the Daugava River near the hydro power plant

This bridge is situated on the Riga bypass highway A5 (Fig. 7). The bridge is located beside a hydro power plant "Rīgas HES" and has two lanes of traffic with of over 10 000 vpd. The bridge was built in 1973. The superstructure of the investigated bridge consists of six 24 m long spans; each span has six prestressed concrete bulb-tee beams of 450 kg/cm² compressive strength at 28 days (concrete class M400). Above each pier there is one expansion joint.

investigation were obtained from the bottom part of the beam near reinforcements. This bridge also has leaking joints that cause chlorides to reach surfaces of the piers
