# LARGE-SCALE TESTING AND LONG-TERM MONITORING OF REINFORCED EARTH ABUTMENT – A CASE STUDY

**Abstract.** Standard methods of controlling geotechnical structures are based on testing of individual elements (e.g., piles, anchors, barrettes) or on inventory of their displacements (for instance, current control, i.e., monitoring of retaining structures). It is only the bridgework where, due to uniqueness and importance of structures, the examinations are often run for the whole structures. The main problems are then the following: how to ensure proper repeatability of measurement accuracy (for long-term testing), how to establish optimum criteria of assessing the test results, how to use the results to make possible repair actions and how to interpret the obtained results. Based on an example of test of bridge abutment out of reinforced earth, the paper presents the method of displacement testing, basic criteria of assessing the results, measurement results during static load phase, during dynamic phase and results of long-term measurements. Large number of measurements enables for both evaluation of technical condition of the structure under testing (which was the main goal of the pr

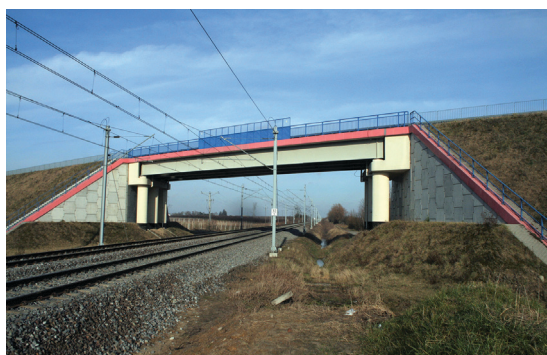
**Figure 1.** General view of the overpass

General view of the object is shown in Figures 1 and 2. Figure 3 shows a selected defect of retaining structure. A set-off between facing panels and their rotations and inclinations are visible. Prefabricates are clearly displaced each other and many of them are not in vertical plane.

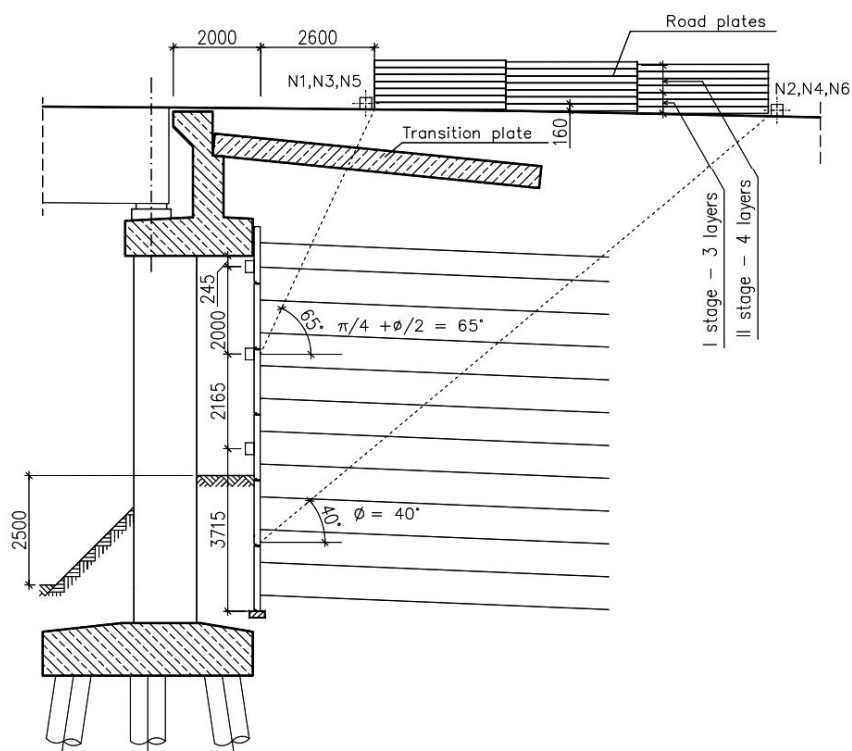
The plates were not placed over the whole transition plate, so as the load was transferred rather to embankment earth than to the support via the transition plate. Load scheme and pressure distribution on retaining structure are shown in Figures 4 and 5. When determining the load position and pressure distribution, the internal friction angle of soil built into the reinforced structure was assumed as  $\phi = 40^\circ$ .

**Figure 4.** Arrangement of loading road plates – longitudinal view, scheme of load transfer to reinforced earth structure

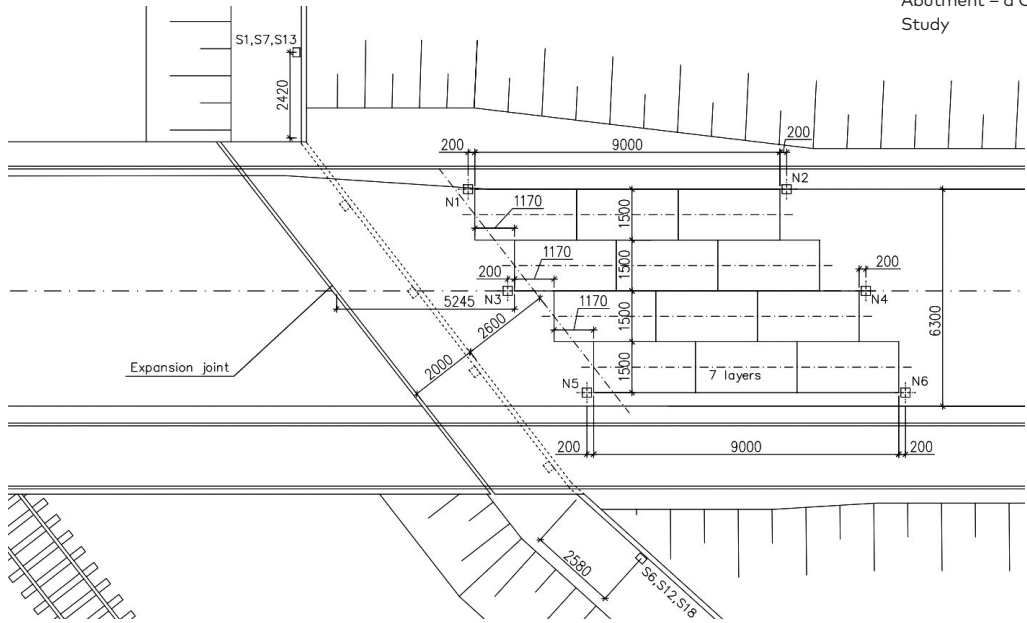
**Figure 5.** Arrangement of load plates – plan view

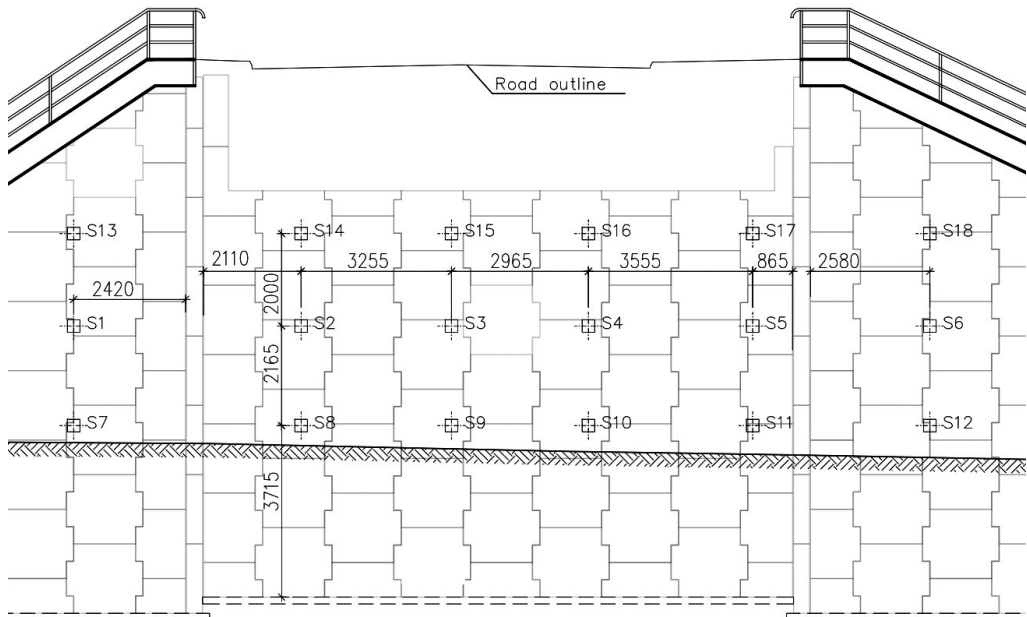
**Figure 6.** Arrangement of control points on front wall and wings of reinforced earth abutment

points S1–S18 were used (see Figure 6). The results obtained from the S1, S2, S4, S7 and S8 control points are not reported in this paper due to the fact that they were destroyed as act of vandalism committed. It should be mentioned that during the test load and immediately after, only slight horizontal displacements, i.e., up to 2.6 mm, were found (see Table 4). The results of long-term measurements of horizontal displacements of the control points on the facing panels are shown in Figures 10–12. It should be noted that Figure 10 shows the results of measurements of the control points located in the middle of the height of the frontal surface and the abutment wings. Figure 11 illustrates the results for the points lying in the lower part of these surfaces, and Figure 12 shows the results for the points lying in the upper part of the structure.
